Inspection Report

115 E. Ogden
Naperville IL

Insight Property Services, Inc

Date: 1/1/2013	Time: 2:54:30 PM	Report ID: HI - 11-012
Property: 115 E. Ogden Naperville IL	Customer: T. Smith	Real Estate Professional:

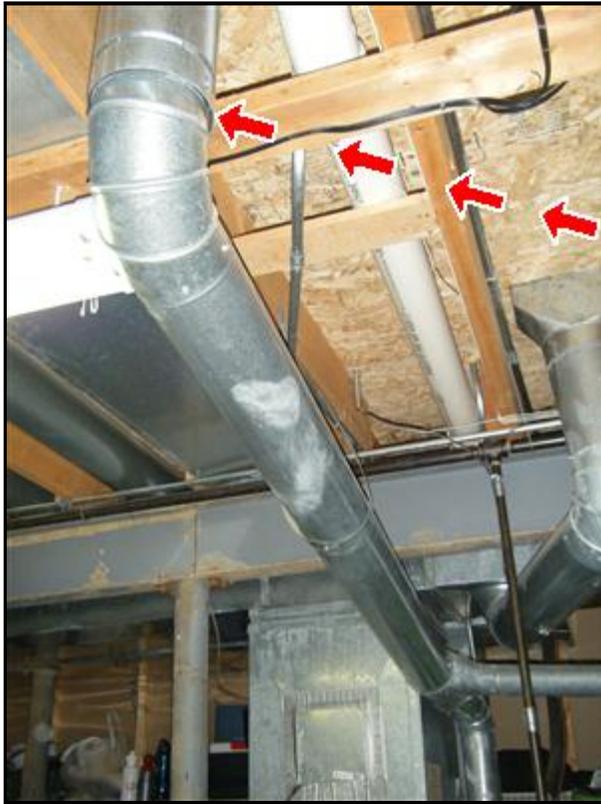
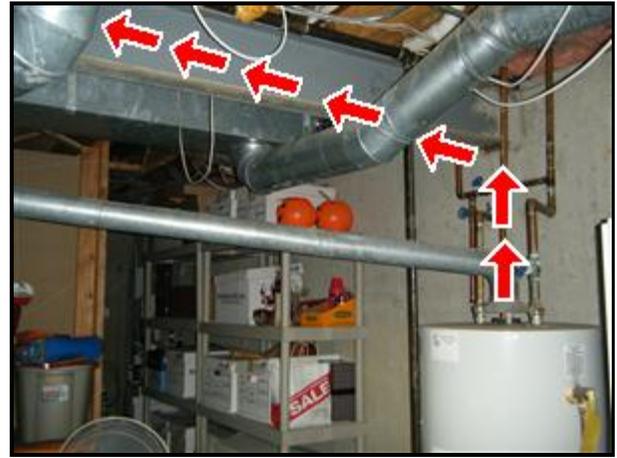
- (1) **Spillage Test Results:** A spillage test was conducted on the water heater. According to BPI Technical Standards, combustible appliances may spill fumes for up to 60 seconds on start up. **Your water heater vent spilled beyond 60 seconds and "Failed" the spillage test.** Under this Worst Case Scenario the spillage did stop at 1.5 minutes. Improving the design of the exhaust piping should alleviate this condition.
- (2) The water heater started to draft appropriately shortly after the one minute benchmark.

Increasing the vertical rise of the water heater exhaust line, at least 8", would help foster greater draft pressure. The vertical pipe can be increased in length as long as the horizontal section maintains a 1/4" per foot rise.

Also, the water heater should join the furnace exhaust with a 'Y' fitting nearer to the vertical section. The Y fosters better upward flow and decreases the chances of exhaust back drafting - only if the furnace & water heater connect at the branches of the Y and both flow toward the main exhaust riser.

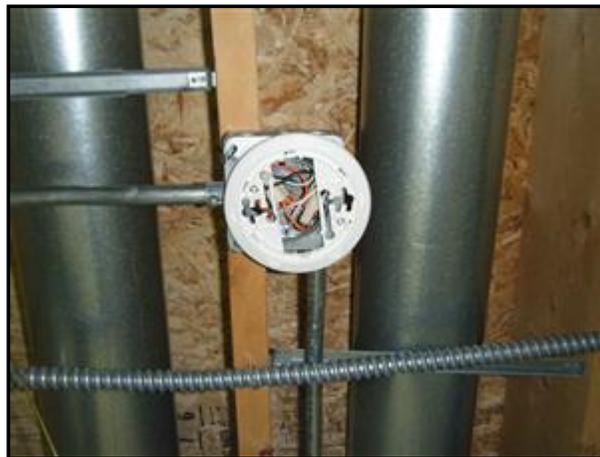
2.20.A Picture 1 Install Detectors

The average service life of a smoke detector is 10 yrs. Be sure to replace batteries yearly and replace the units entirely after 10 years. Recommend one smoke detector per floor and one within 15 feet of the bed rooms.

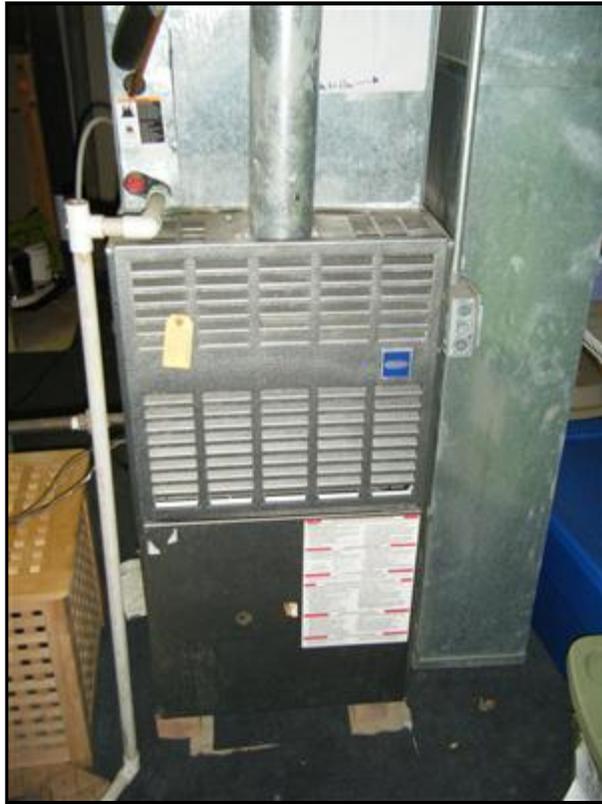
3.0 Picture 1 Furnace

The furnace is 16 years old and is 80% efficient. Considering the relative tightness of the home, upgrading the furnace is the next best opportunity for decreasing the home's gas bill. It is recommended this unit be upgraded to a sealed combustion, 96% efficient or greater unit with an integrated HRV for continuous, balanced fresh air ventilation. A qualified HVAC contractor should perform Manuals J & S calculations to determine the heating & cooling load of the home and proper size of the furnace & AC **after air sealing and insulating have been completed.**

Update: The furnace has been replaced with a new sealed combustion unit. This replacement resolves

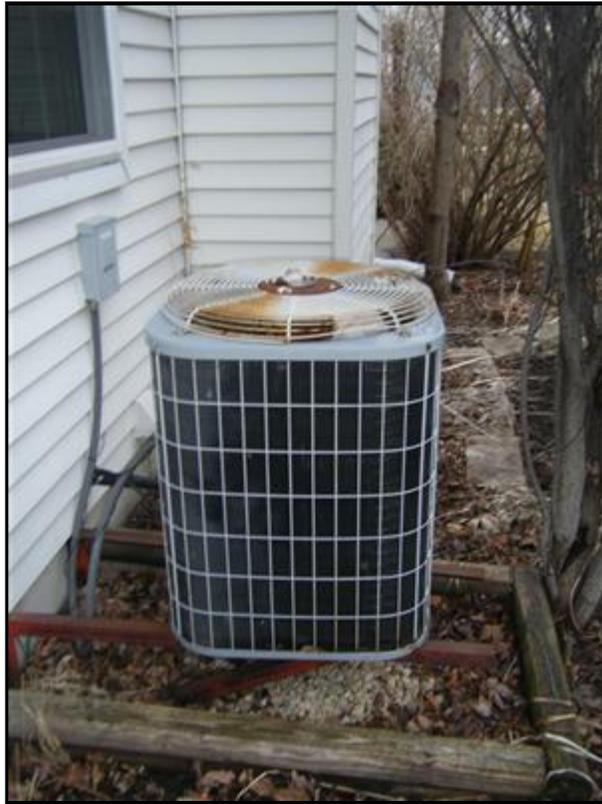
3.1 Picture 1 Air Conditioner

The air conditioner is at least 15 years old, of an estimated life span of 20 yrs. The unit would benefit from regular cleaning and service. Consider upgrading the air conditioner along with the furnace to see reduced utility bills.

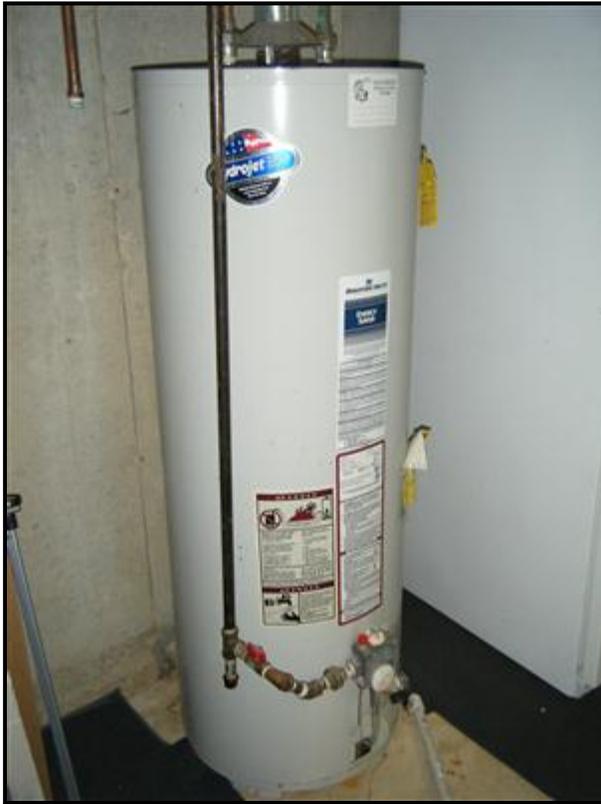
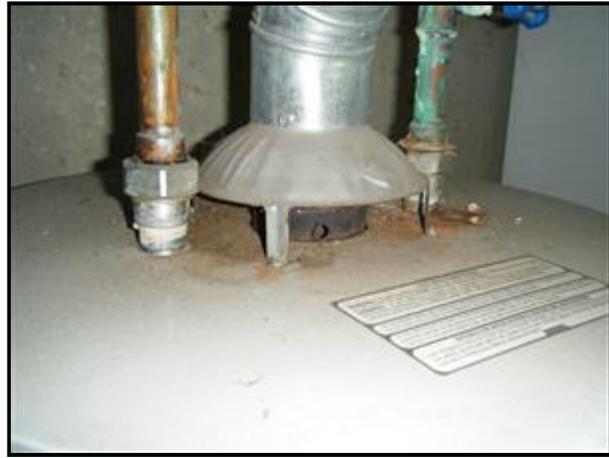
The existing water heater is 15 years old and is beyond the typical life span of 12-15 years. Expect to replace this unit within the next few years. Recommend the unit be upgraded to a power vented or sealed combustion unit. These are more energy efficient and they eliminate combustion safety risks due to exhaust spillage.

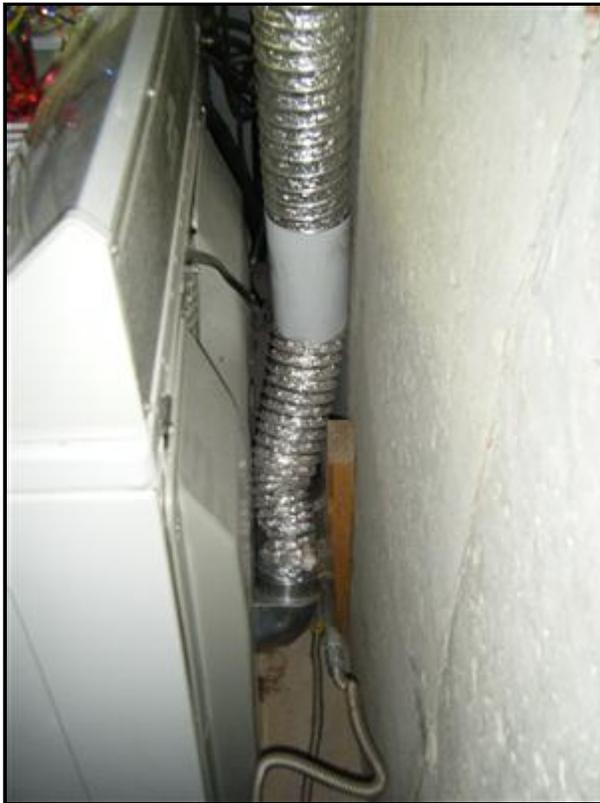
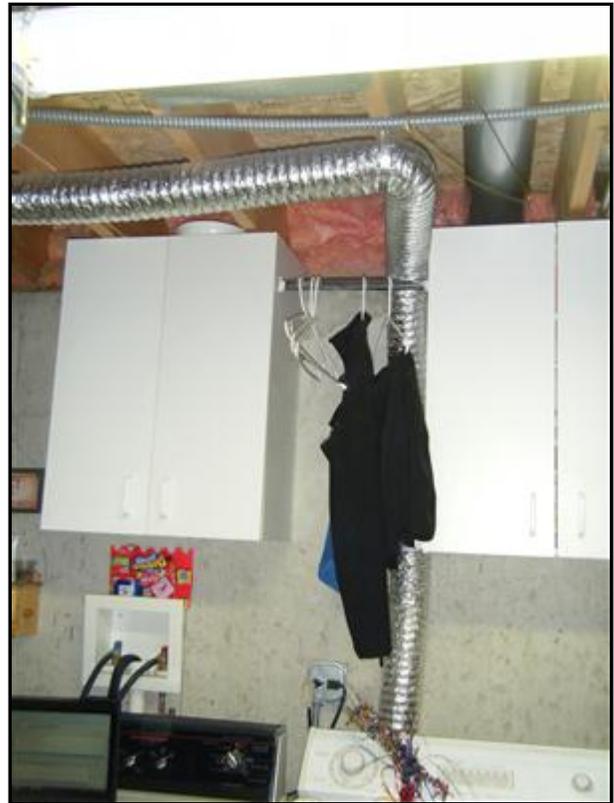
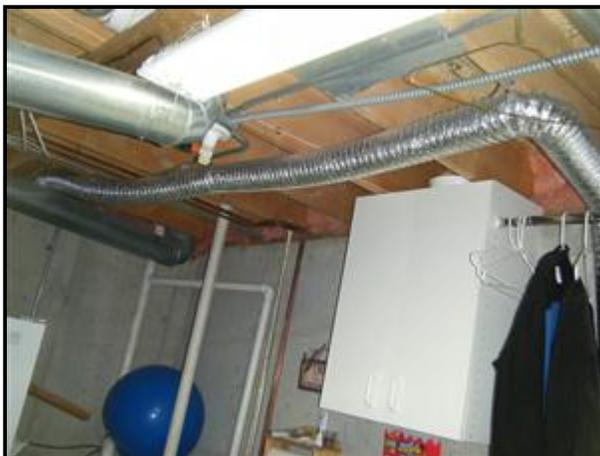
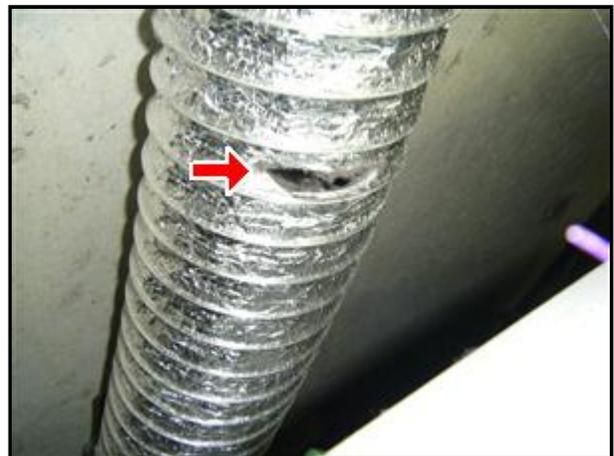
(1) The dryer vent piping is damaged, is kinked, is too long and can trap lint at sags, and also has a long vertical section with 90 degree turns which can trap lint at the elbows. Vent pipes should be cleaned regularly if they are longer than normal (10 feet or more) or vented vertically, and should use the most direct route to the exterior. Replace and re-route the exhaust line with flexible or solid metal pipe.

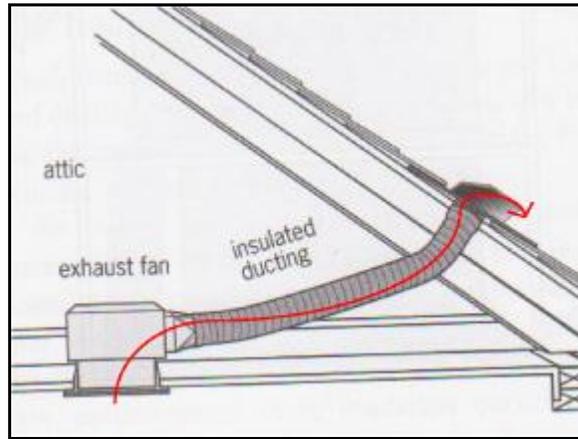
4.6.A Picture 5

(2) The bath fan flow for the Master bath is 41cfm & the 2nd floor bathroom is 32cfm. Considering these bathrooms are used for showering and generate significant moisture, recommend both units be upgraded to a high-quality, quiet (<1.5 sones), 80+cfm exhaust fan.

Both 2nd floor fans are currently run into the soffit where the in-flowing air currents carry moisture back into the attic. The new fans should be exhausted to the outdoors by way of insulated ducting through roof or wall mounted, dampered vents.

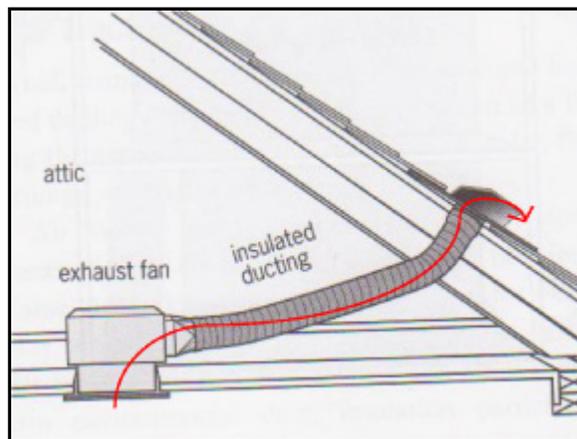
4.6.B Picture 1

There is no exhaust fan in the bathroom. It is recommended that every bathroom have a high-quality, quiet (<1.5 sones), 80+cfm exhaust fan installed. These fans should be exhausted to the outdoors by way of insulated ducting through a roof mounted, dampered vent.

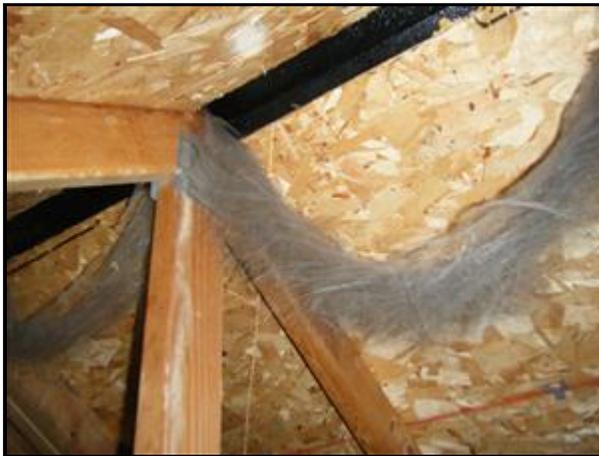
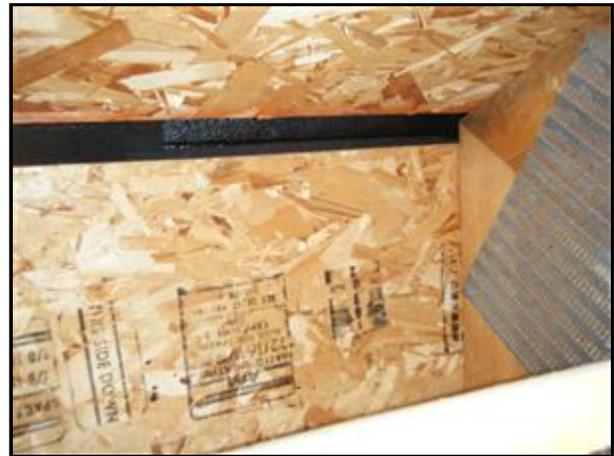
The roof ridge vents appear to be in poor condition and should be replaced. The mesh material that is supposed to allow ventilation while protecting the attic space from pests and the elements is missing or damaged in most places. Water damage in the living room is likely the result of accumulated snow blown into the exposed ridge which then melted onto the attic floor (living room ceiling) below. The damaged area was inspected within the attic for moisture, but no moisture was present at the time of inspection.

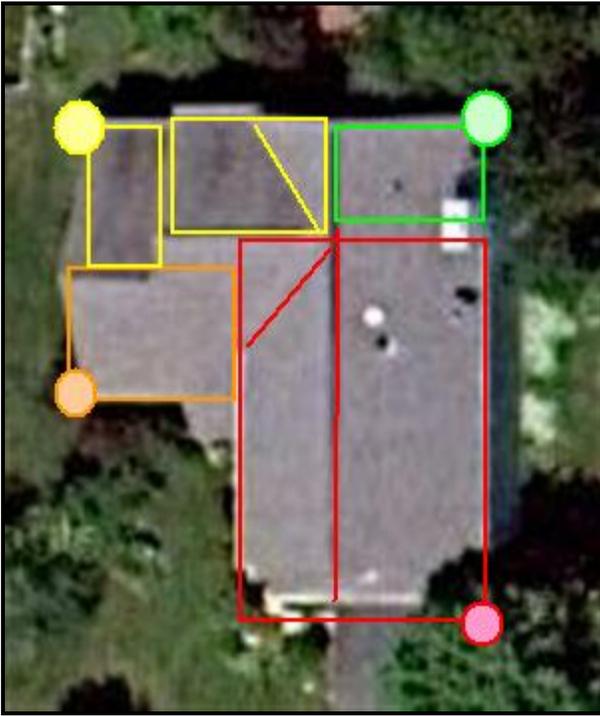
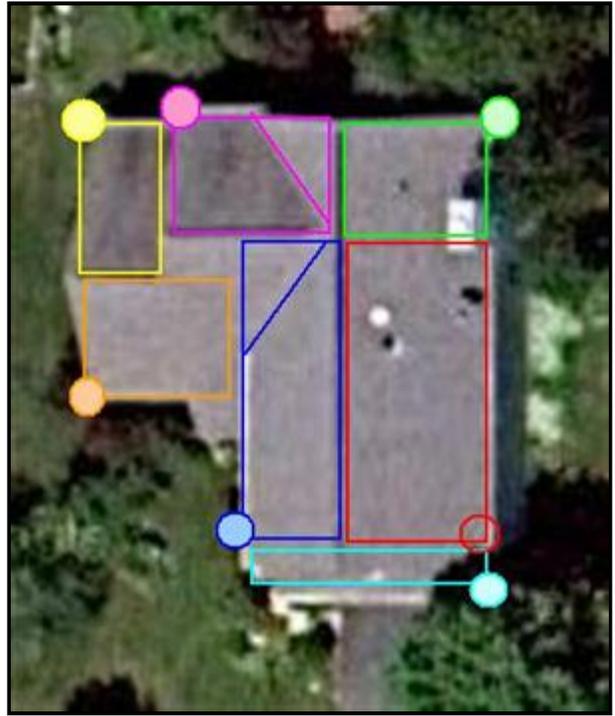
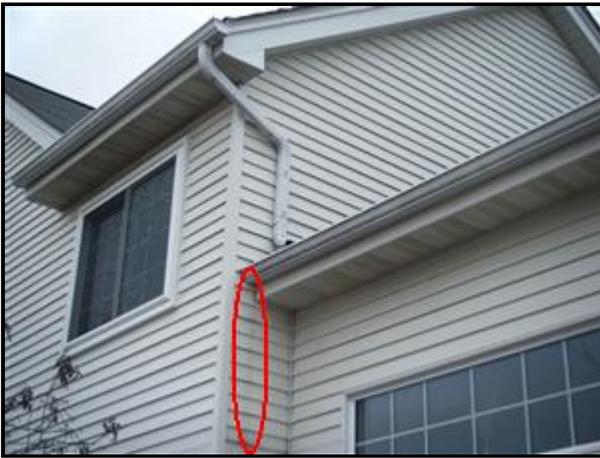
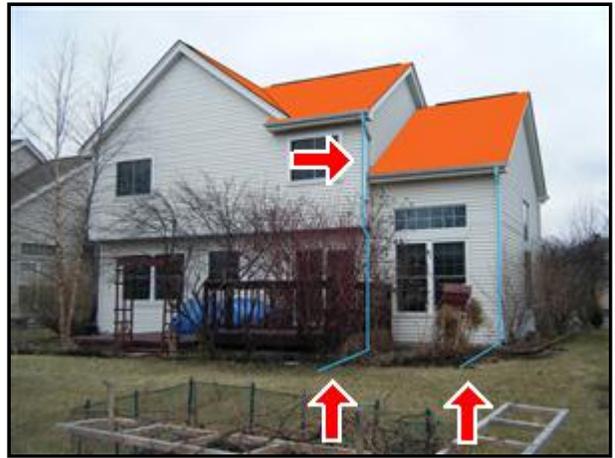
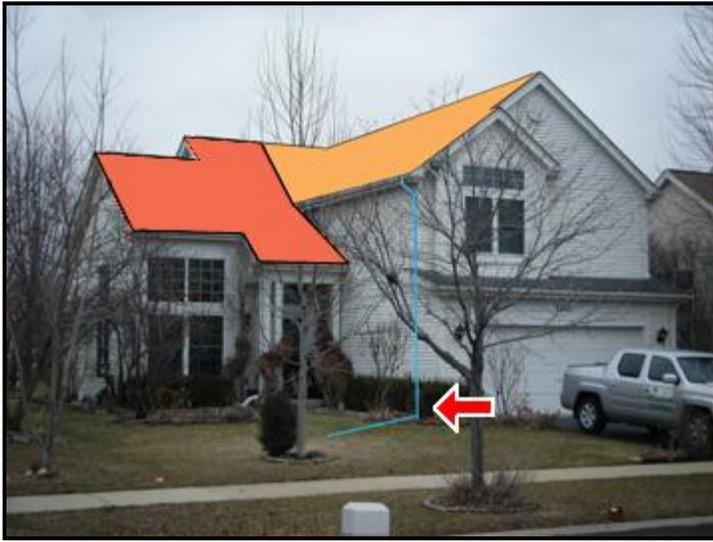
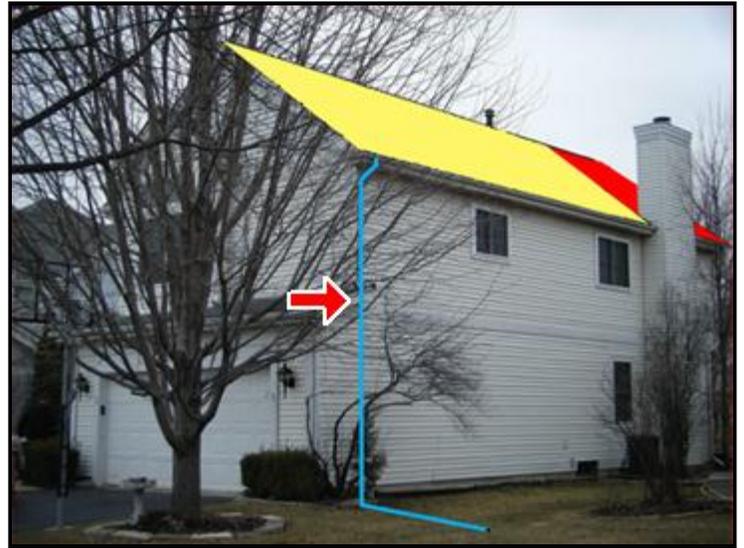
Similarly, on the west side of the second story roof, the existing downspout should be directed to a drain line that runs under the entry sidewalk to a pop-up away from the home.

Lastly, the downspout on north end of the second story should divert water directly to the ground rather than dumping its water onto the living room roof and relying on that gutter to carry the extra load.

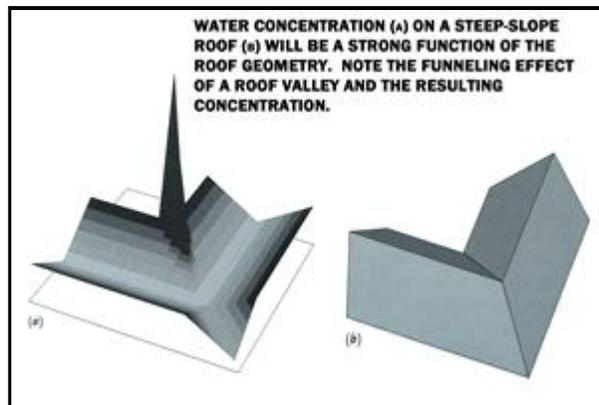
5.1 Picture 7 Valley Water Concentration

(2) Valley roof sections not only carry a large amount of water, but that water is funneled down to a point. As shown in the diagram, the eave of the valley concentrates all the water from an entire corner of roof section to a single point. That point where roof sections are joined becomes a critically important area of water management.

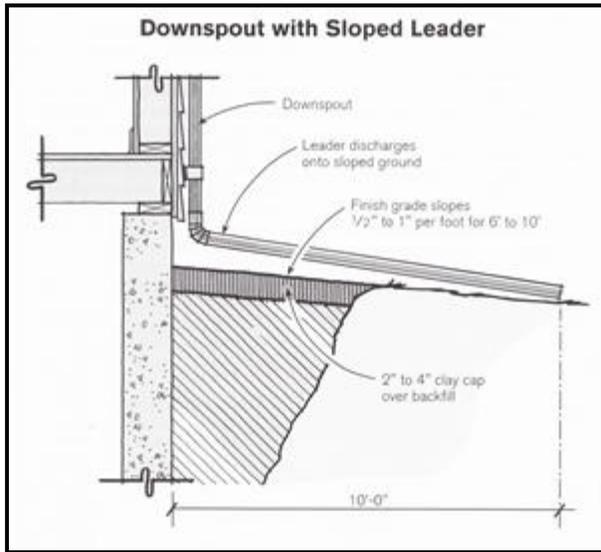
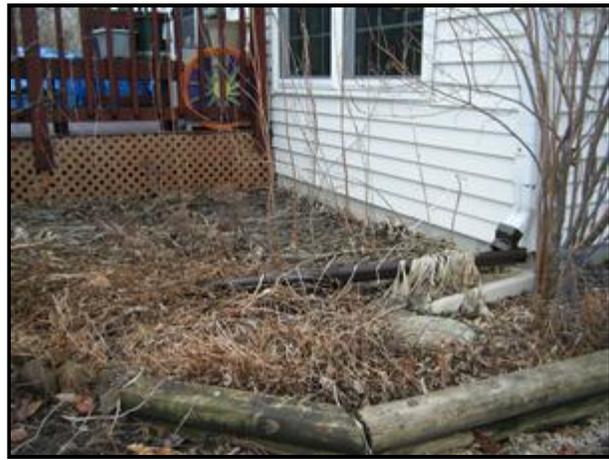
There is a negative slope at the front, rear and sides of home and can cause or contribute to water intrusion or deterioration. I recommend correcting landscape to drain water away from home.

Recommend a qualified individual repairs the slope of the grade, so that all water flows away from the homes foundation to prevent any flooding, or damage to the home.

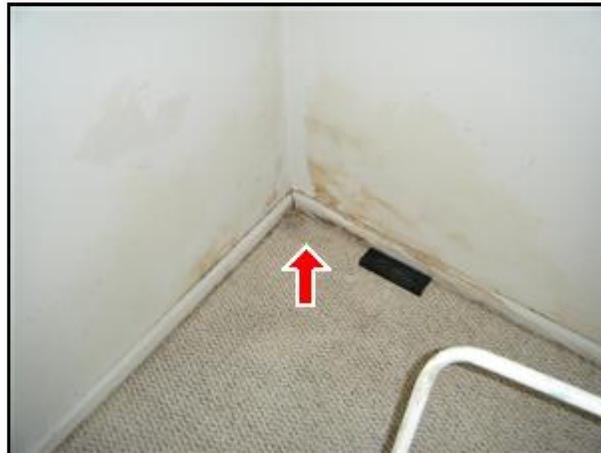
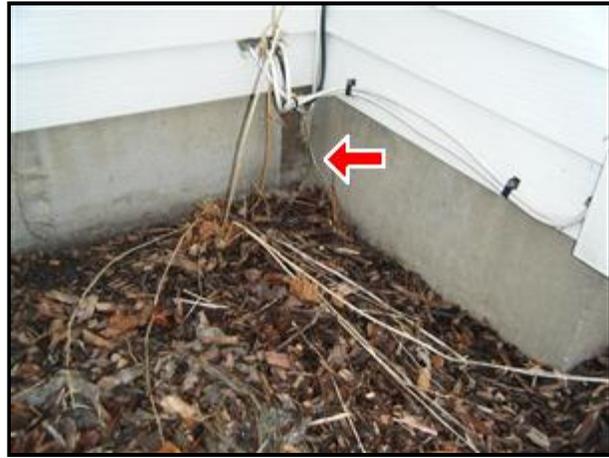
(1) Visible signs of water intrusion in the basement are present from water stains on the wall at the baseboard. Water intrusion if not corrected can lead to other problems including mold and cause excessive moisture to floor system that can lead to deterioration and increased repair cost. It is recommend to monitor closely and repair as needed. It is not clear whether or not water damage has been addressed or is still occurring in the northwest corner.

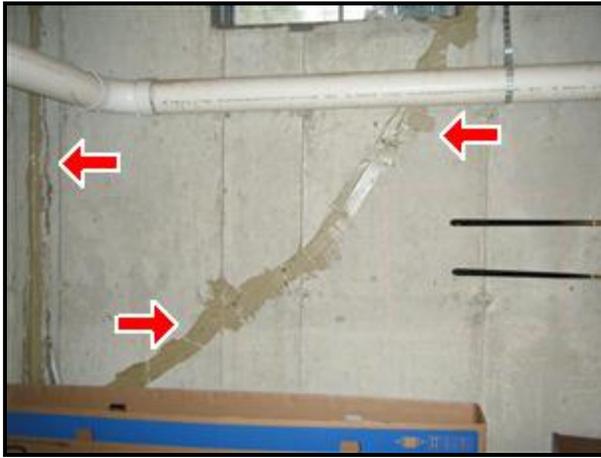
5.3 Picture 2 Sealed Cracks

(2) The structural cracks in the foundation wall at the front of both sides of the home have been previously addressed. The previous repair made to the wall appears adequate. No repairs to the foundation walls are needed or foreseen at this time. The main concern, however, is to prevent further damage by eliminating the source of the water intrusion. It is recommend that you monitor periodically for further damage. Typical cracks may need periodical sealing.

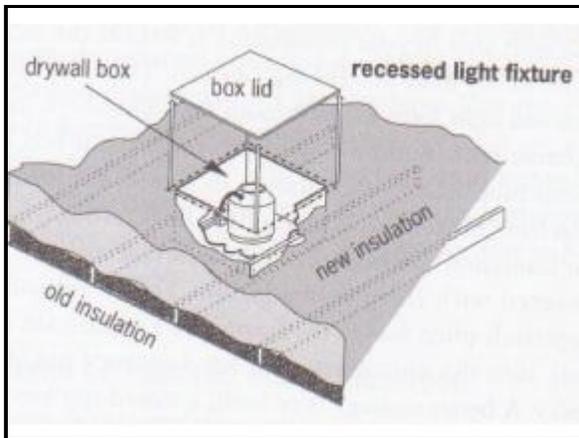
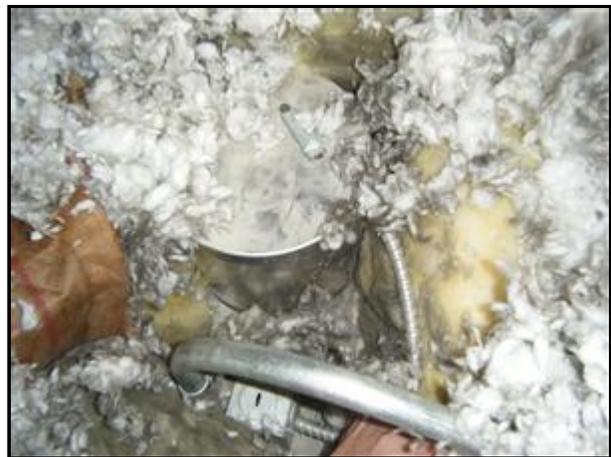
An airtight box, made of either drywall, duct board or foam board, seals air leaks around a heat-producing recessed light fixture. The box should be large enough to leave a 4" space on all sides to allow heat from the fixture to dissipate.

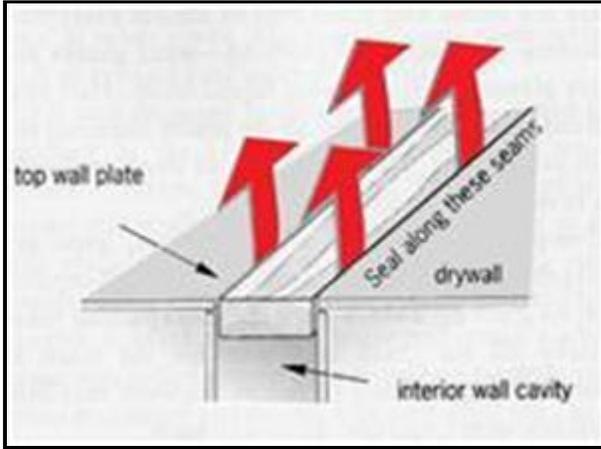
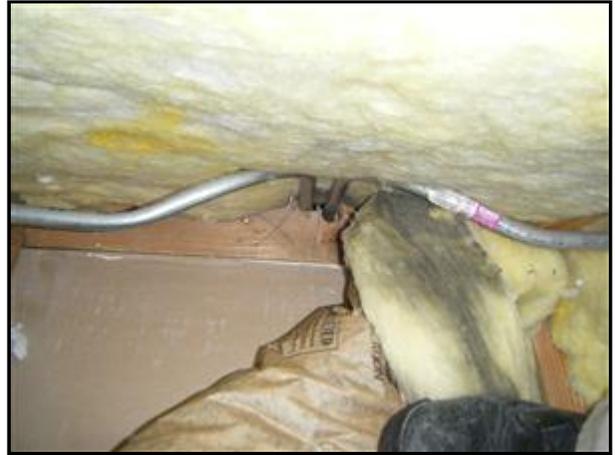
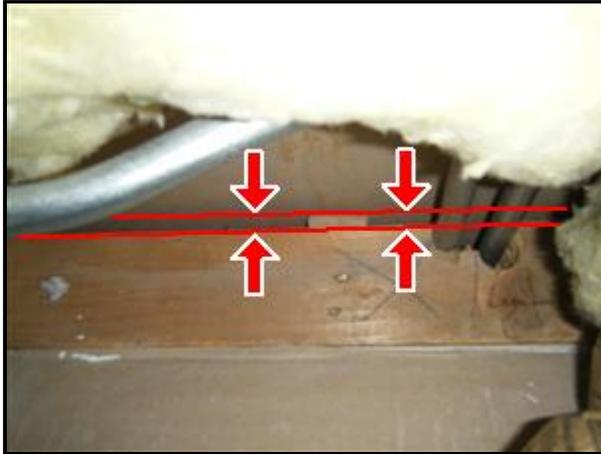
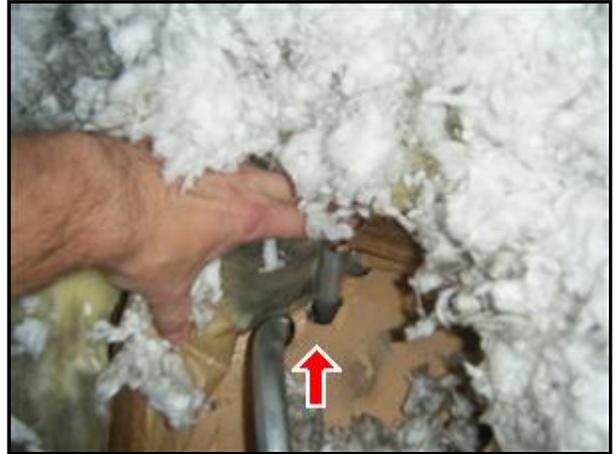
As the framing in a home dries over the years, the top plates of both interior and exterior walls allow large amounts of air to leak from the wall cavity and up into the attic. Recommend that these areas be sealed with a 2-part foam spray.

Penetrations in the form of plumbing penetrations, electrical conduit, boxes and fixtures should be exposed and sealed before additional insulating. Attention should also be paid to the duct in the attic - seal all joints and where ducts/registers pass through the 2nd floor ceiling at the attic.

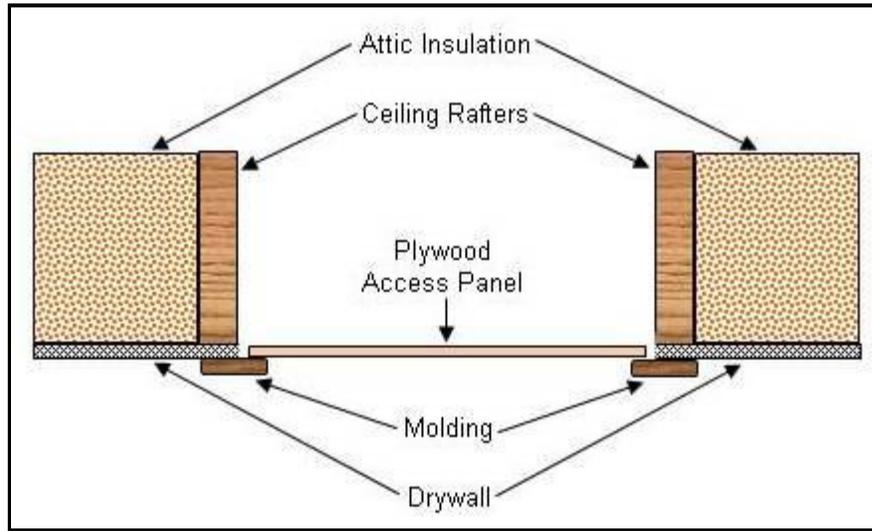
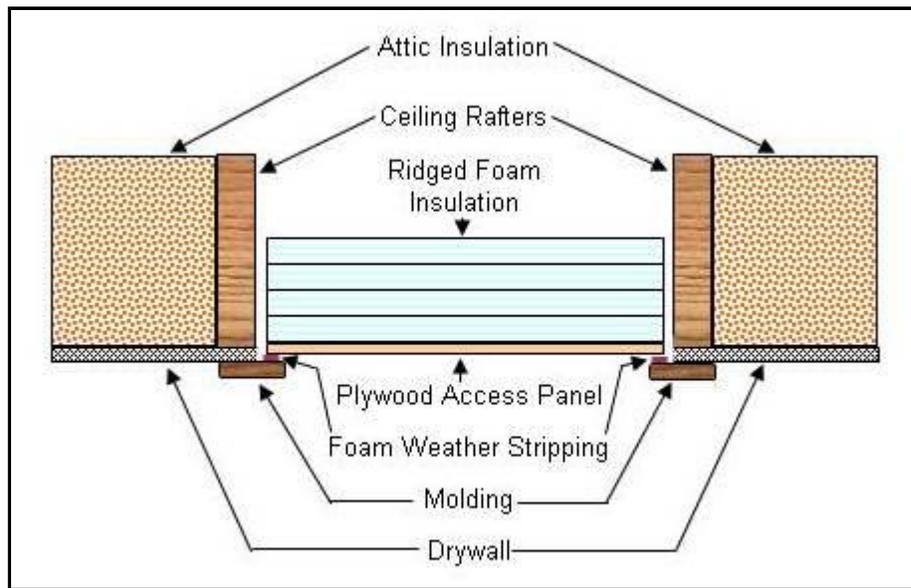
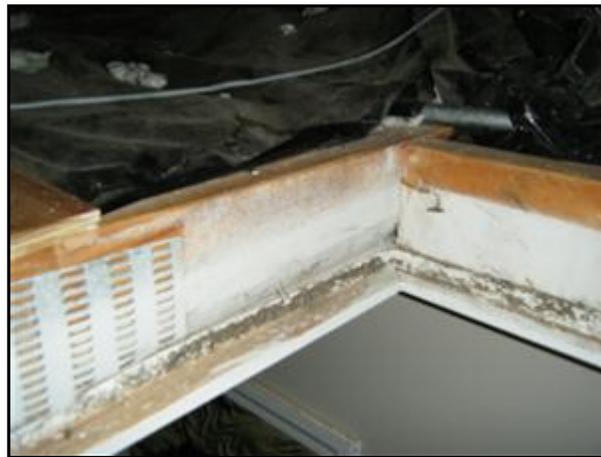
The attic hatch should be air sealed and insulated. The casing should be fastened securely to the ceiling and caulked at all corners & seams. Weather strip should be installed where the cover sits on the casing. The cover should have 8" of foam board fastened to the top, resulting in an R-40 assembly.

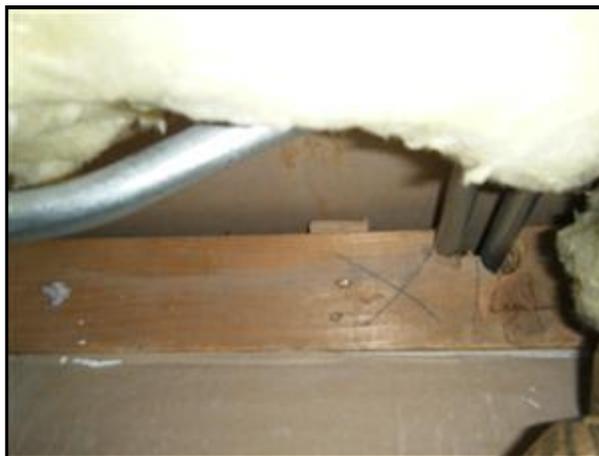
6.4 Picture 1

(1) The stud cavity serving as a chase for the bathroom plumbing is a major air by-pass from the attic to the basement allowing cold air to fall and warm air to escape. Recommend the opening around the pipes be sealed with foam board and 1-part foam where the pipes leave the conditioned space. The area where the attic walls meet the attic ceiling should also be sealed to halt air flow between the wall cavities and the attic. This will also keep insulation from falling down into the walls, if/when the attic is insulated.

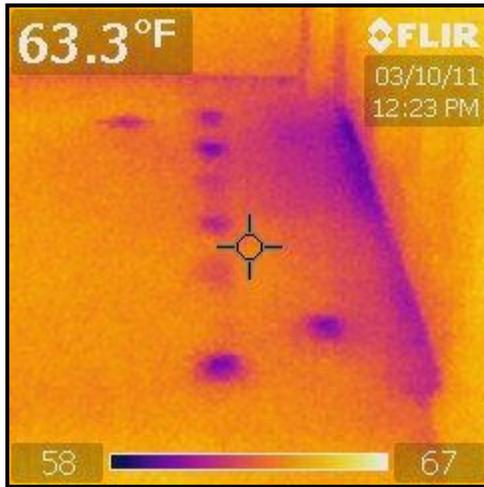
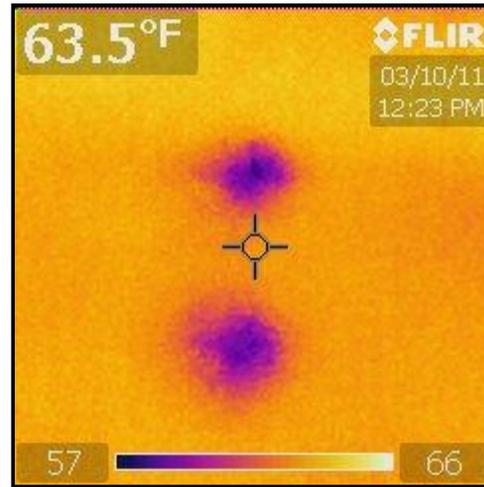
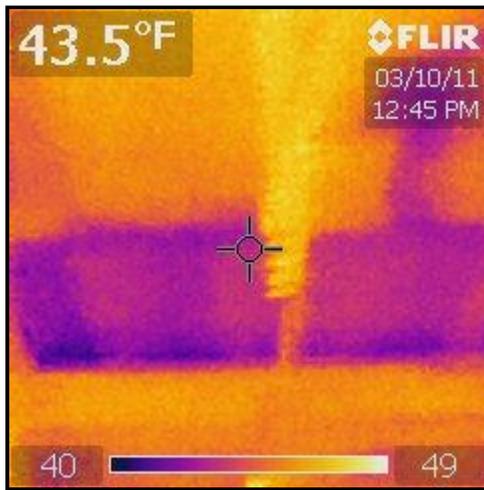
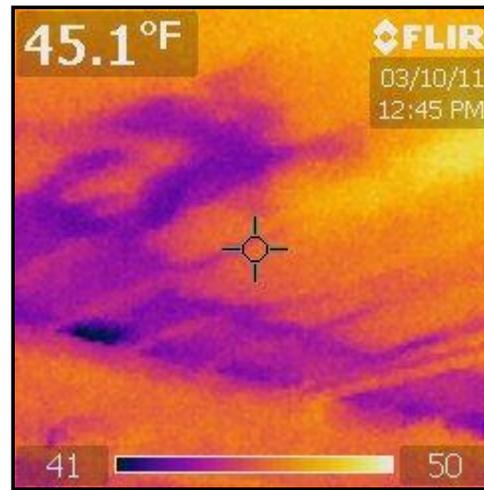
(2) There is a thermal connection between the garage and the master bedroom. This is occurring because of the metal framing hardware (joist hangers ?) that are connected to the cold unconditioned garage space. This hardware is acting as a heat "drain", transmitting the warmth of the floor to the colder garage. There is also air leakage through the floor framing from the small attic area below the garage roof, toward the center of the master bedroom.

The heat 'drains' from the framing hardware are creating cold spots about 4-6 degrees cooler than the rest of the floor. It may not be cost effective to address this issue. It would require installing foam board below the floor framing (a thermal break to the hardware) and then drywall to create the required flame resistant surface required in a garage. However, should the garage ceiling/floor framing need to be exposed in the future, installing foam board before replacing the drywall, would then be cost effective.

The air leakage may be stopped by removing the drywall from below the small garage roof attic and air sealing the wall/floor connection.

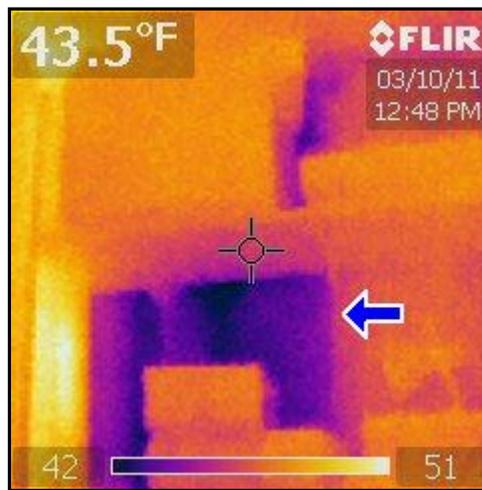
6.4 Picture 6 NE corner of garage

(3) There seems to be an air bypass following a heat duct that travels to the 2nd floor through the wall cavity in the garage at the NE corner. This area should be sealed where it passes through to the attic.

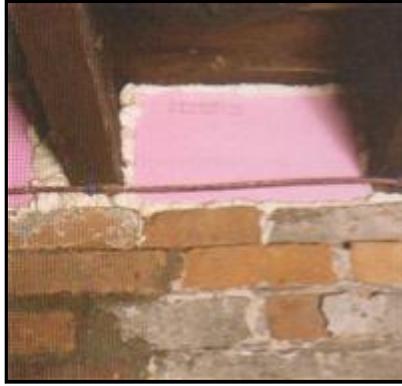
6.5 Picture 1 Air Sealed Rim Joist

Recommend sealing the exterior rim joists of the home with 1" foam board should be cut to fit between the floor, foundation, and joists and sealed with 1-part foam.

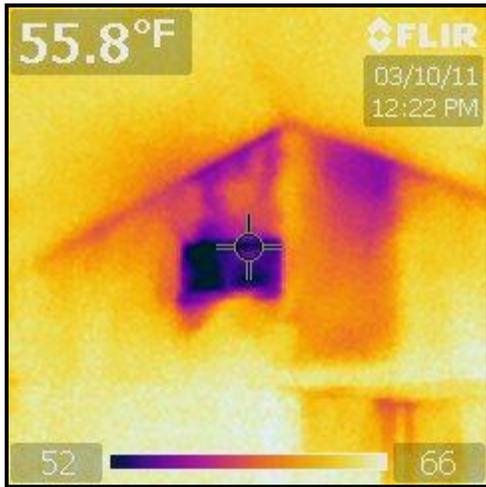
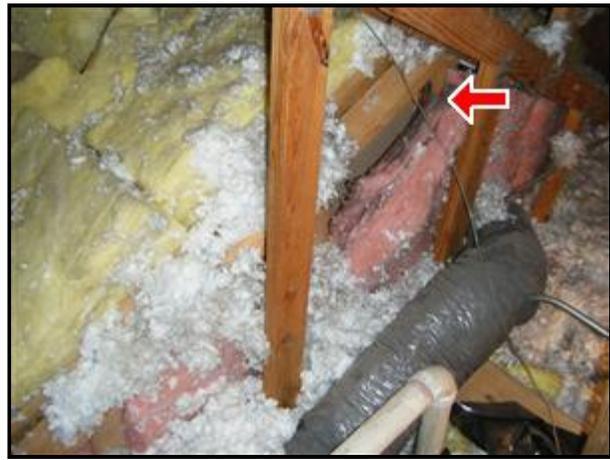
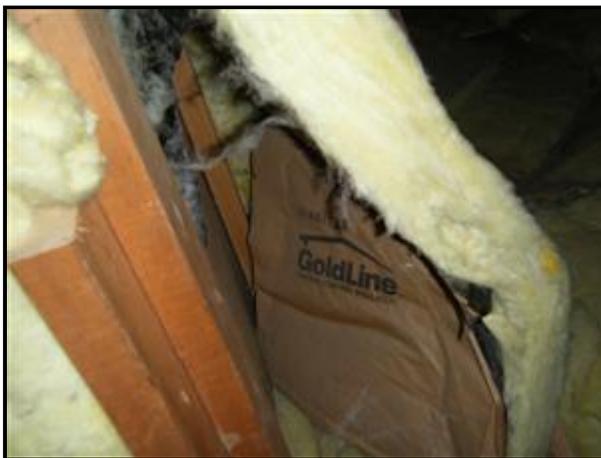
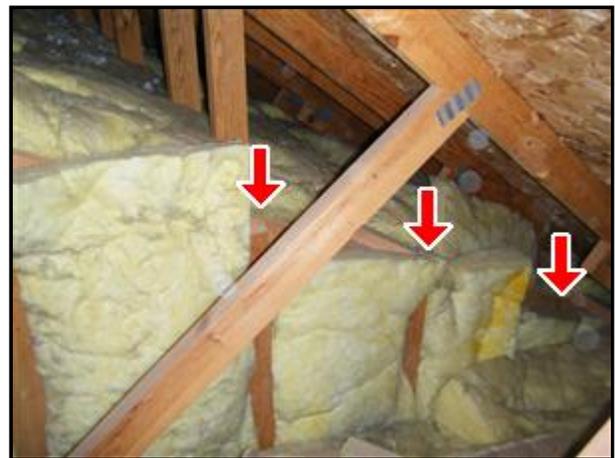
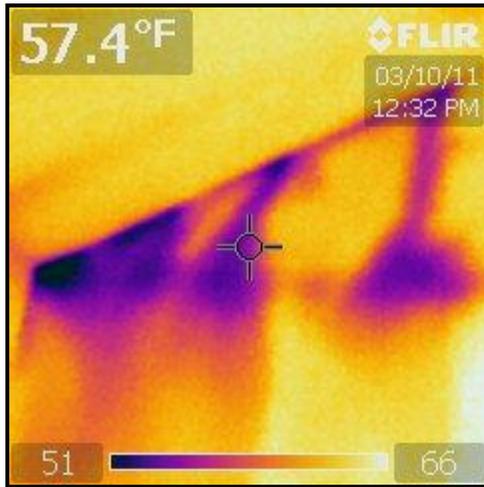
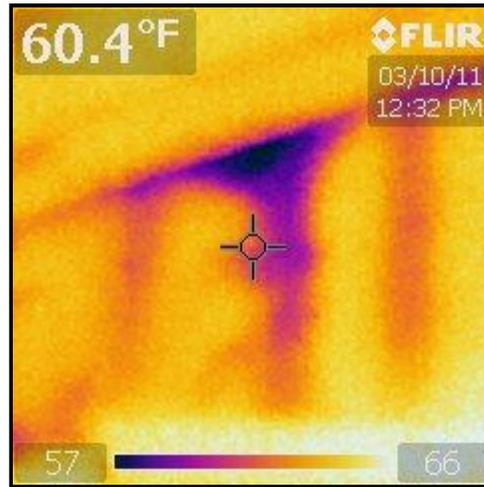
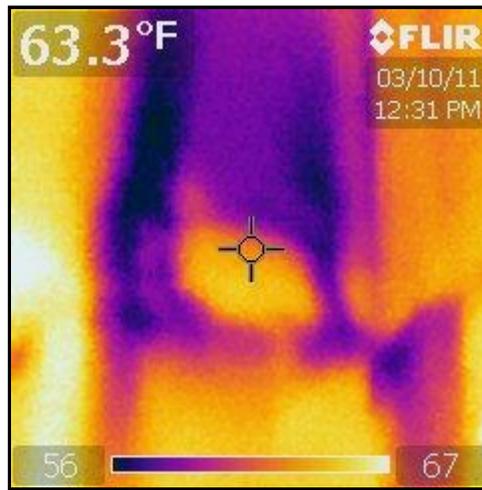
Any vertical walls exposed to attic spaces should be insulated to an R-38, just like the horizontal surfaces. Fiber glass insulation does not perform as rated unless it is enclosed on all six sides. As long as the batt insulation fits properly within a stud space they may be left in place and simply covered over with foam board - taped at the seams and sealed at the perimeter. 2" 'Thermax' foam board would add R-10 to the walls and the foil face would serve to reflect radiant heat from the hot roofs in the summer and keep the heat in during the cold winter months.

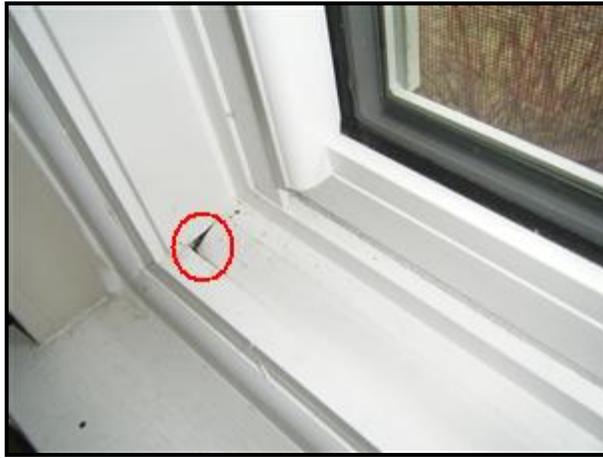
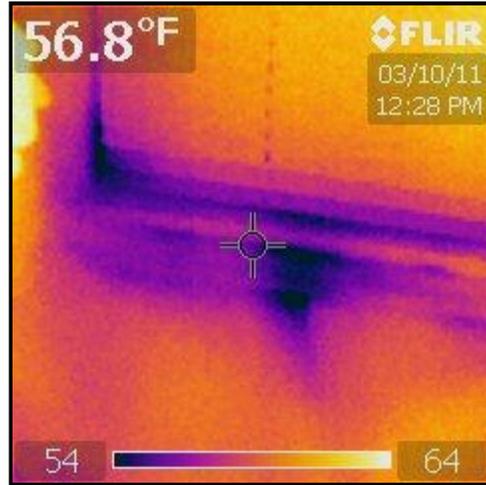
Minor air leakage was detected around the casing of the window frames. Recommend sealing these gaps with a clear, high quality, paintable caulk.

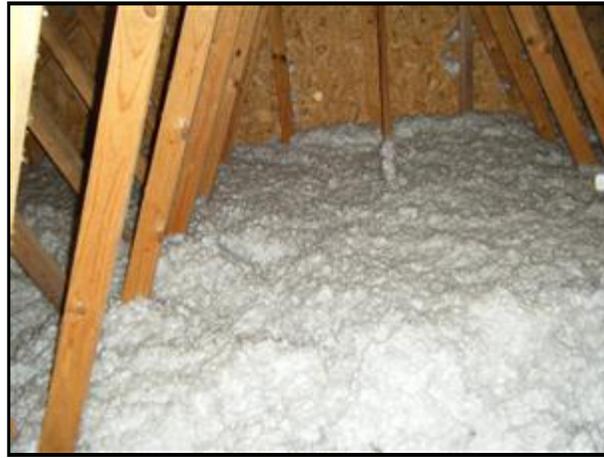
7.0 Picture 1

The attics currently have about an R-25-30 and could be increased to at least an R-38, although an R - 50-60 would be best. **This should be done after air sealing and attic ventilation and before resizing and replacing the furnace.**

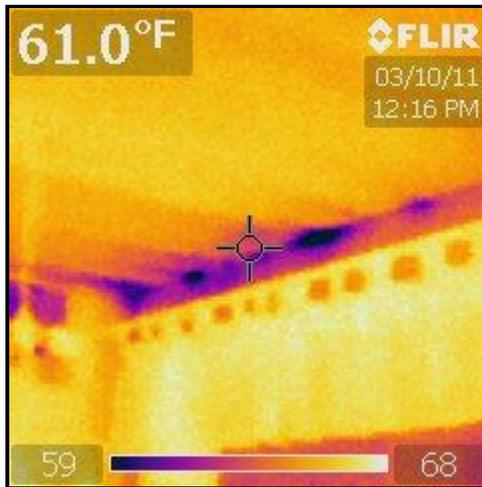
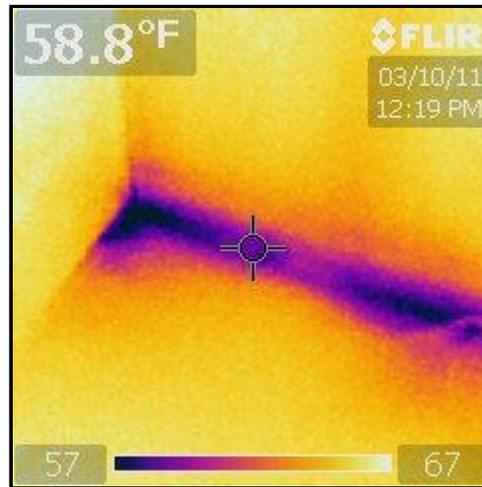
Cantilevered floor sections are often a significant source of air leakage because they are often insulated without first being air sealed. Air sealing the cantilever floor section will allow the insulation in that area to perform more effectively. During the blower door test, cold air was drawn into the home through the floor, highlighting the effects that air penetration has on reducing the value of the insulation.

The most effective way to air seal & insulate (if needed) this area is to remove the material below the cantilever to expose the floor & adjacent wall framing and seal with foam board and/or 1 or 2-part foam as necessary to create a continuous air barrier between the 1st floor wall, floor and 2nd floor wall.
