Inspection Report

115 E. Ogden
Naperville IL

Date: 1/1/2013	Time: 12:00 PM	Report ID: II - 120519
Property: 115 E. Ogden Naperville IL	Customer: T. Smith	Real Estate Professional:

Workscope Phase 1

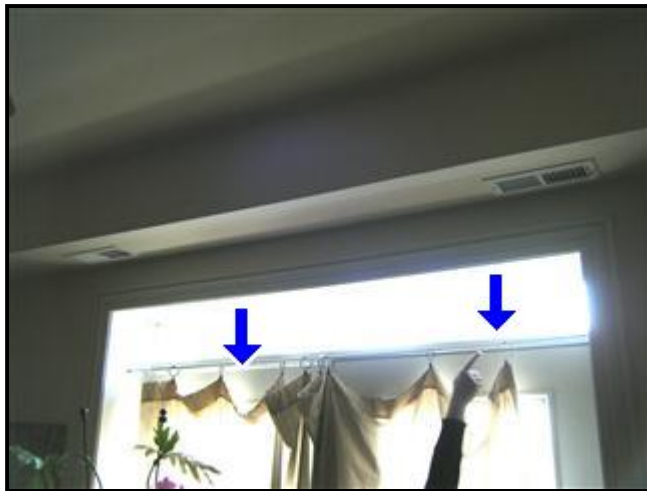
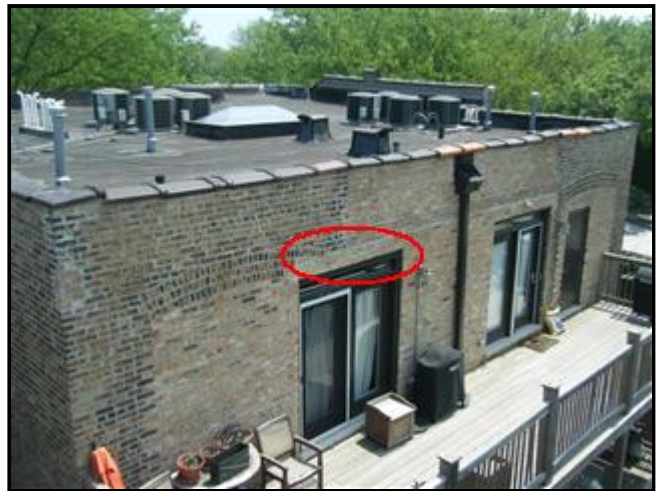
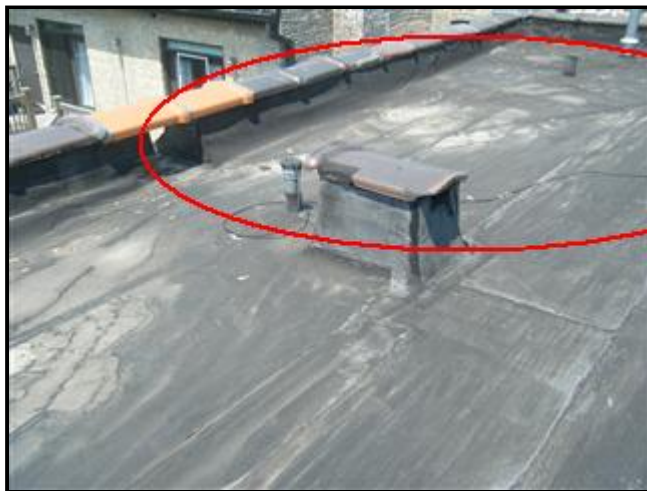
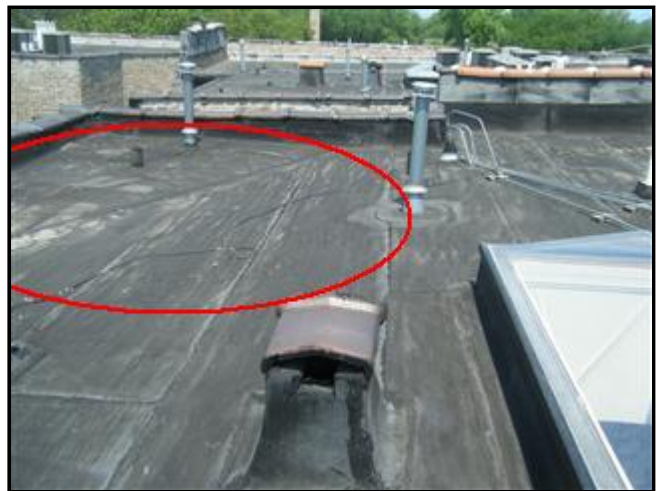
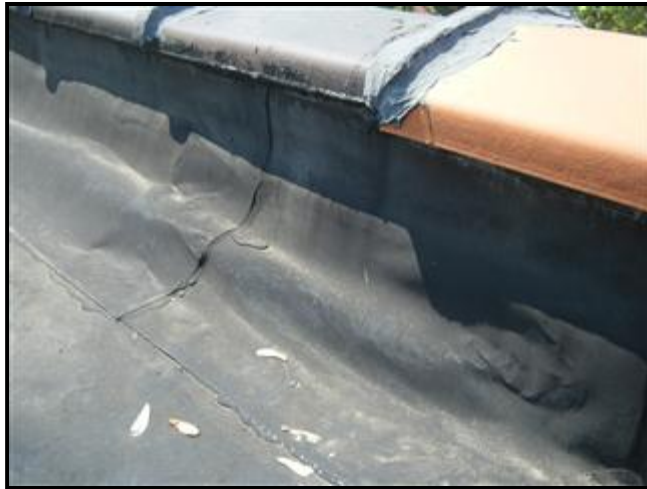
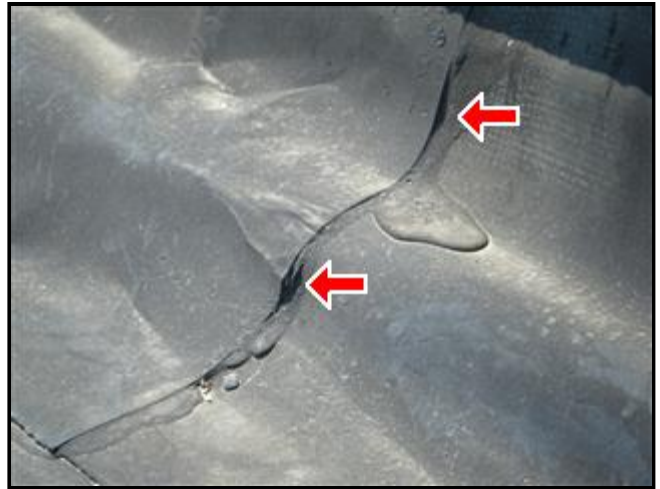
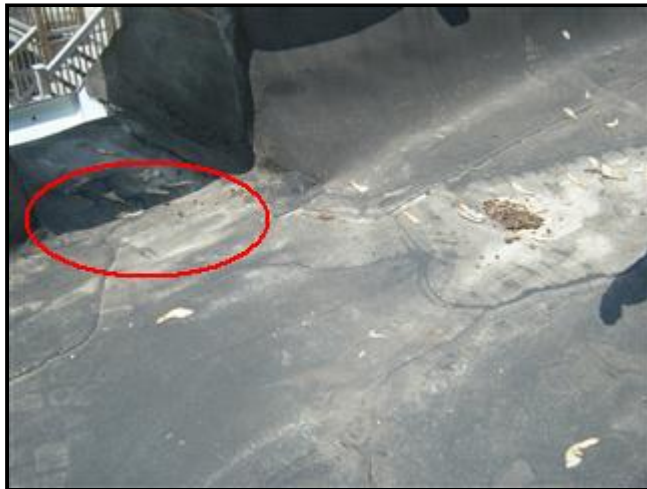
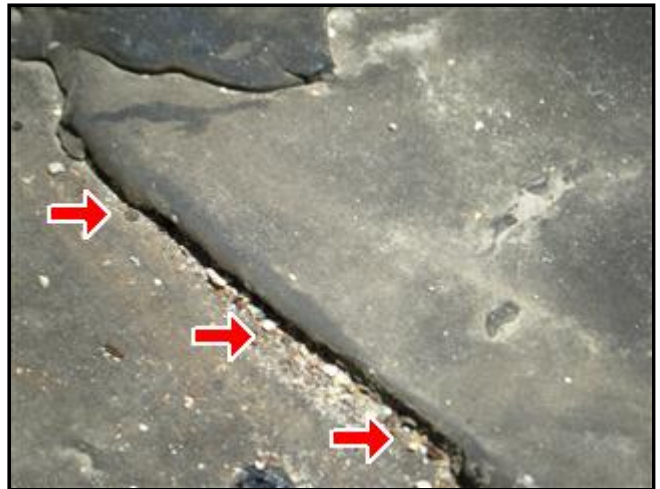
(1) The door jamb of Tammy's patio door leaks constantly in the winter due to melted snow puddling above her unit, up to 7" deep in places. This resulted in a constant stream of water draining into her unit until all the water was gone. Inspecting the roof membrane above, we found areas of roof membrane around the scupper drain and along the parapet with gaps at the membrane seams.

(3) Installing a spray polymerizing foam material will insulate the roof, create a water proof layer inches thick and the white wear-layer reflects solar heat - keeping the roof cooler. The existing roof does not need to be torn off and only the AC units need to be moved during installation.

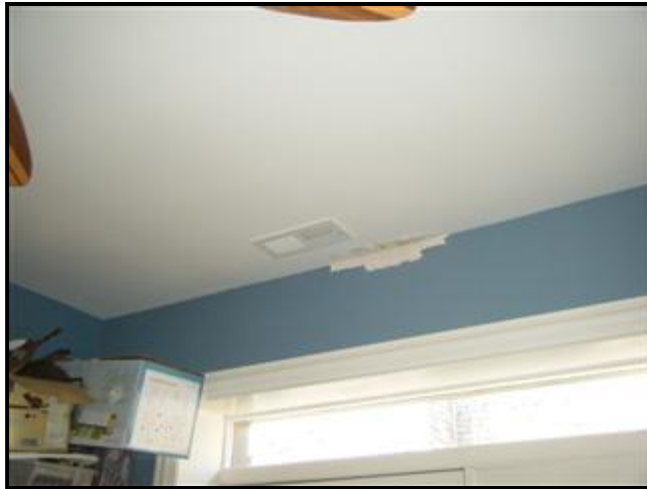
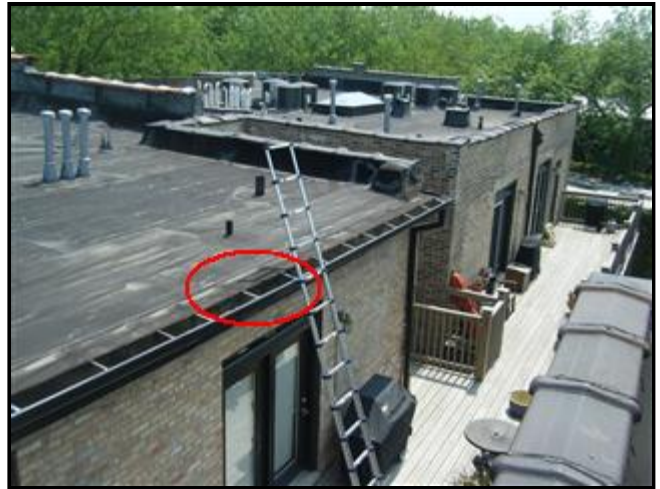
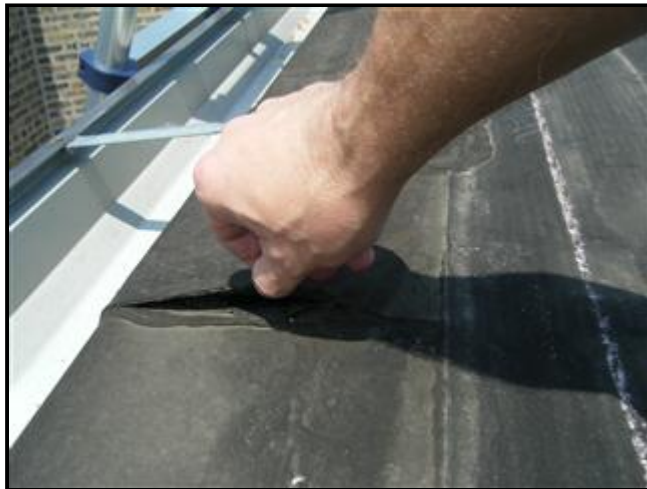
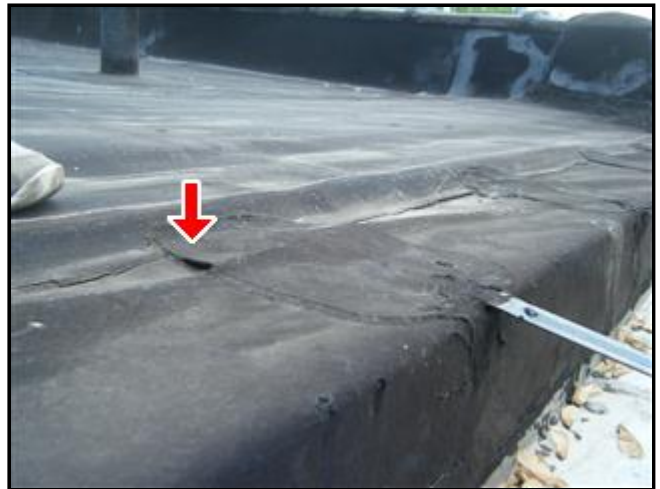
(2) The ceiling of Dan's unit (5026?) near the rear patio door is showing signs of water damage inside, with corresponding efflorescence on the exterior brick. Inspecting the roof membrane above, we found areas of roof membrane around the gutter straps that are allowing water underneath.

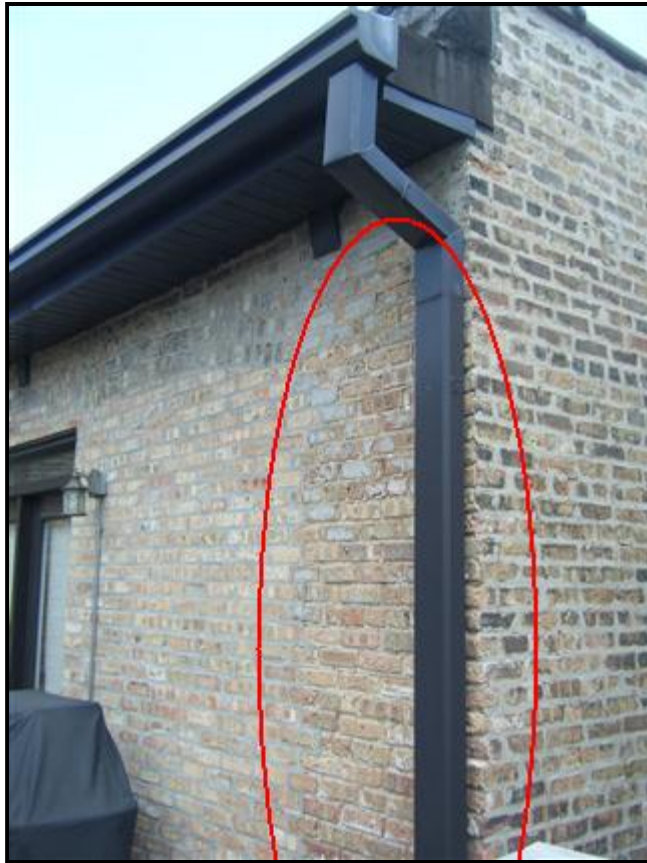
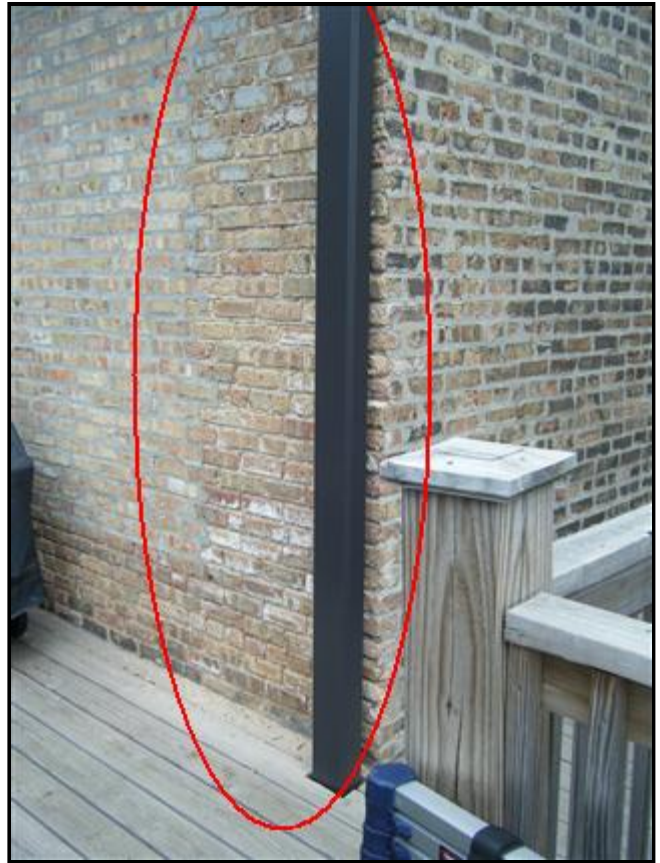
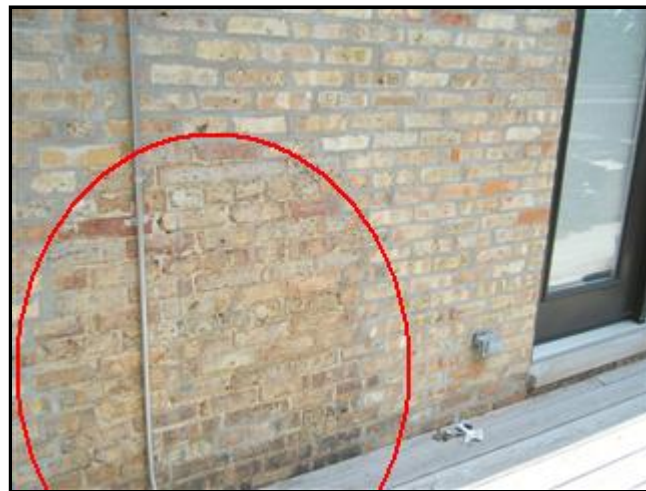
- 🔧 (1) Water spilling over the gutters is deteriorating the mortar that was applied the last time the walls were tuck pointed. Once the snow melt is managed by insulating the roof, the existing dark brown gutters should get warm enough from the winter sun to allow water to drain properly.

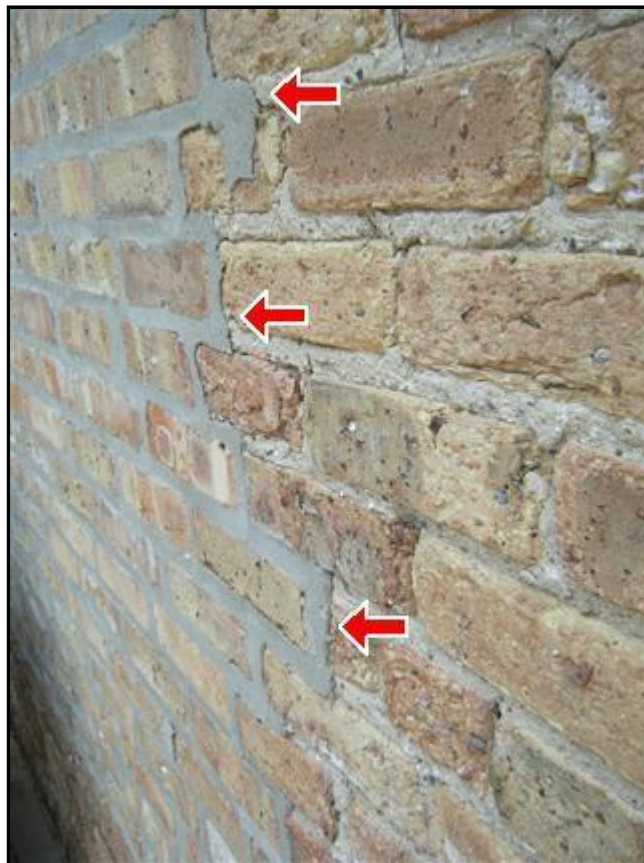
1.2 Picture 1

(1) The hard mortar is inappropriate for this structure. Mortar should be softer than the brick so that moisture damages it rather than the bricks which cannot be easily replaced. The hard mortar will have to be removed at some point and the walls tuck pointed with an appropriately soft mortar.

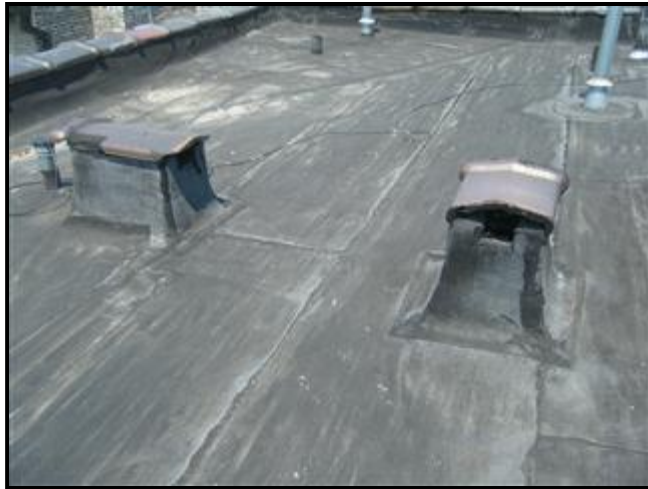
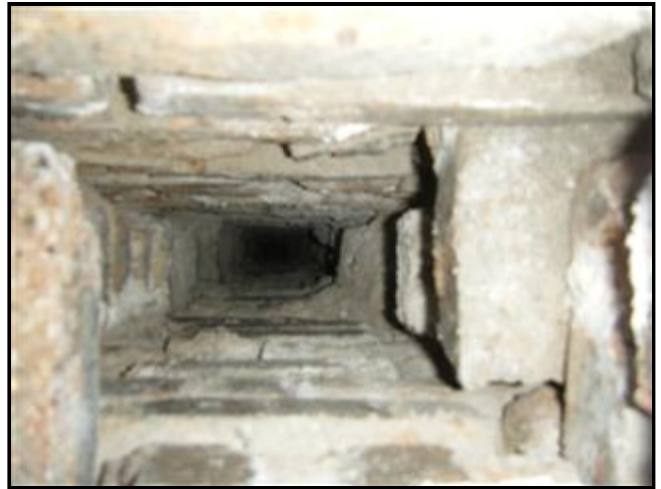
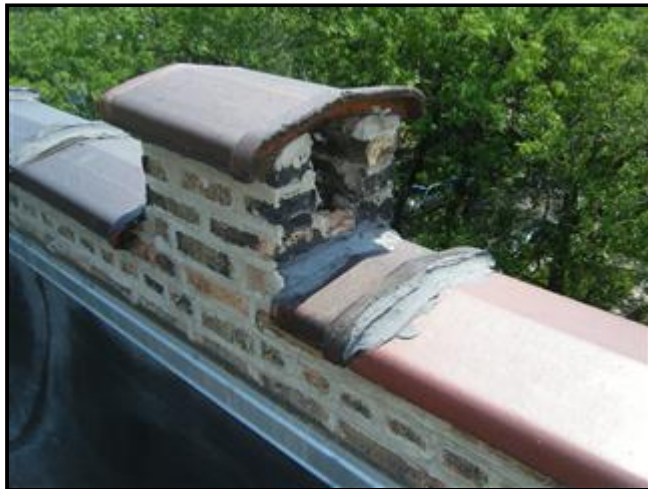
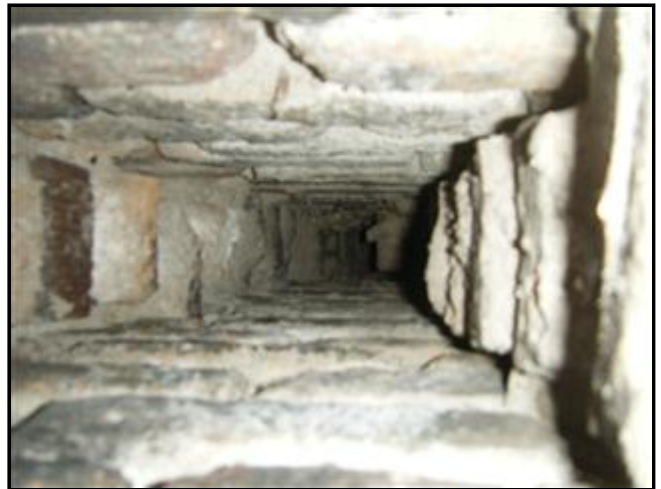
(2) The small chimneys are likely old exhaust chases - using convection to draw odors and moisture out of the units. They have been sealed off on the inside and may be closed off at roof level.

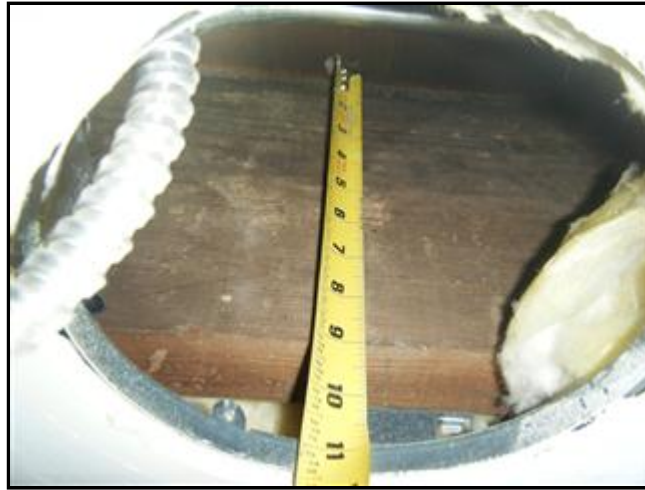
2.0 Picture 1 2x10 Roof Joists

The ceiling structure is insulated with fiber glass batt insulation and has multiple air leaks, allowing significant heat loss to the attic, resulting in snow melt. This water then freezes when it reaches the cold overhangs, creating an ice dam. Insulating the top of the roof will decrease the snow melt. Insulating the top of the roof will also keep moisture from condensing on the underside of the roof.
