Home Performance Report

115 E. Ogden
Naperville IL

Insight Property Services, Inc

Date: 1/1/2013	Time: 09:20 AM	Report ID: HP - 11-010
Property: 115 E. Ogden Naperville IL	Customer: T. Smith	Real Estate Professional:

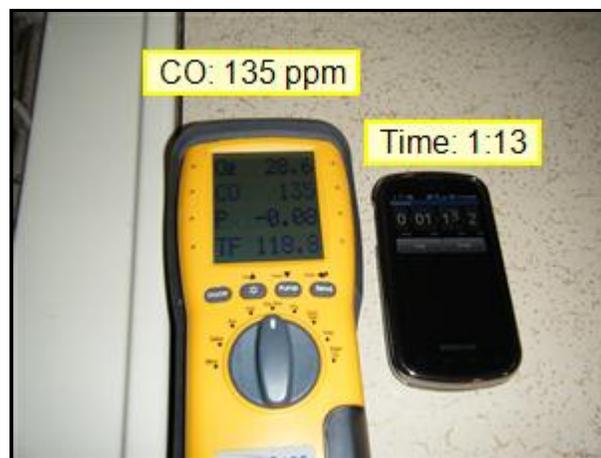
2.14 Picture 1 Gas Oven Max CO

Your oven outputs high levels of CO upon startup and reaches a maximum of **135 ppm** about **1.22 minutes** into its warm up cycle. Recommend having the burners cleaned and adjusted by a qualified appliance repair technician and retested for CO output at startup. In the mean time, do not open the oven while it's warming up as this will prolong the period of high CO production as well as increase CO exposure levels.

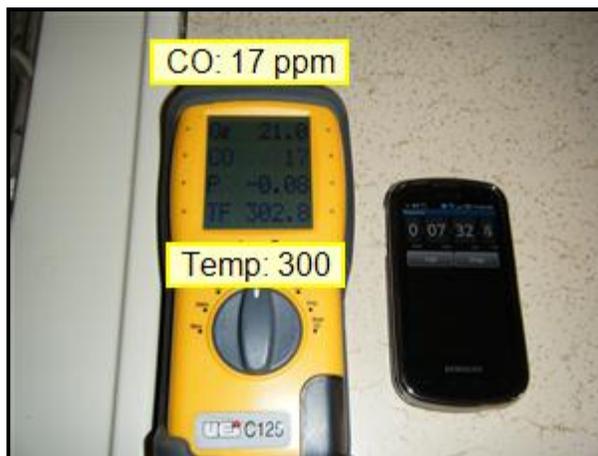
2.15 Picture 1 Gas Oven Steady State CO

The CO measured at Steady State operation of the gas oven is **17 ppm at 300 degrees**. CO less than 25 ppm is ideal. 26-100 ppm recommends a cleaning and adjustment. 100+ ppm requires the unit be thoroughly serviced, cleaned and adjusted by a qualified service technician.

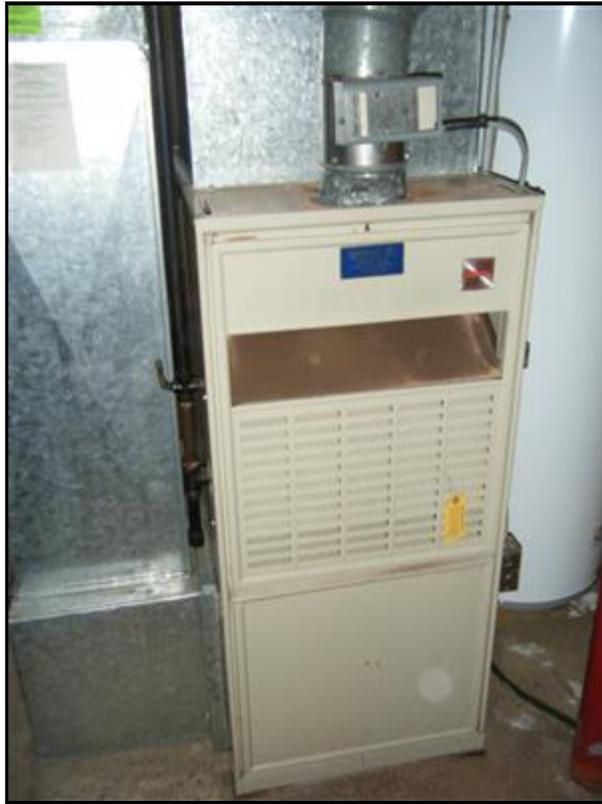
3.0 Picture 1 Furnace

The furnace is at least 25 years old and is less than 80% efficient. Considering the relative tightness of the home, upgrading the furnace is the next best opportunity for decreasing the home's gas bill. It is recommended this unit be upgraded to a sealed combustion, 96% efficient or greater unit with an integrated HRV for continuous, balanced fresh air ventilation.

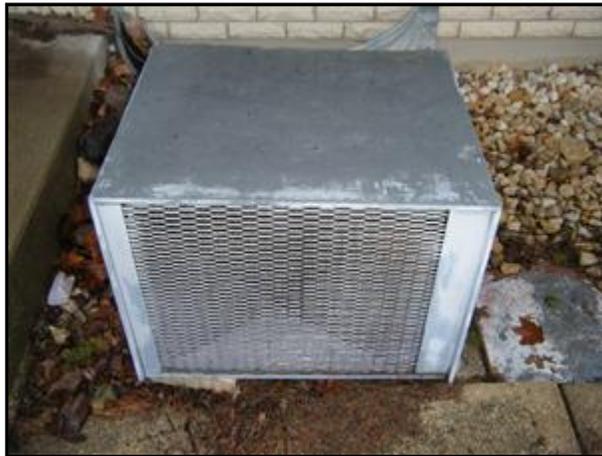
3.1 Picture 1 AirTemp

The air conditioner is at least 20 years old, of an estimated life span of 20 yrs. The unit would benefit from regular cleaning and service. Consider upgrading the air conditioner along with the furnace to see reduced utility bills.

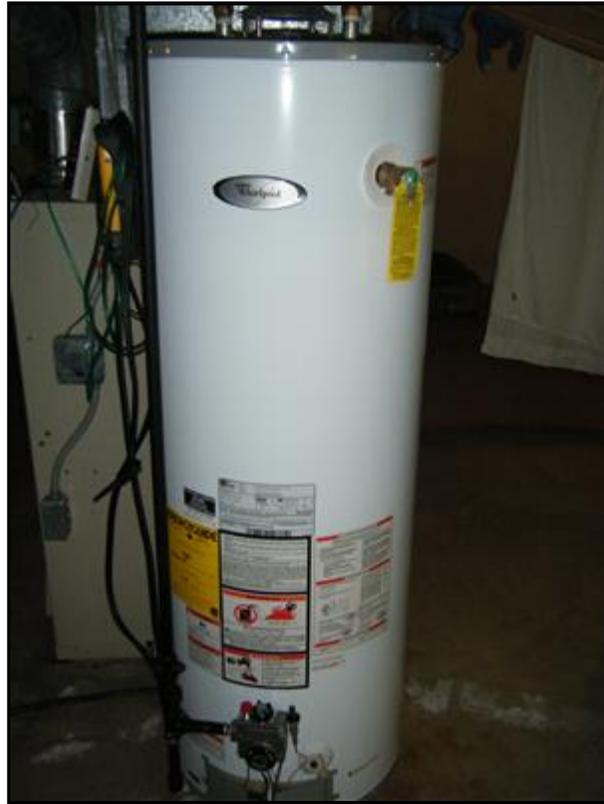
3.2 Picture 1 Water Heater

The existing water heater is about 5 years old and should have a typical life span of 12-15 years. Recommend the unit eventually be upgraded to a power vented or sealed combustion unit. These are more energy efficient and they eliminate combustion safety risks due to exhaust spillage.

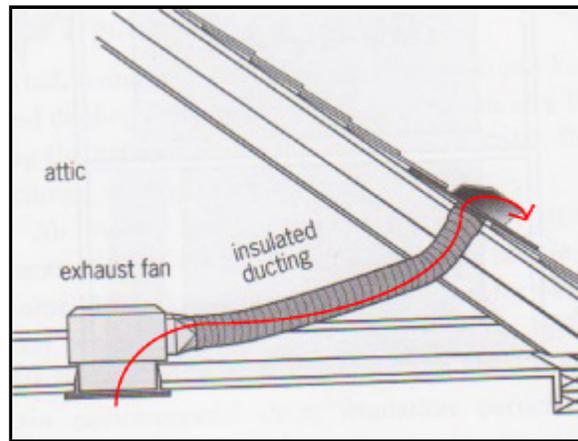
4.6 Picture 1

(1) There is no exhaust fan in the bathroom. It is recommended that every bathroom have a high-quality, quiet (<1.5 sones), 80+cfm exhaust fan installed. These fans should be exhausted to the outdoors by way of insulated ducting through a roof mounted, dampered vent.

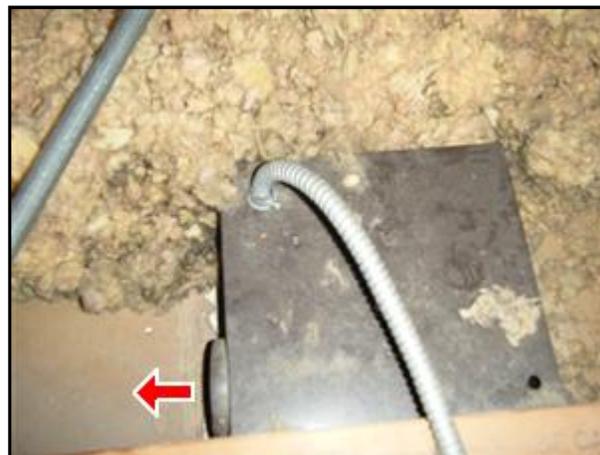
4.6 Picture 2 Vents Into Attic

(2) The existing bath fan appears to take several minutes to reach its full capacity, which is still lower than the normally recommended 80 cfm rated capacity. Recommend upgrading the existing bath fan in conjunction with the addition of the second bathroom vent fan. These fans should be exhausted to the outdoors by way of insulated ducting through a roof mounted, dampered vent.

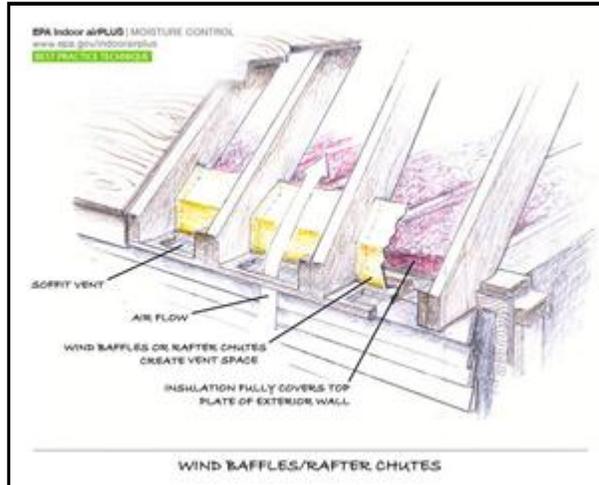
4.8 Picture 1 Wind Baffles

(1) The attic currently does not contain wind baffles. It is recommended to install vent chutes with wind baffles between each rafter and seal the perimeter top plates with 2-part foam. This will halt wind washing through insulation and ensure a clear ventilation space, should additional insulation be installed.

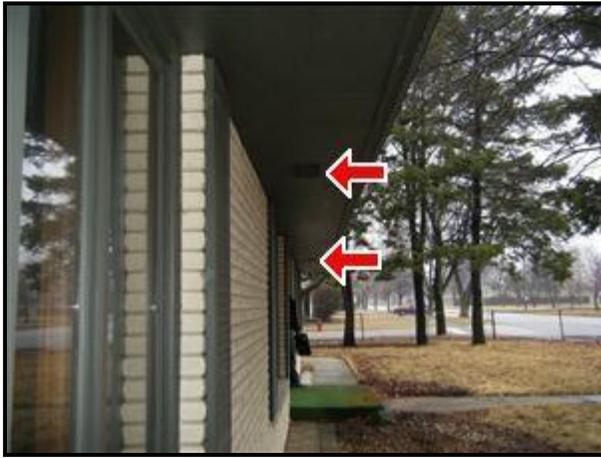
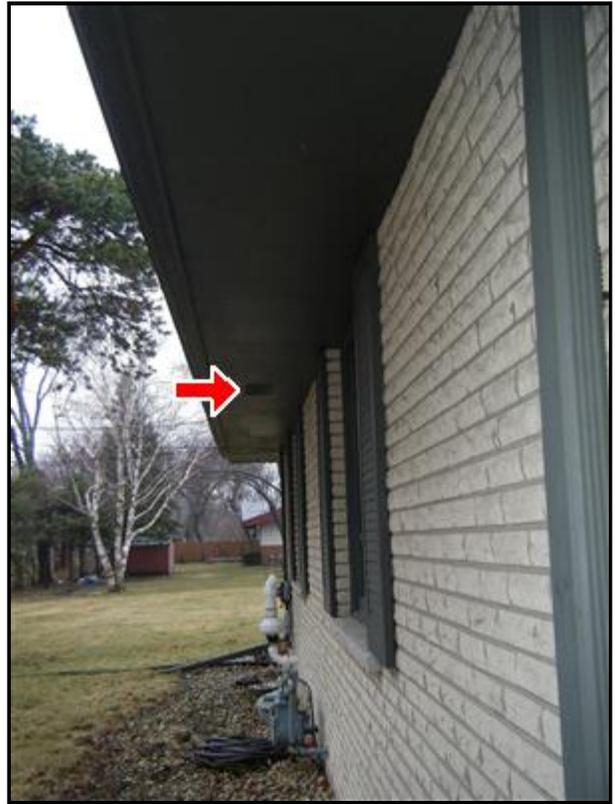
(3) The attic could benefit from having additional soffit vents cut into the eave overhangs to allow additional ventilation capacity. This is especially true when increasing the tightness of the conditioned space of the home, when the attic no longer relies on ventilation from the rest of the house. Minimum required ventilation is to have 1 square foot of ventilation for every 300 square feet of attic floor area. Minimum recommended ventilation is to have 1 square foot of ventilation for every 150 square feet of attic floor area is often recommended. For this attic, that means about 8 to 16 square feet of soffit ventilation.

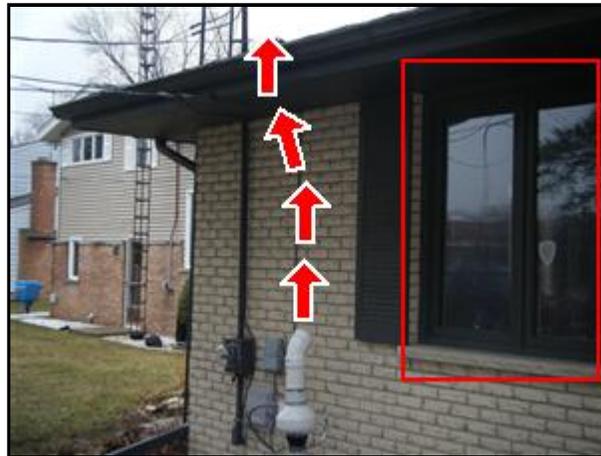
4.9 Picture 1 Radon Exhaust Near Window

(1) The radon ventilation system did not vent above the roofline, which prevents radon gasses from possibly being reintroduced into the home through windows, doors, or other openings. Also, it is not standard practice for the radon ventilation to use the sump pit from which to draw soil gasses. This scope of this inspection did not include radon remediation, so it recommended to contact a radon remediation specialist for further consultation.

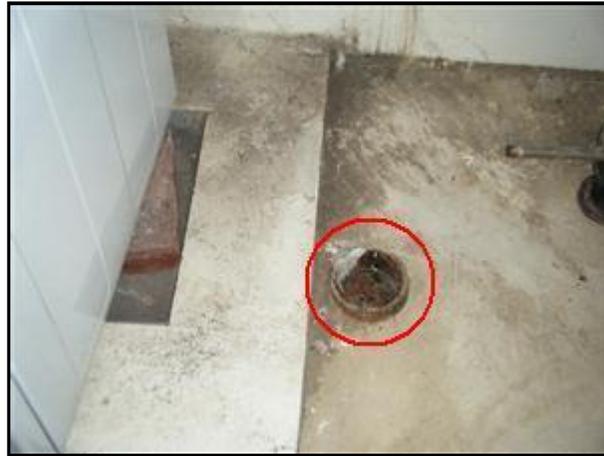
4.9 Picture 2

(2) The floor drain in the basement is connected to the waste water system without being sealed off with a check valve or P-trap. Not having a check valve allows the intrusion of drain line gasses or even waste water in case of the system getting backed up.

Recommend installing a secure, semi-permanent seal at the floor drain (plug or other seal). This will prevent water backing up into the basement through the floor drain. The next lowest point of entry in case of the waste water getting backed up would be the basement utility sink drain, which is a better location to monitor for water intrusion.

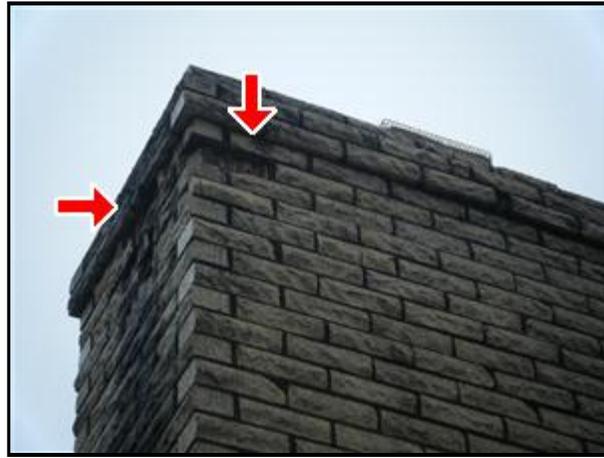
5.0 Picture 1 Chimney Damage

There is some evidence of damage to the bricks at the top of the chimney. This should be repaired by a qualified masonry contractor to prevent further deterioration.

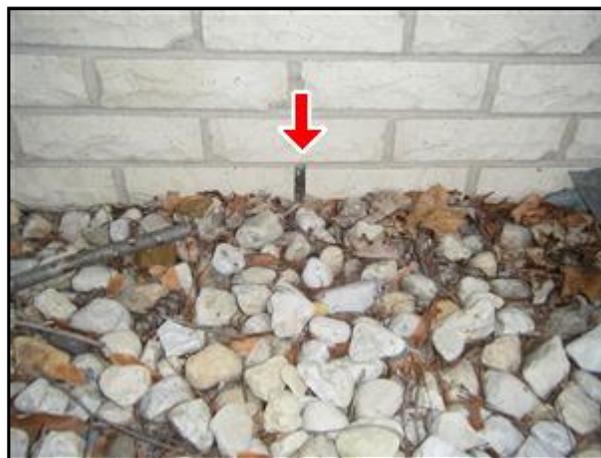
5.2 Picture 1 Brick at Ground

(1) Exterior grading (dirt or mulch) should be below the level of the concrete foundation walls and not be in contact with any brick. Brick is quite porous and allows water to enter the wall structure easily.

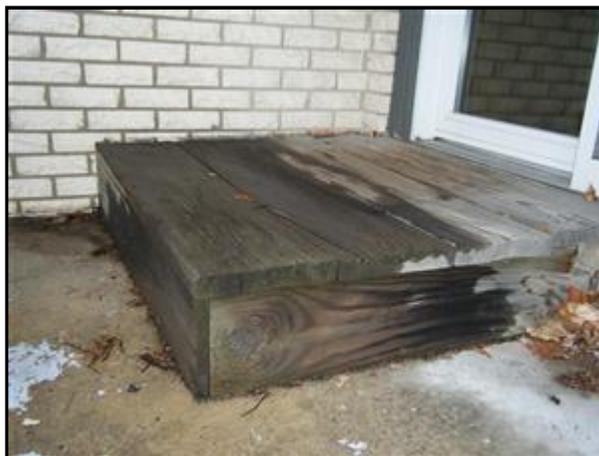
5.3 Picture 1

The wood floor on the porch deck at the rear of home shows signs of moisture damage. Water can cause further deterioration if not repaired and sealed properly. This is a cosmetic issue for your information.

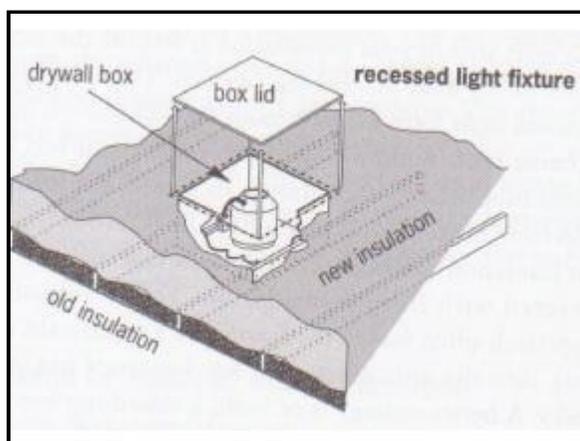
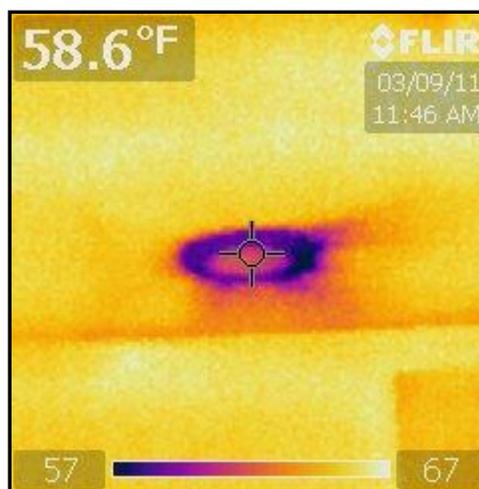
All recessed lights in the attic need to have air-tight, foam box, with 4" of internal clearance installed over each unit and sealed to the drywall and surrounding framing. Since all of the existing can lights are in soffit spaces rather than in the attic space, the goal would be to create an air barrier at the top of the soffit (at the ceiling level). This recommended practice for air sealing attic can lights does not apply today, but is something to be aware of for future reference.

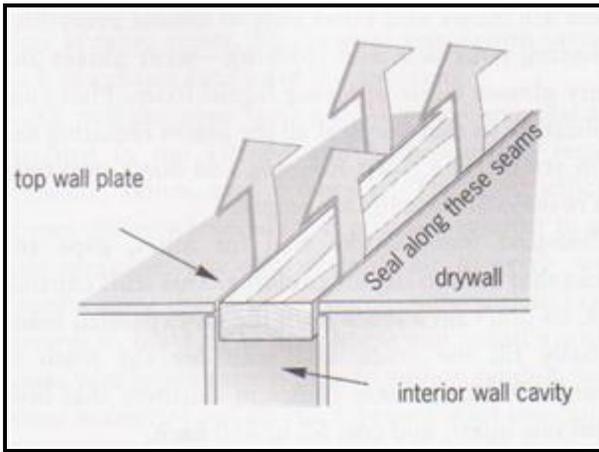
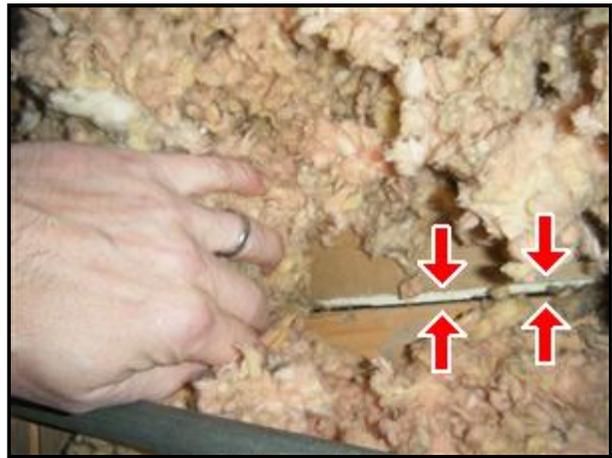
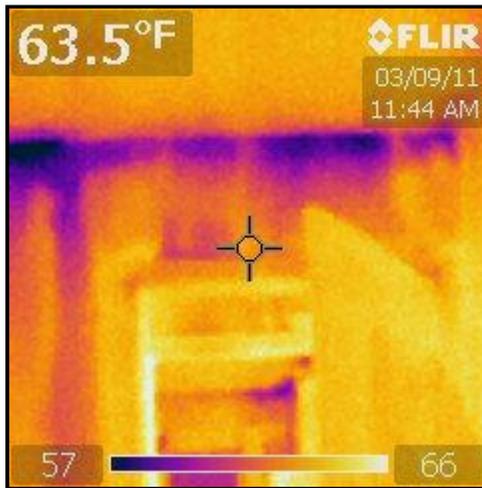
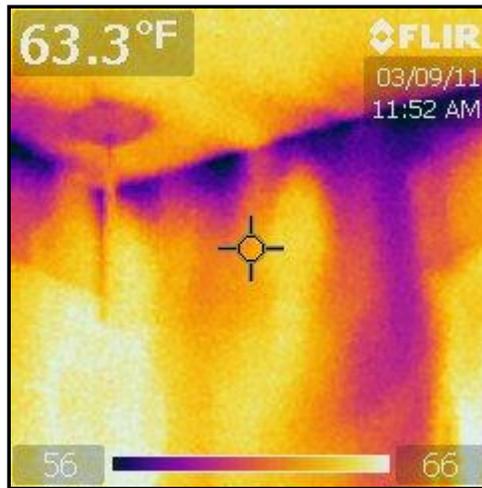
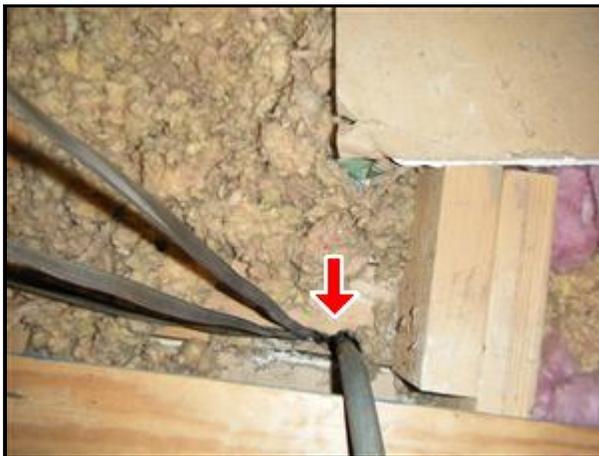
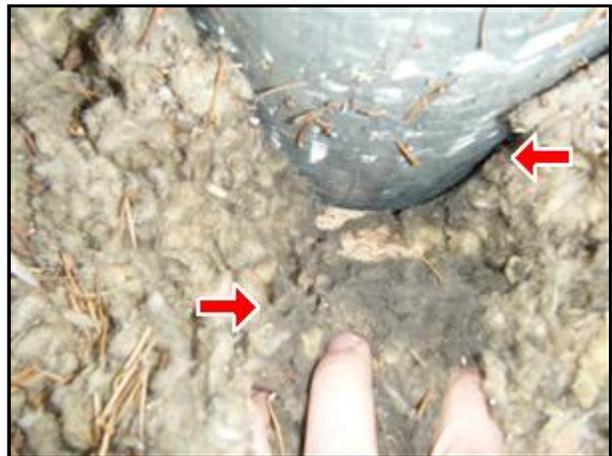
As the framing in a home dries over the years, the top plates of both interior and exterior walls allow large amounts of air to leak from the wall cavity and up into the attic. Recommend that these areas be sealed with a 2-part foam spray.

Penetrations in the form of plumbing penetrations, electrical conduit, boxes and fixtures should be exposed and sealed before additional insulating.

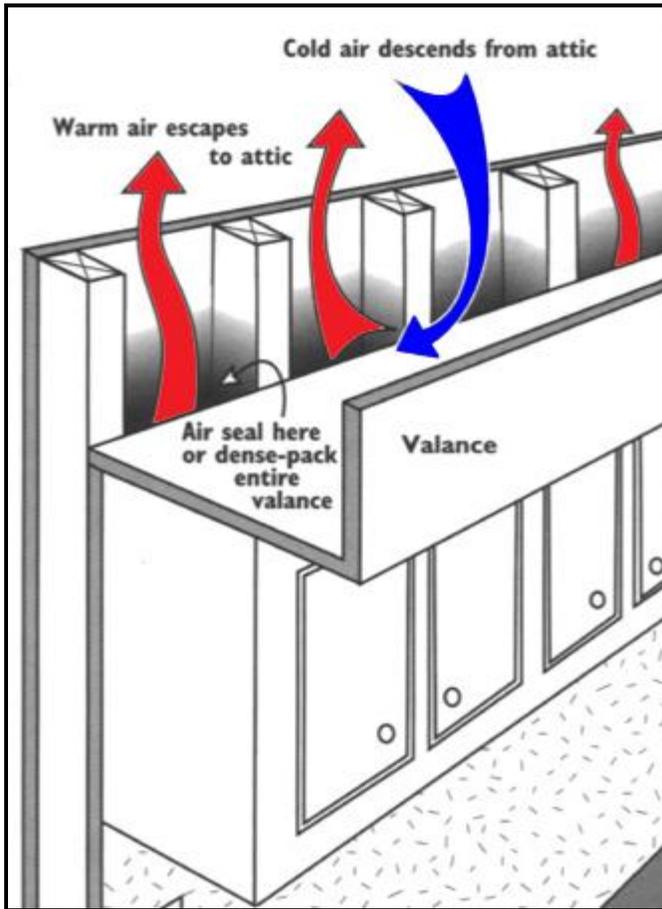
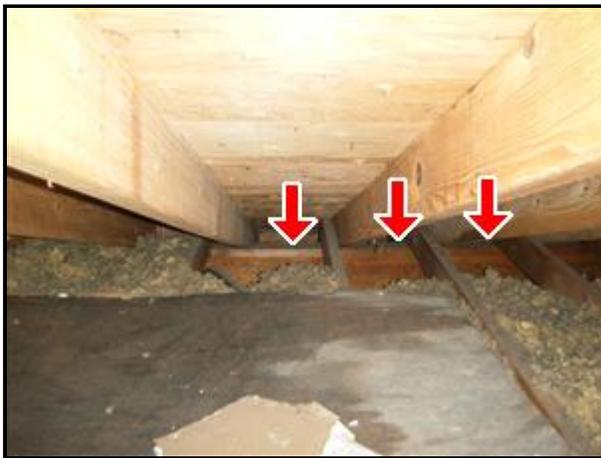
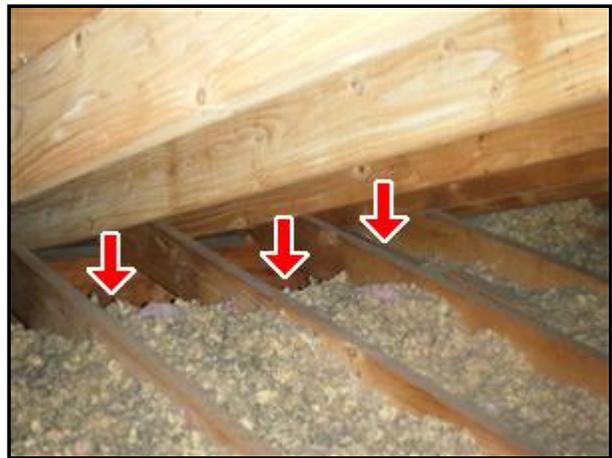
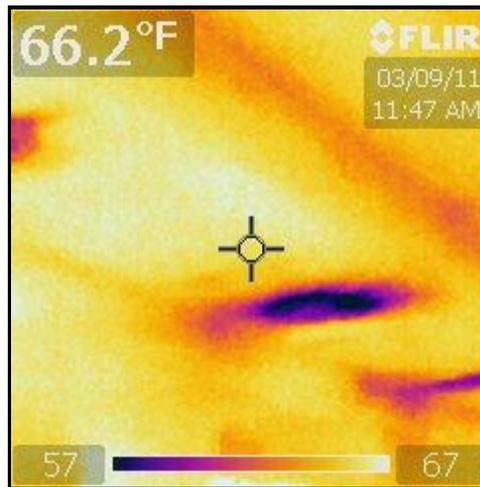
The top of the soffit should be covered with foam board and sealed to the framing and drywall to create a continuous air tight sealing, the air barrier between the conditioned second floor and the unconditioned attic.

Recommend having a qualified contractor insulate, and air seal the soffit.

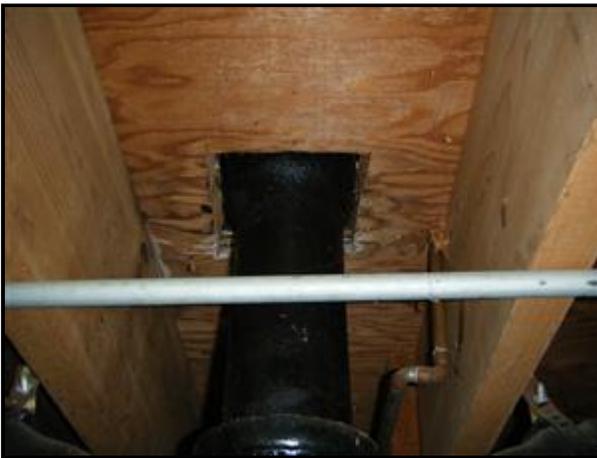
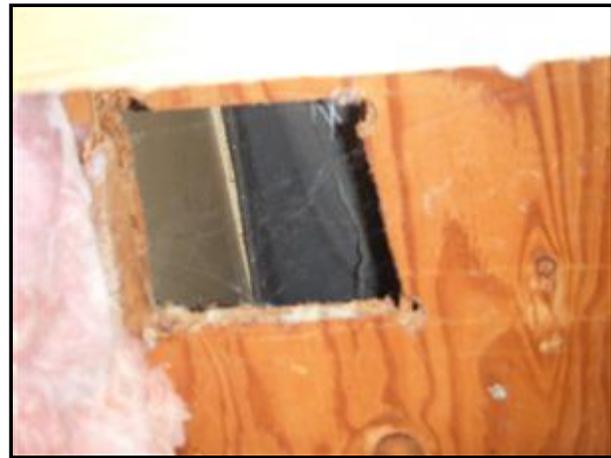
The stud cavity serving as a chase for the bathroom plumbing is a major air by-pass from the attic to the basement allowing cold air to fall and warm air to escape. Recommend the opening around the pipes be sealed with foam board and 1-part foam where the pipes pass into the attic.

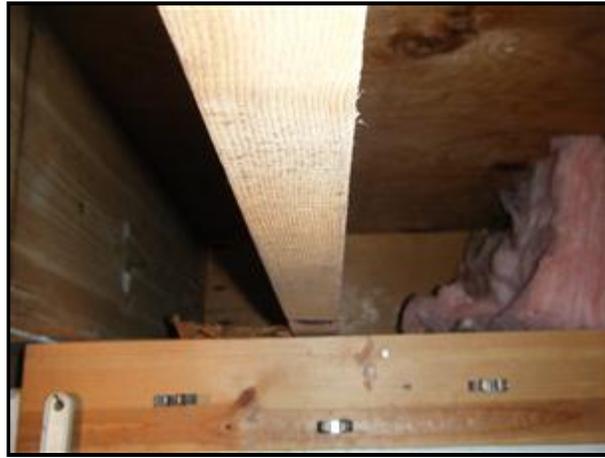
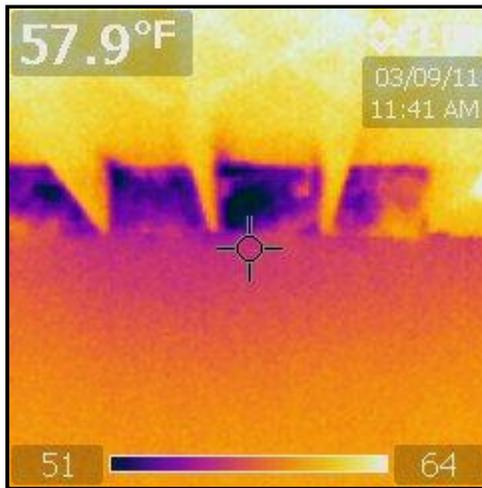
Recommend sealing the exterior rim joists of the home with 1" foam board should be cut to fit between the floor, foundation, and joists and sealed with 1-part foam.

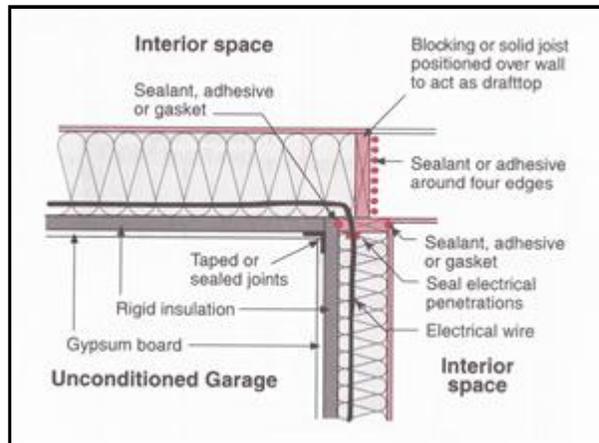
6.5 Picture 1

The wall that separates the garage from inside the home is important to prevent the air in the garage which may contain pollutants, chemicals etc. from entering the home. All wall penetrations should be sealed with a fire rated spray foam or caulk. Good garage door seals are critical for keeping harmful exhaust, chemical fumes and VOCs from entering the home from the garage. Replace and maintain as necessary.

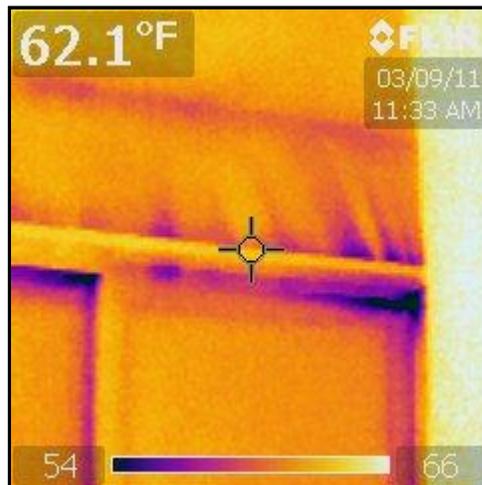
6.8 Picture 1 Sliding Doors

(1) The back porch sliding doors are a significant source of air leakage, around the casing, threshold, and between the glass panes where they slide along the track guide. All sides of the door should be air sealed with a clear, paintable caulk and the weather strip between the sliding panels should be adjusted or replaced to make a tighter seal.

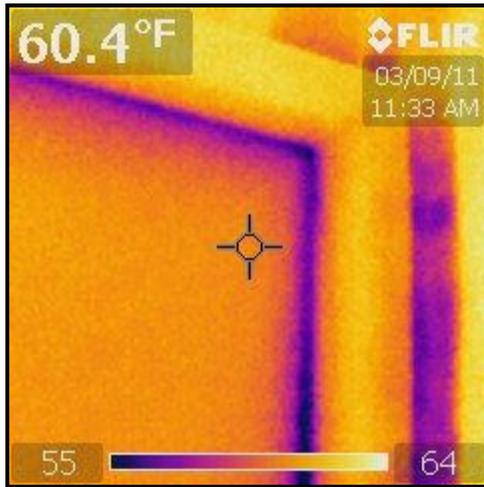
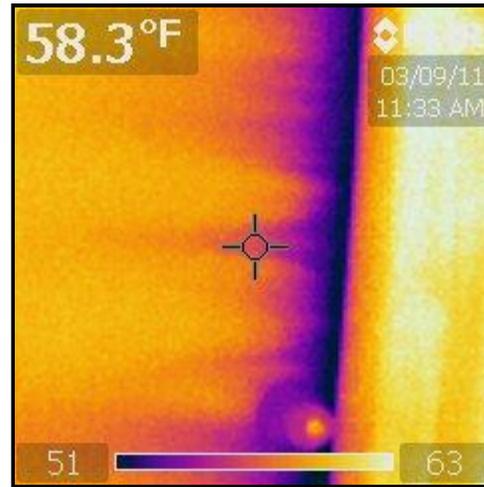
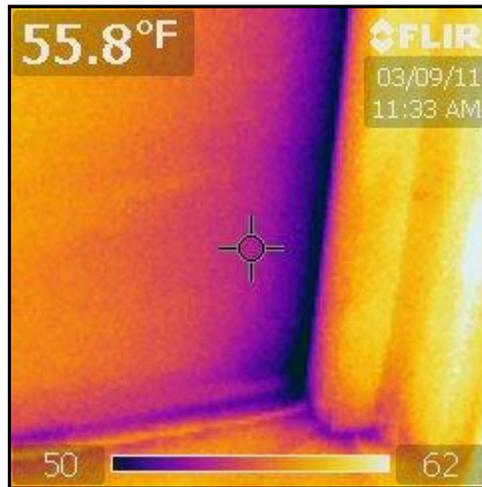
(2) The garage door should also have weather strip and door sweep installed.

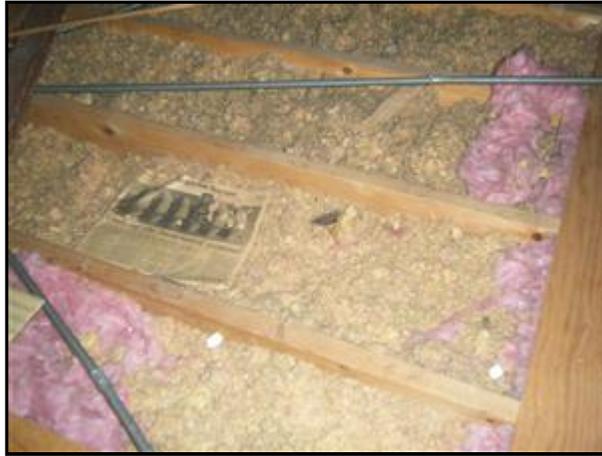
7.0 Picture 1 Insufficient Insulation

The attic currently has about an R-8 and should be increased to at least an R-38, the current code minimum. Recommend the attic be insulated to an a more cost effective R 50-60 with blown cellulose (settles to an air-impermeable mass - unlike fiber glass), **only after air sealing and attic ventilation** issues have been completed.
