Inspection Report

Property Address:
115 E. Ogden
Naperville IL

Insight Property Services, Inc.

Date: 1/1/2013	Time: 02:20 PM	Report ID: II - 120611 II
Property: 115 E. Ogden Naperville IL	Customer: T. Smith	Real Estate Professional:

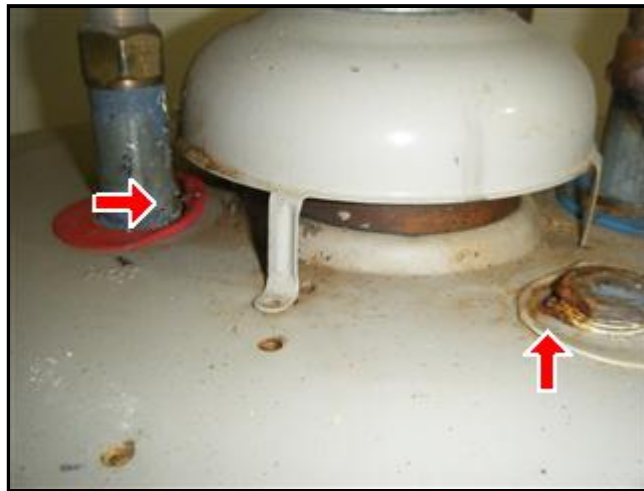
1.0 Picture 1

- While investigating air low between units, it was noted that the water heaters in units 2208 and 2210 show signs of exhaust spillage - melted gromets and rusted surfaces.

Recommend a BPI certified building analyst perform a combustion safety test to determine the conditions that lead to exhaust spillage. Install a CO monitor above the unit on the nearest wall and when the units fail, upgrade to a power-vented or sealed combustion unit to eliminate the risk of exhaust spillage.

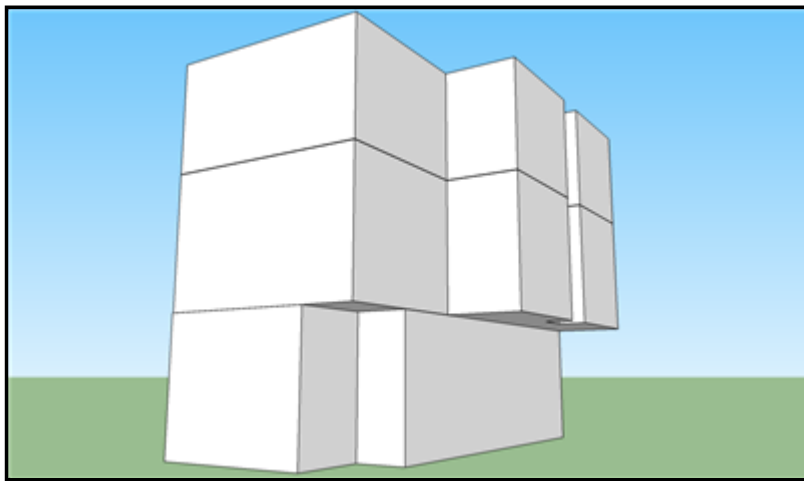
2.0 Picture 1

The "Thermal Boundary" of your home is what separates the conditioned air inside from the outside air, attic or adjacent units. Typically the thermal boundary is made up of an air control layer (like gypsum board) and a thermal control layer (insulation). A thermal boundary has 6 sides (top, bottom, front, back and two sides). Anywhere along the thermal boundary that is not aligned properly (meaning air control layer or thermal control layer, missing or not in tact) energy loss, odor transmission and fire spread risk can occur. Unintended openings between the units and within the units allow air & odors to move throughout.

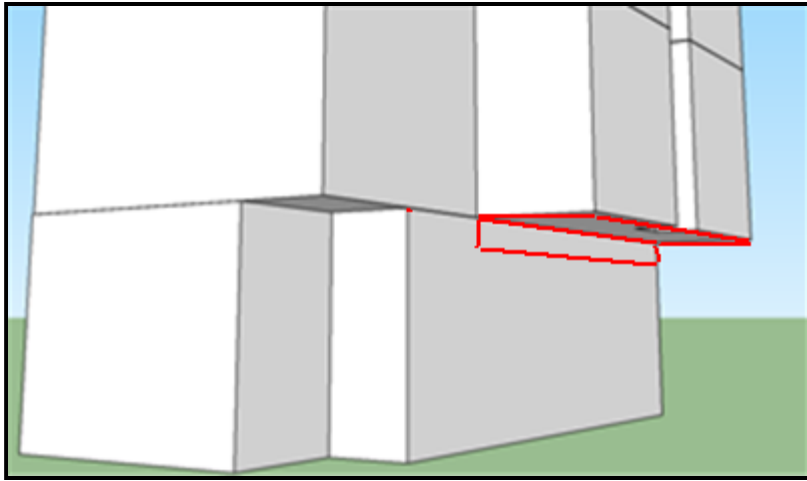
The major openings between 2208 & 2210 are the gaps between the truss joist, at the top of the concrete masonry unit (CMU) wall separating the garage. This area is most easily accessed through the garage of 2210. The ceiling drywall and fiberglass insulation may be removed, the openings blocked with an appropriate fire-rated material and the walls & floor to unit 2208 air sealed and insulated with closed-cell spray applied foam. This will form an air tight barrier between 2208, 2210 and the garage. Once completed, the drywall ceiling should be replaced with all seams, holes & perimeter sealed.

3.0 Picture 1 Underside & wall openings to be air sealed

Recommend the openings to 2210 be sealed as well for fire protection and limiting exhaust gas entry from the garage.

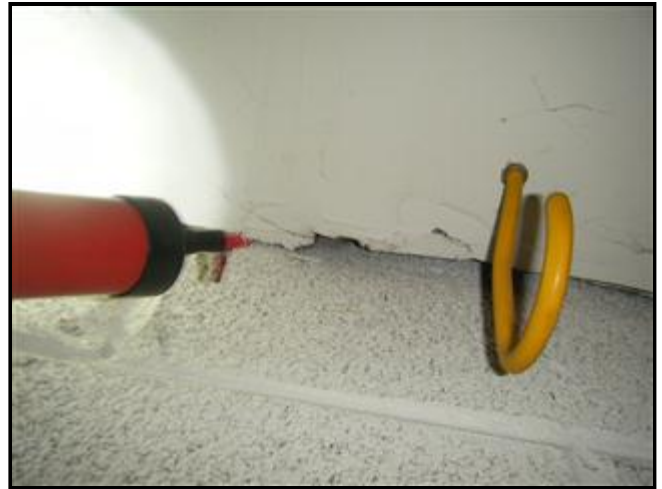
3.0 Picture 2 Air leakage along garage ceiling perimeter

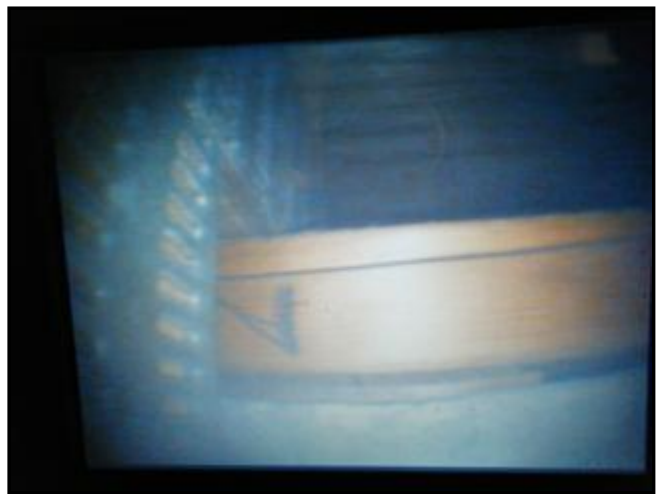
3.0 Picture 4 Opening above CMU block wall to garage

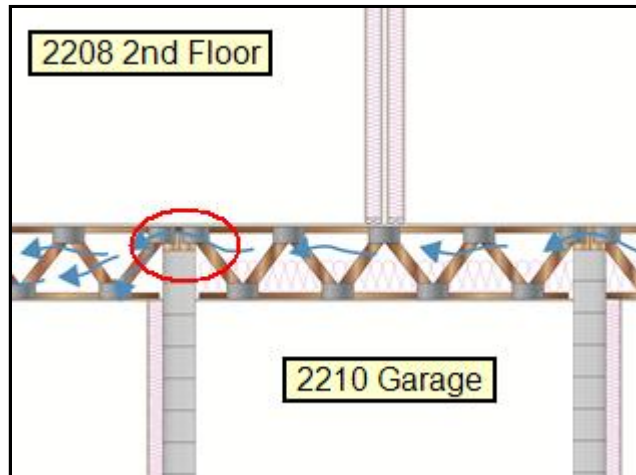
3.0 Picture 5 Opening above block wall

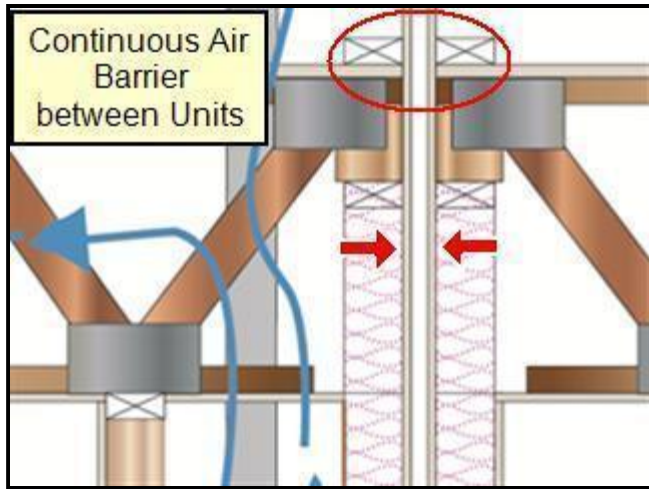
A proper partition wall (party wall) would have drywall on the back side of each framed wall (See 3.1 Pic.1). This drywall is present at the framed chase that the furnace flue passes through but apparently does not continue behind the toilet. It is unclear how extensive these areas of single layer drywall are.

3.1 Picture 1 Appropriate firewall separation

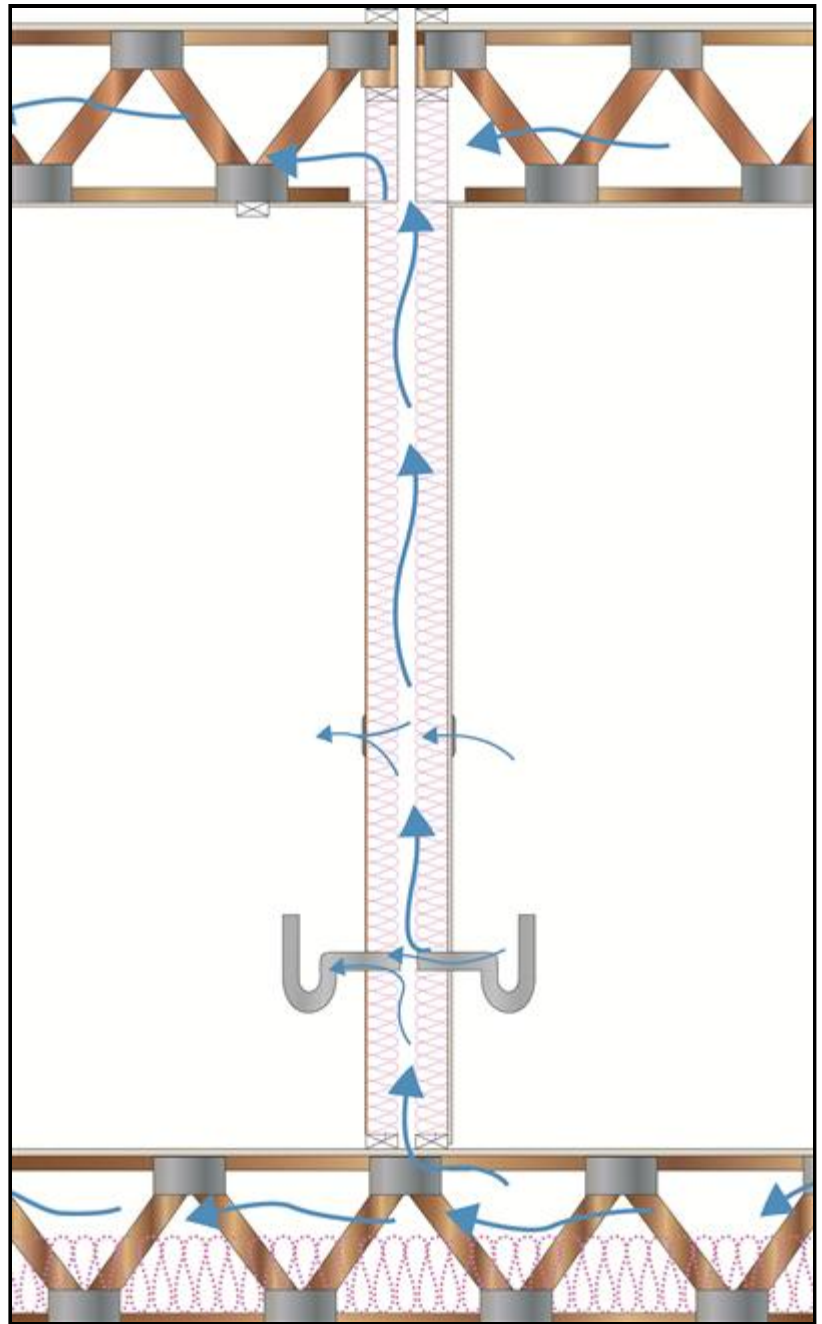
(1) A hole was made in the drywall behind the toilet on the 3rd floor. There was no drywall behind the insulation, on the back of the wall. A gap was observed, then the open back side of fiberglass insulation in the

bathroom wall of unit 2210 indicating there is no drywall on the back of the framing separating the units in this area.

3.1 Picture 2 No continuous barrier allows air flow & no fire protection

Recommend these holes be made when the garage ceiling is opened. If a gap exists, further drywall may be removed in order to seal these areas. All drywall holes may be repaired along with the garage ceiling.

If significant areas of separation wall are missing the interior drywall barrier, sealing holes between floors & all penetrations to this wall at the surface drywall, on both sides, is critical for halting air flow and fire spread. Fire rated sealants must be used in this case. Recommend consulting a City of Chicago code official or an experienced contractor regarding appropriate options for establishing firewall protection in this existing construction.

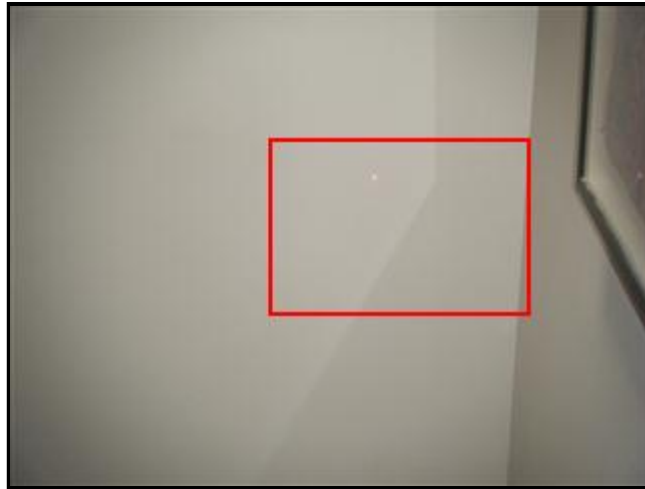
We were not able to visually confirm the continuity of the partition wall or determine its layers of construction as it separates the 2nd & 3rd floors of the homes. There should be no breaks in the drywall between units and no air leaks. This may be confirmed by opening the drywall at the level of the 3rd floor at the stairs - on both sides of the flue chase.

3.1 Picture 3 Cut in access above stair landing where probe hole was drilled

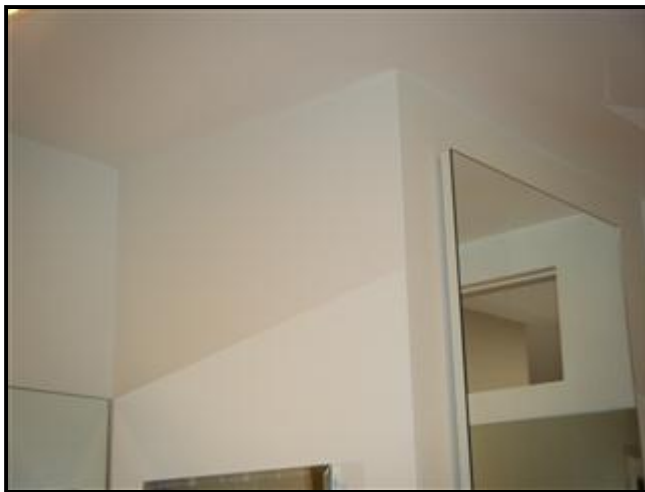
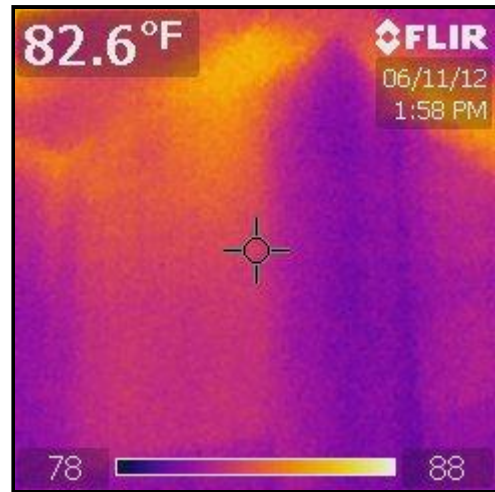
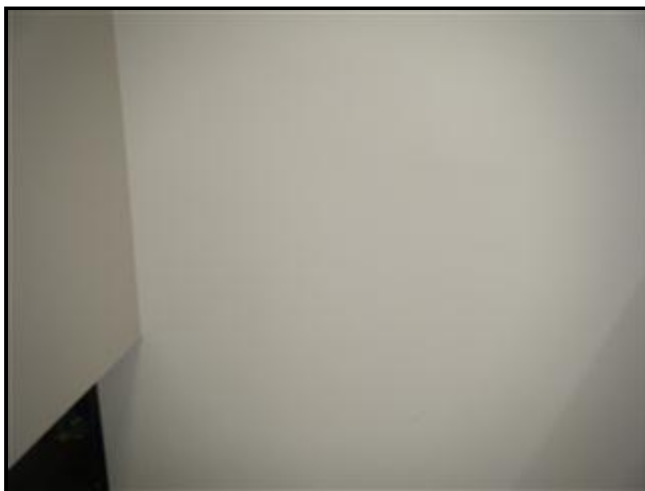
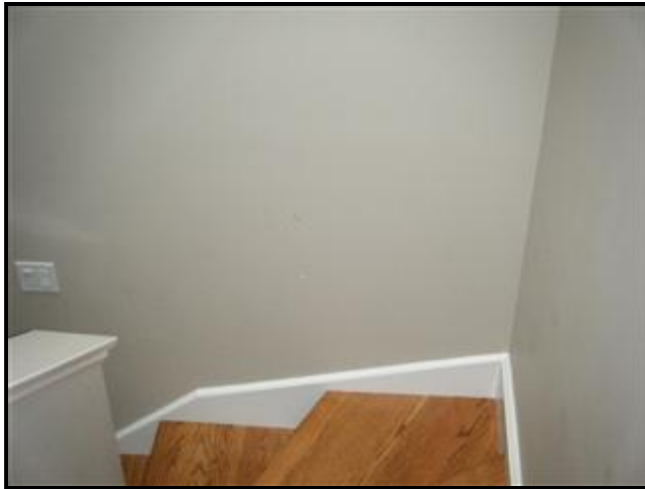
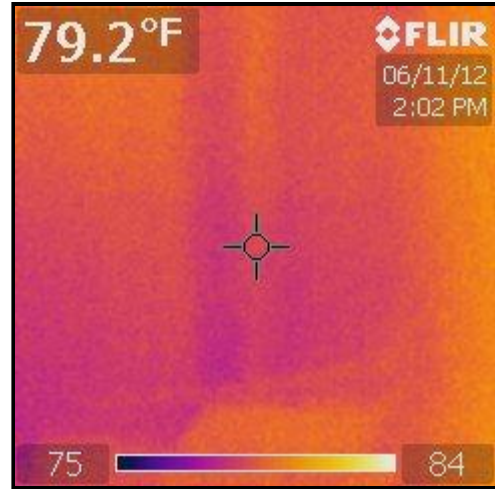
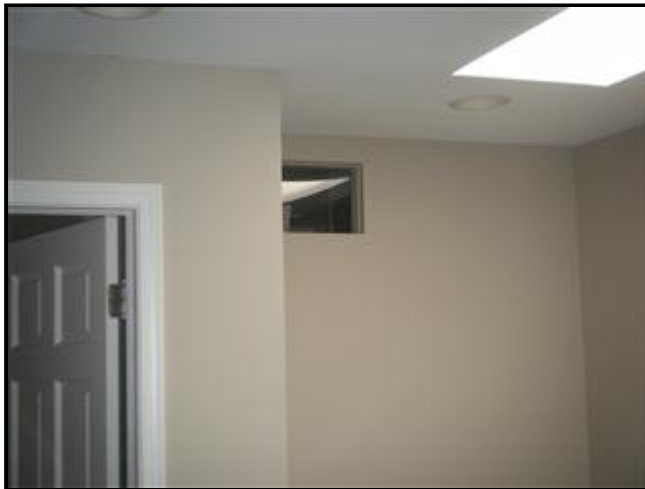
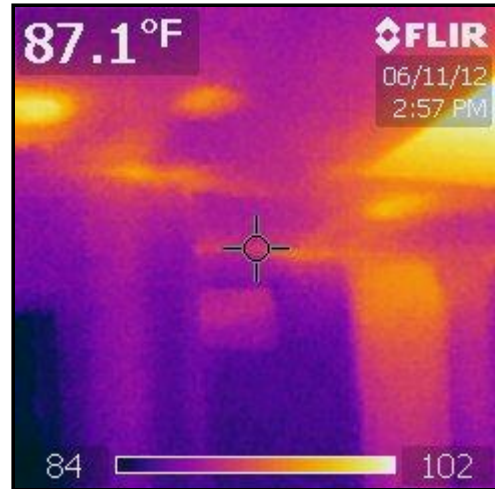
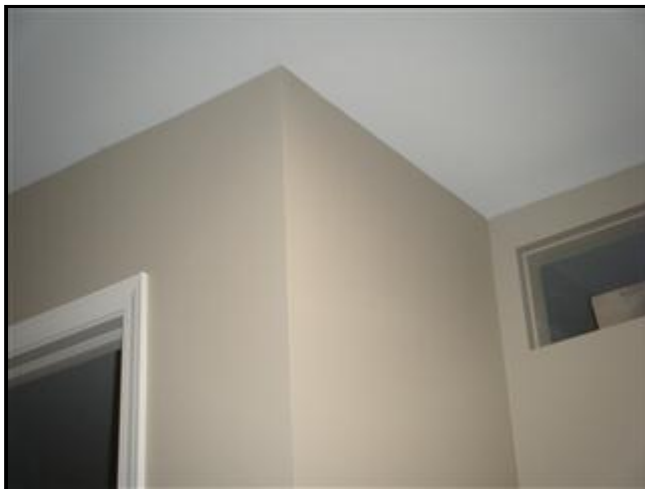
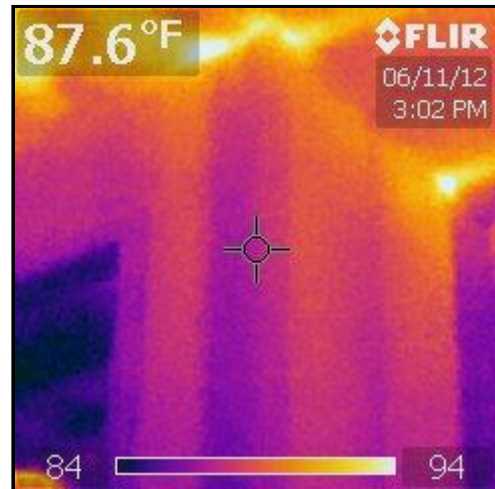
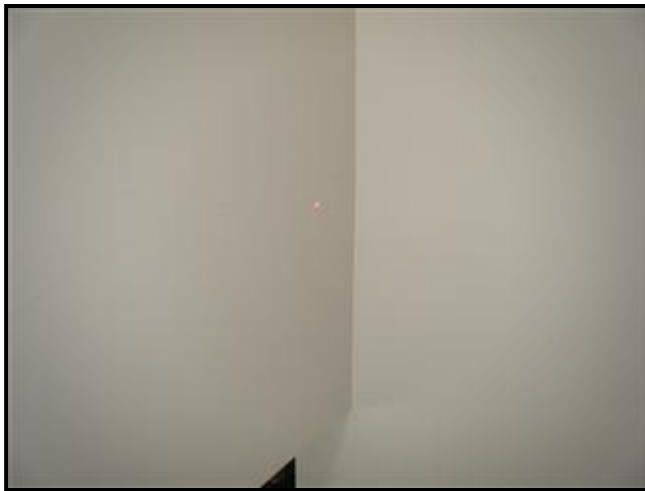
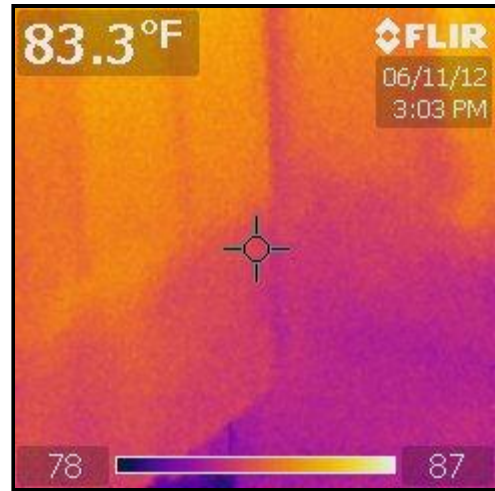
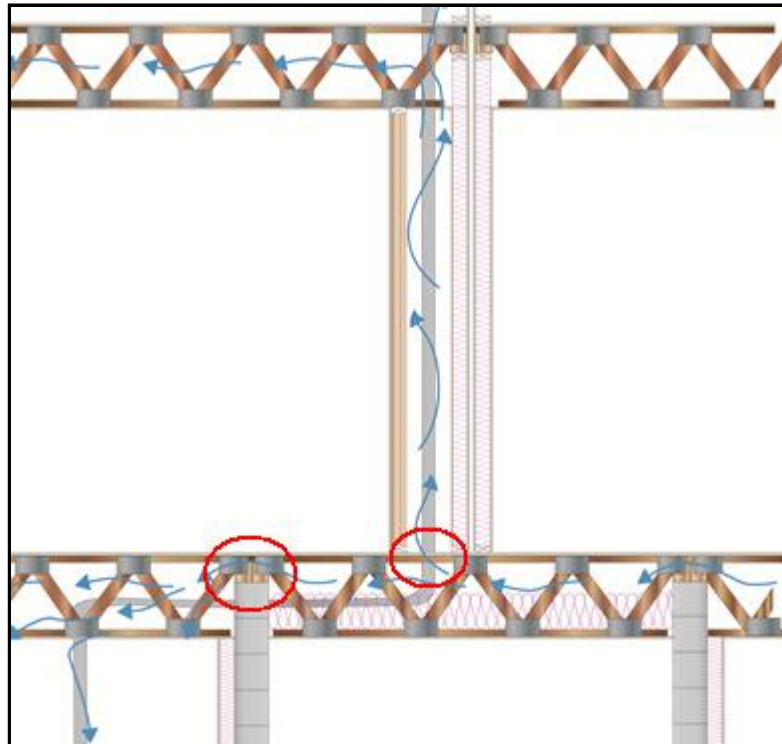
(2) Air can move horizontally through the unit by way of the open truss joists and vertically by way of plumbing, electrical and mechanical chases. This is only an issue if these cavities are open to the outside or adjacent units - as is the case here. Openings to the garage ceiling connect to all the floor spaces throughout 2208, resulting in a significant risk of fire spread and the current odor issues.

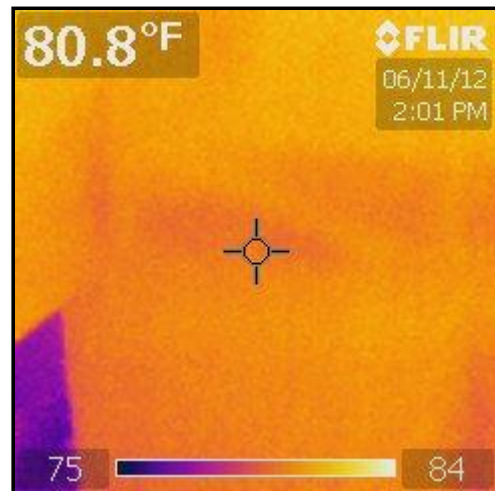
3.1 Picture 7 Truss-joist visible

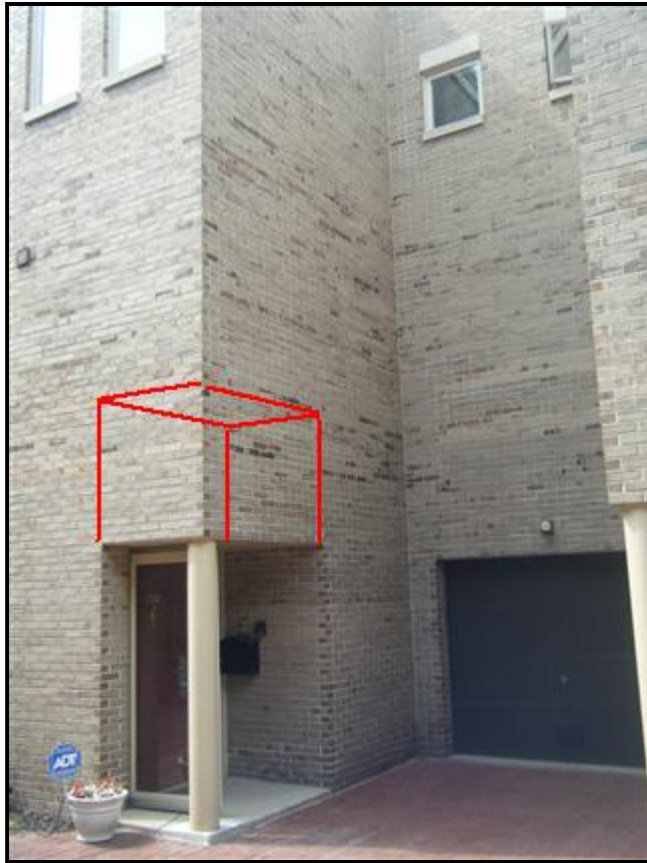
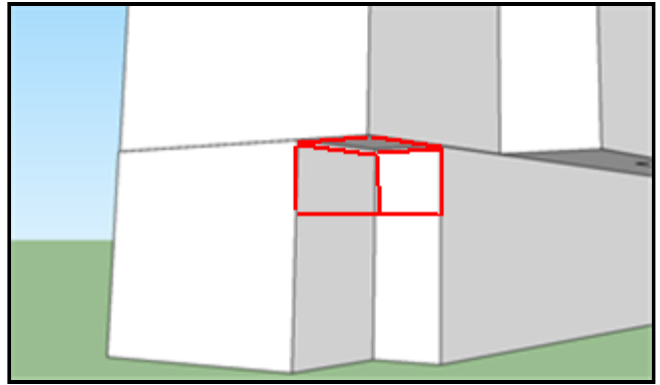
The underside of the 2nd floor that overhangs the front entry is not air sealed and insulated poorly with fiberglass, resulting in cold floors above. Recommend underside of the floor and the walls to the conditioned space be air sealed & insulated with spray applied foam when the garage is treated.

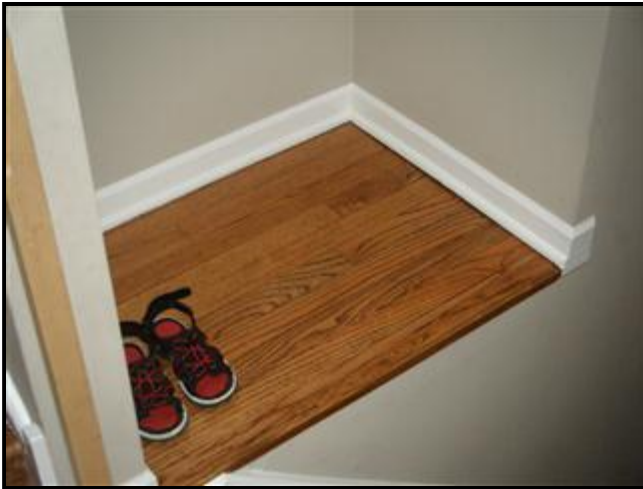
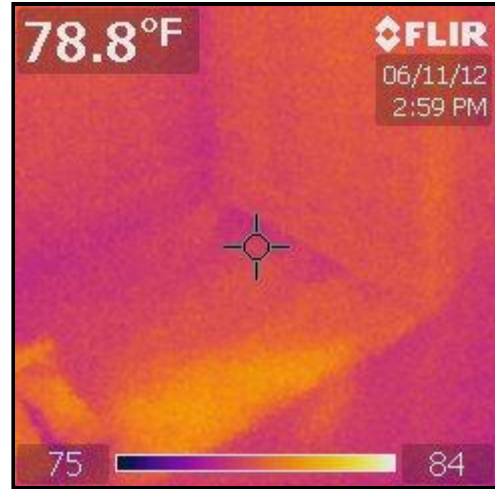
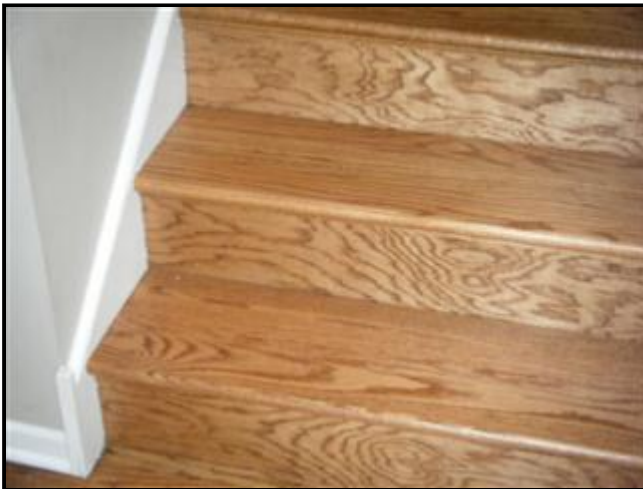
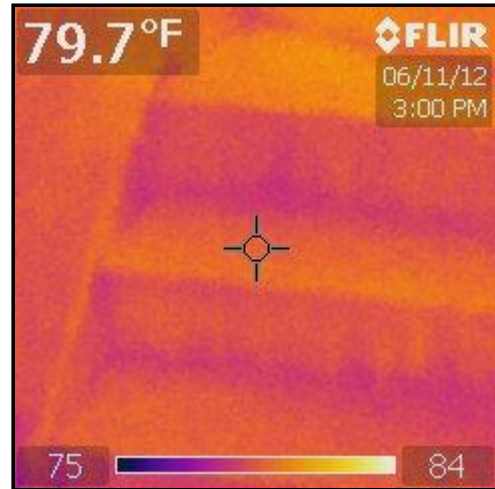
Air leakage around the stairs is another indicator of the connections between floor and wall cavities. Sealing the major openings should halt the minor leakage around the stairs.
