# Inspection Report

115 E. Ogden  
Naperville IL

**Insight Property Services, Inc**

<b>Date:</b> 1/1/2013	<b>Time:</b> 02:45 PM	<b>Report ID:</b> HI - 120411
<b>Property:</b> 115 E. Ogden Naperville IL	<b>Customer:</b> T. Smith	<b>Real Estate Professional:</b>

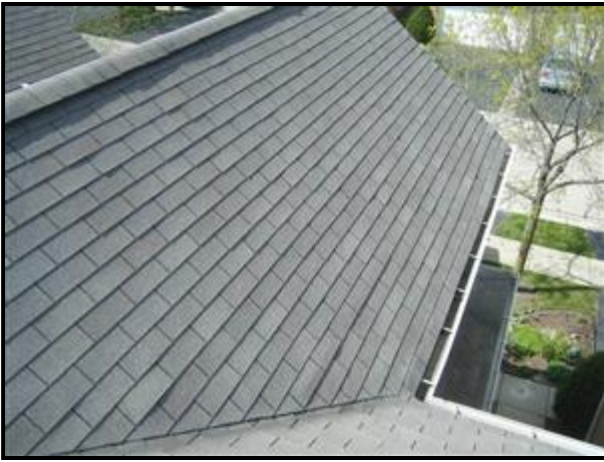
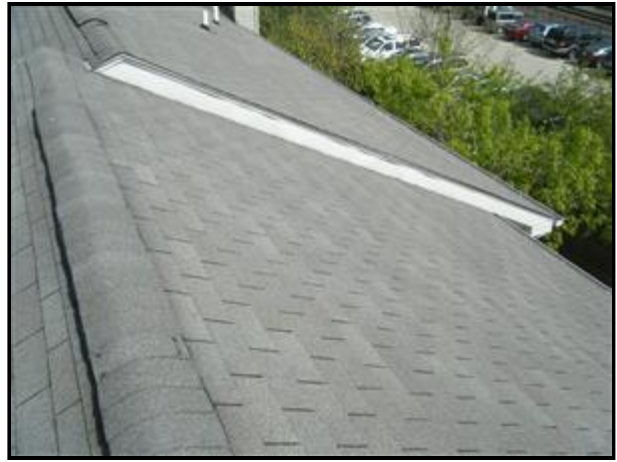
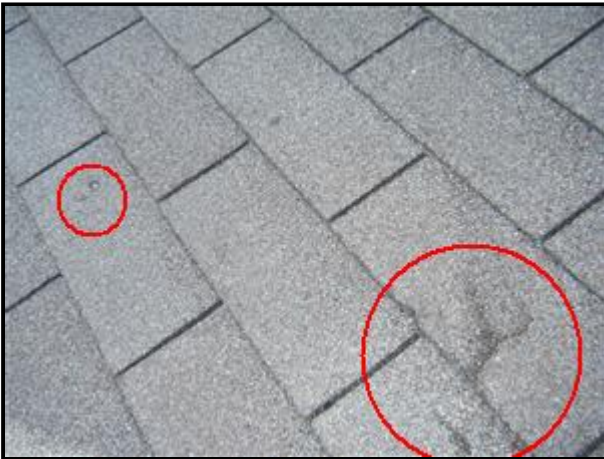
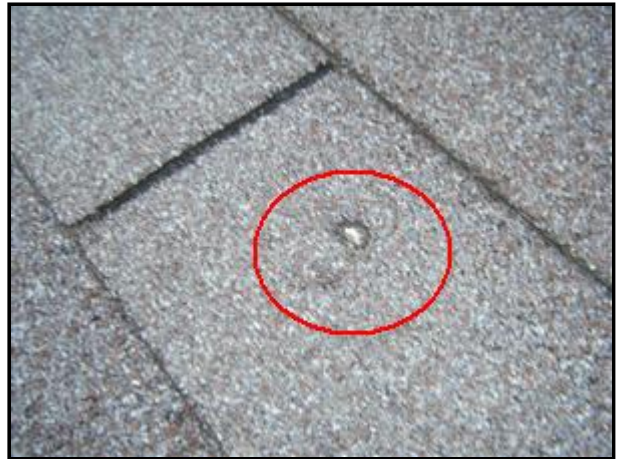
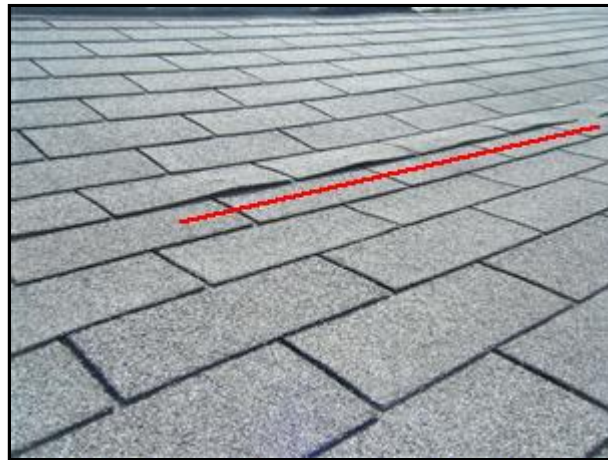
The roof appears to be the original installed 1997 is in good condition. There are a few areas of minor mechanical damage (nail head punctures, scuffs and raised shingles). Recommend these areas be proactively addressed and monitored for leaks during rains (from the attic below).

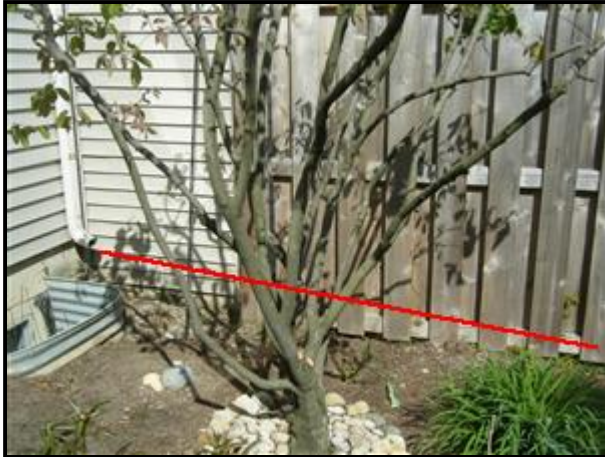
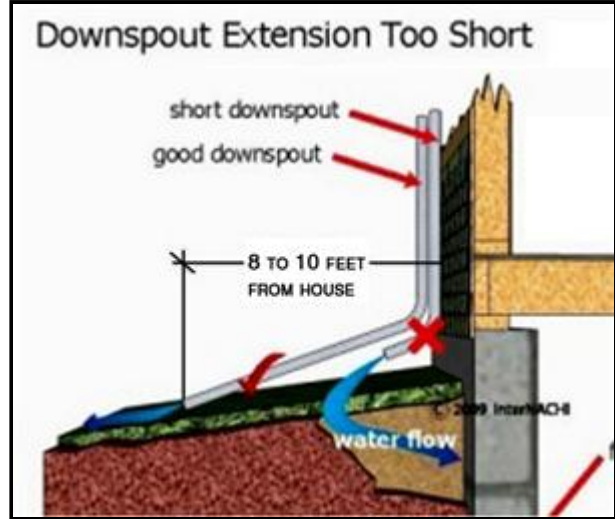
The gutters are in fair condition and seem to be managing rain water effectively. Recommend monitoring during rain events to determine whether additional downspouts are needed (wherever rain is spilling over gutters).

Sloped downspout leaders should discharge at least 8 to 10 feet away from the foundation wall. If downspout is too short, water will not drain properly and can collect next to the foundation wall and penetrate into the basement.

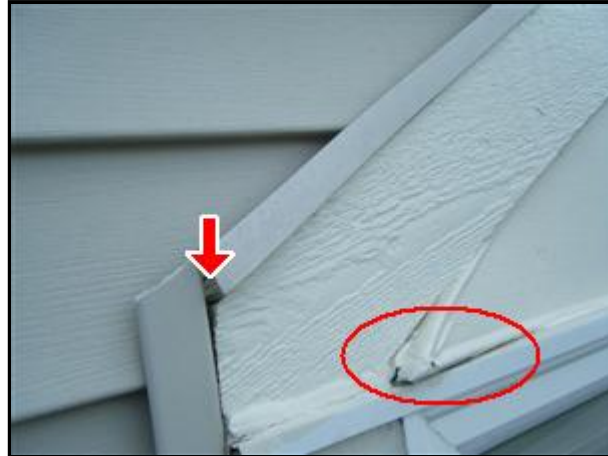
2.0 Picture 1

The flashing and trim at the top left of the window above the garage has gaps that may be allowing water to enter the wall assembly. Recommend a qualified individual properly flash and seal this area.

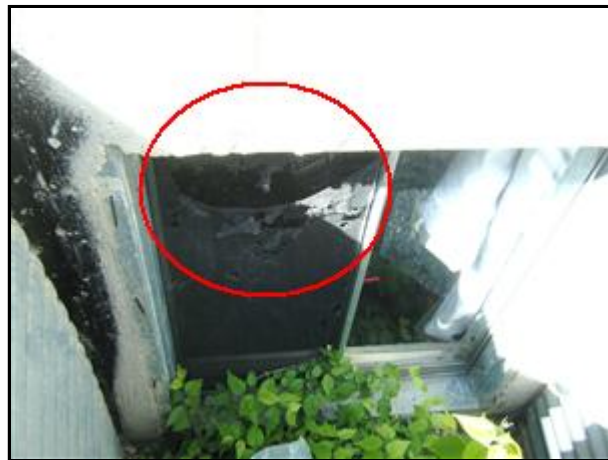
2.2 Picture 1

Basement screen is damaged, likely from animal attempting to escape the open window well. Repair screen and cover well.

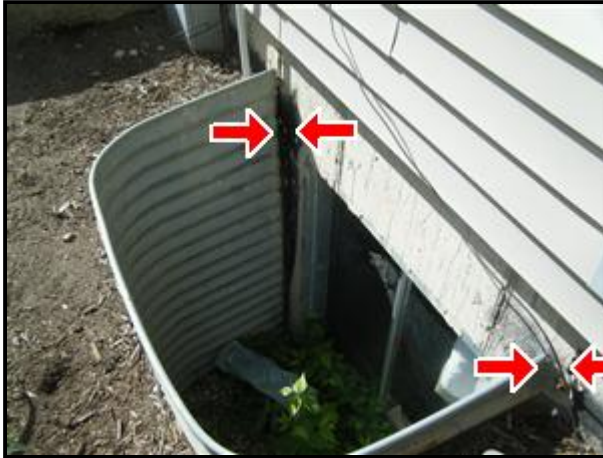
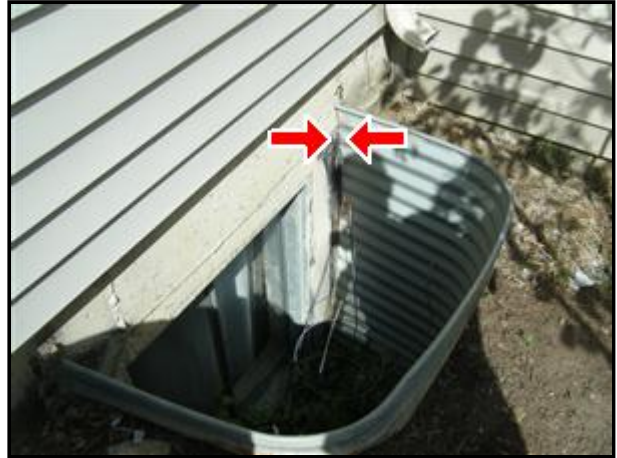
The window wells should be properly sealed and fastened to the wall to halt any seepage from the saturated soil. After debris and vegetation is removed & drain is cleared, a cover should be installed on each well to maintain a clean and dry assembly.

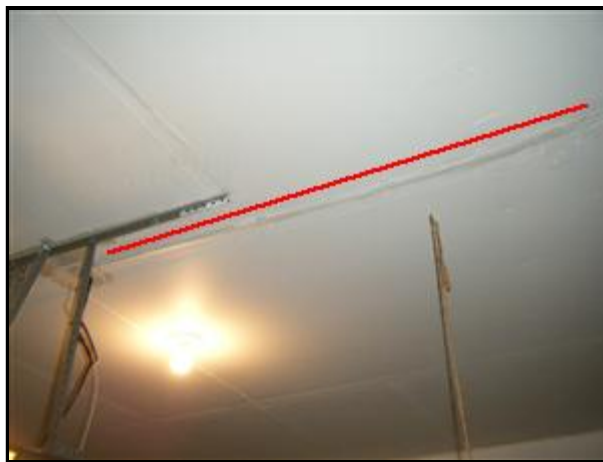
3.1 Picture 1

Recommend open seams be resealed in the garage drywall. All gaps and holes should also be sealed to halt air leakage and provide fire protection. Also recommend to seal and paint the garage drywall with a 'low perm' paint to halt possible Carbon Monoxide migration from the garage to the room above.

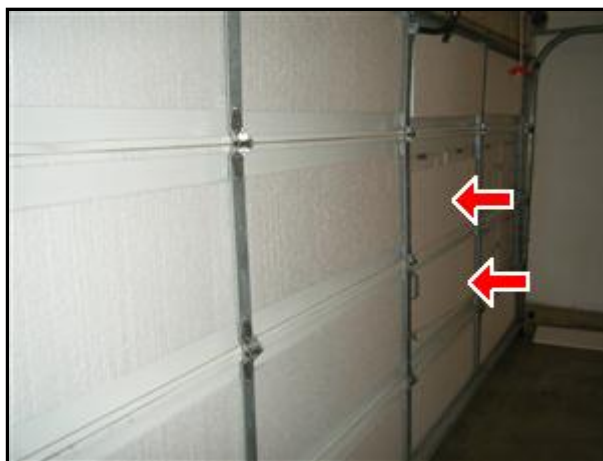
The steel garage door has attached foam board panels, some of which have fallen off. These panels are doing little to insulate the garage or absorb sound. The door is otherwise in fine condition.

3.4 Picture 1 Delaminated foam board

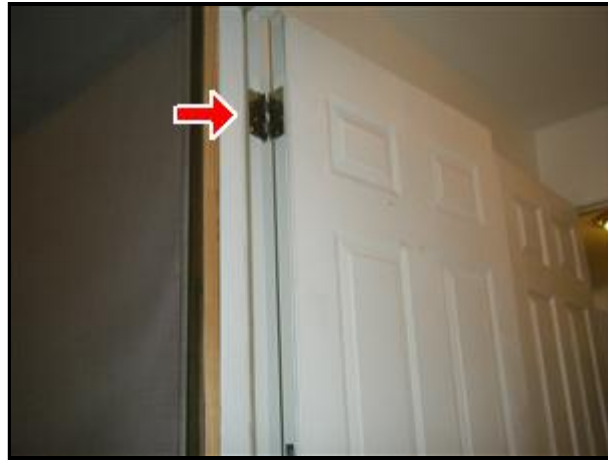
The door to the garage does not close automatically. Recommend spring hinges or a door closer be installed to ensure that the door closes and limits the amount of exhaust and fumes entering the home from the garage.

3.6 Picture 1 Install spring hinge or closer

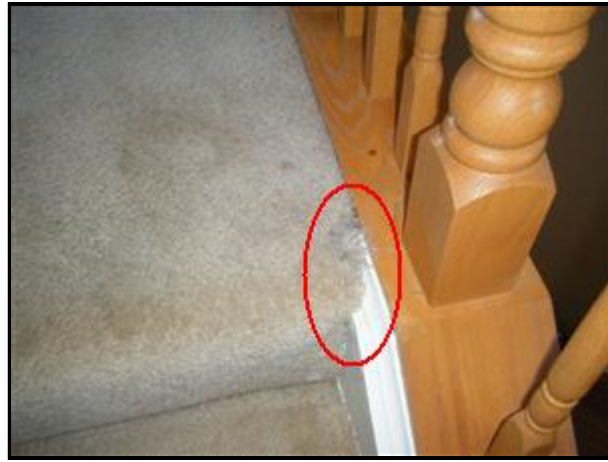
4.2 Picture 1

The carpet at the top of the stairs is worn, likely from a pet or vacuum brush.

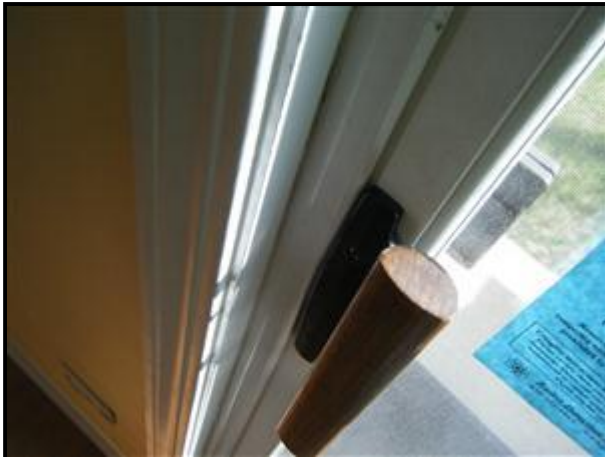
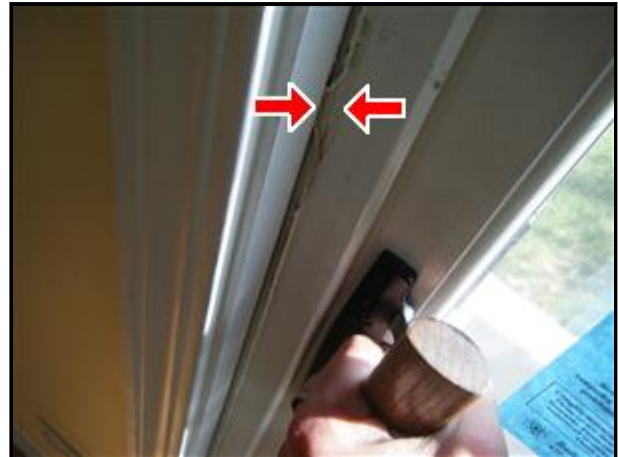
(1) The sliding glass patio door latch is secured to the door frame and not through to the wall framing, resulting in the door frame flexing when the locked door is pulled. Securing the latch to the framing will avoid damage to the frame and better secure the door.

4.5 Picture 2 Flexing door frame

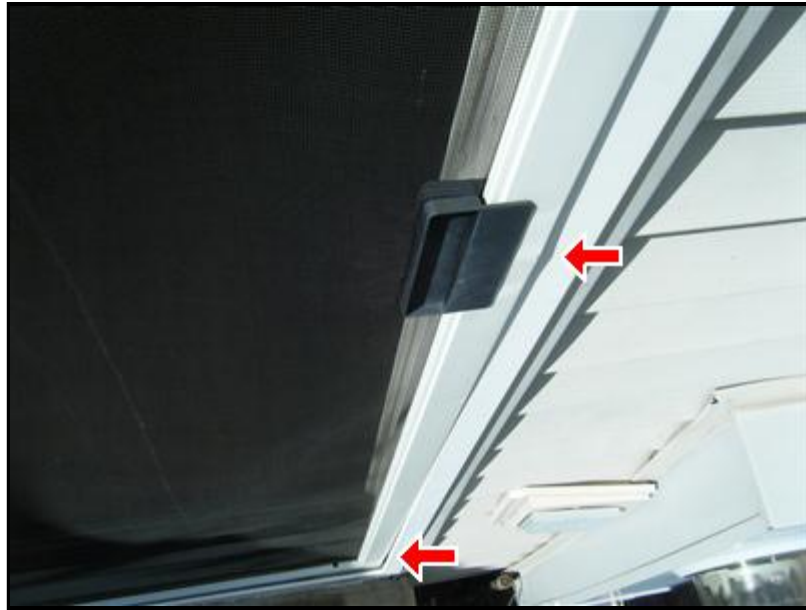
4.5 Picture 3

(2) The patio screen door frame is bent, does not close & latch and does not open easily. Recommend having the frame repaired or replaced.

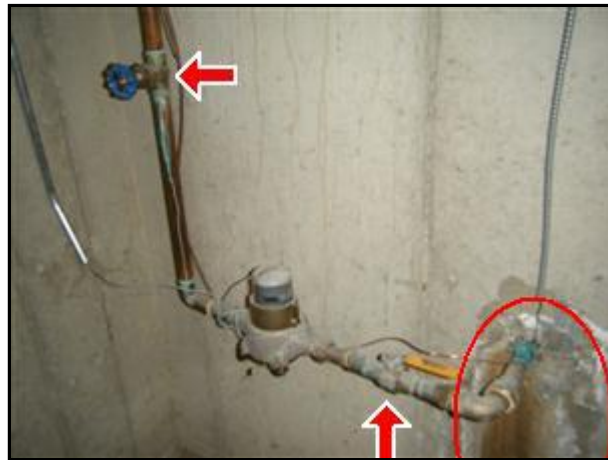
6.0 Picture 1

There is staining on the wall that suggests either minor seepage through the foundation wall along the water supply pipe or condensation from the cold water line running down the wall. Wrapping the pipe with foam pipe insulation will keep warm interior air from contacting and condensing moisture on the pipe. If the wall penetration is found to be seeping, consult a foundation repair specialist to seal this area before finishing the basement.

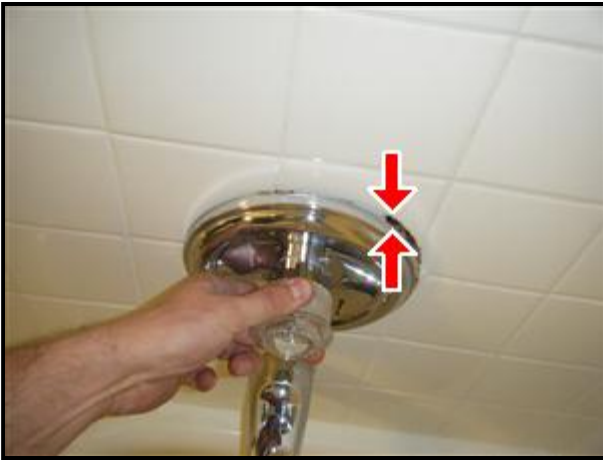
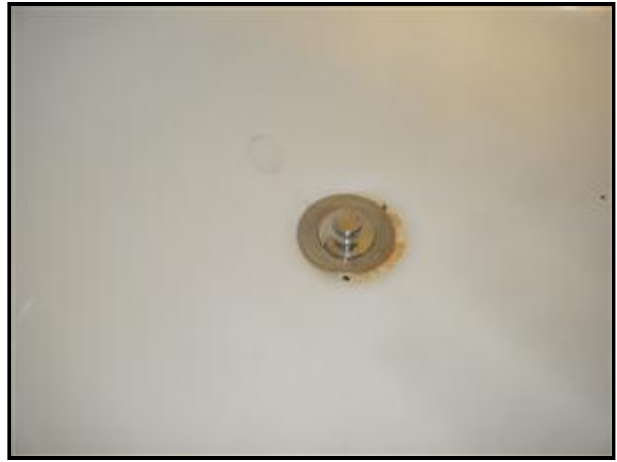
After running the tub and allowing water to run down both the drain and the overflow, a small cool spot was observed on the ceiling below with the infrared camera - suggesting there may be a leak in the tubs drain system. When the wall is opened to secure the faucet, recommend the drains be inspected for signs of leaks and repaired as needed.

6.1 Picture 1 Loose faucet

6.1 Picture 2 Light rust at tub drain

(1) The master tub faucet assembly is not secured in the wall. Recommend the wall in the closet behind be opened to access the faucet and secure it properly.

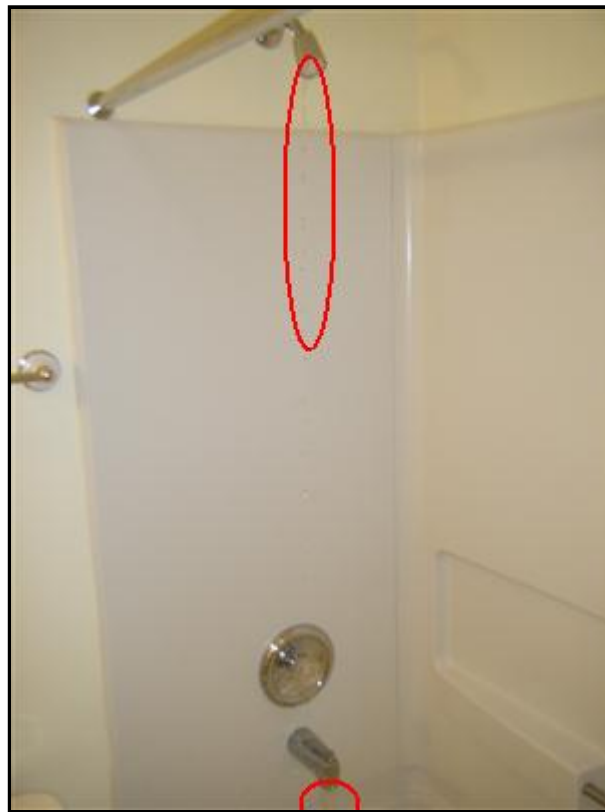
6.1 Picture 3

(2) The spout of the hallway bath tub is diverting water to the shower head, even when 'open', causing water to splash out of the tub. Recommend replacing the tub spout.

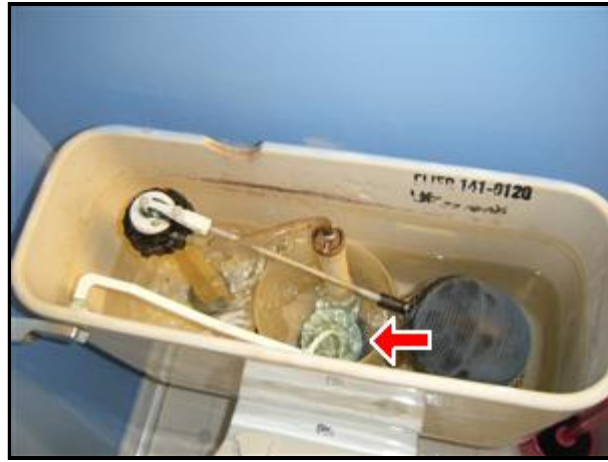
(3) The master bath toilet flapper does not stay up long enough for a full flush - requiring the flush handle be held down. Recommend replacing the flapper with an adjustable unit that can be set to work properly.

6.1 Picture 4 Master bath toilet

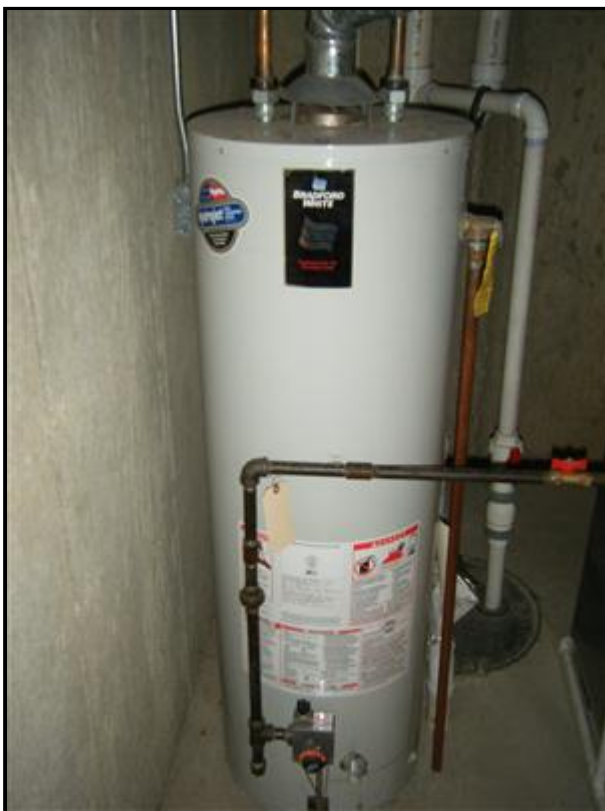
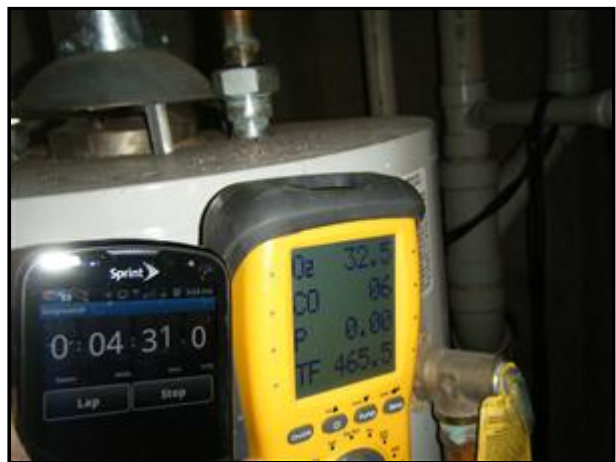
The water heater seems to be functioning well, but is 15 years old and approaching the end of its service life (10-15 years). Recommend the unit be upgraded to a high efficiency power vented or sealed combustion unit, either tanked or tankless. In addition to being more efficient, either type will eliminate the risk of exhaust gas spillage that exists with the current natural draft unit.

6.2 Picture 2 CO - 6 ppm @ 465 degrees

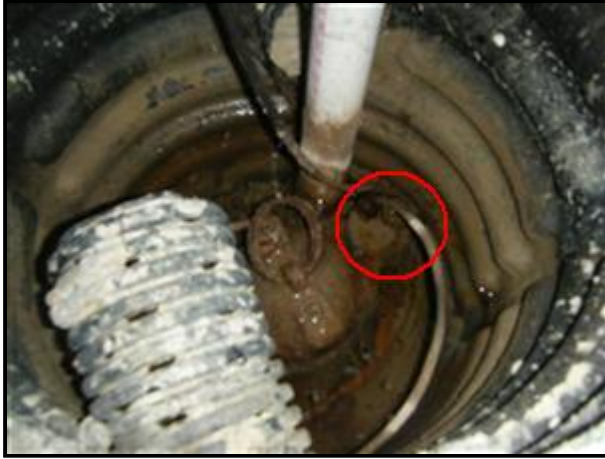
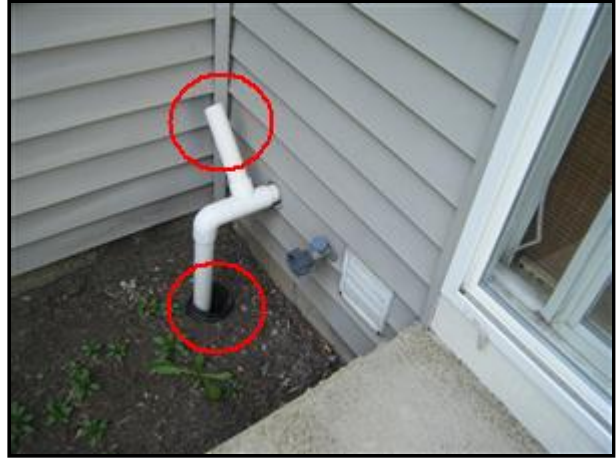
The air vents in the drain lines should be monitored in the winter for signs of freezing or back up which can result in the pump running constantly because the ice is keeping the water from draining out.

6.4 Picture 2 Air vents

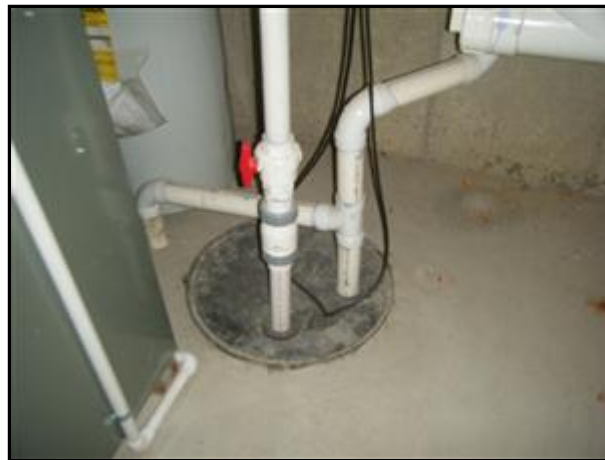
(2) The ejector pit and pump was not observed because the pit is sealed to keep out sewer gases. The pump is removing water that enters the pit and there are no signs of moisture around the unit. Should installing a bathroom in the basement be planned, a qualified plumber can route the drains to this pit which will in turn lift the waste water up to the drain out to the sewer system.

6.4 Picture 3 Ejector pit

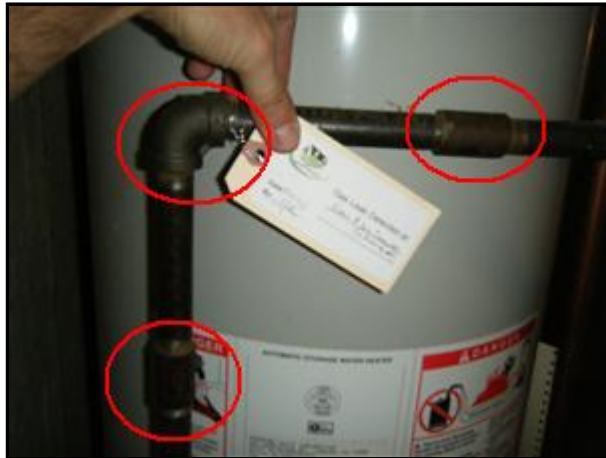
6.6 Picture 1

Gas leaks were located at the couplings and elbow fitting above the water heater control valve. Recommend a qualified individual repair and retest the gas pipes for leaks.

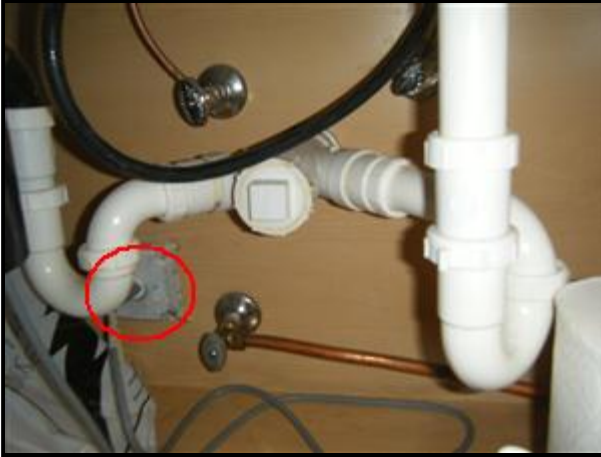
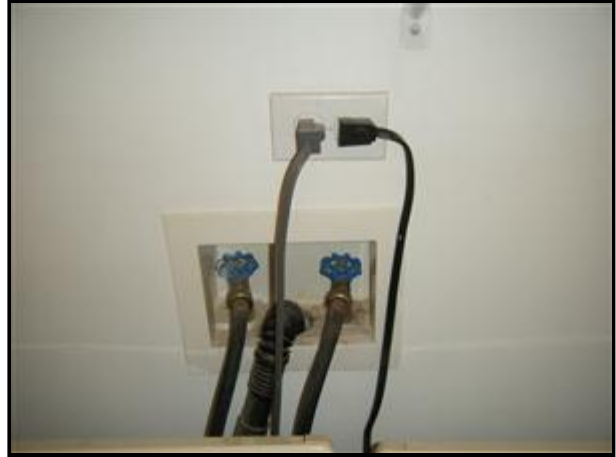
All outlets within 6 feet of a water source (kitchen, bathrooms, laundry, etc) should be replaced or protected with GFCI outlets. Recommend a qualified electrician replace or rewire outlets as necessary.

7.5 Picture 1 Disposal outlet

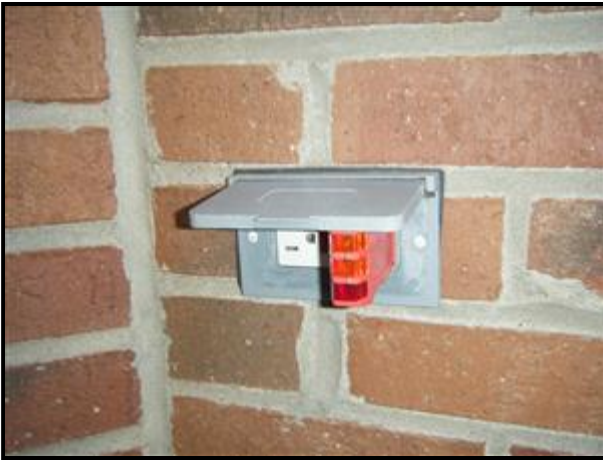
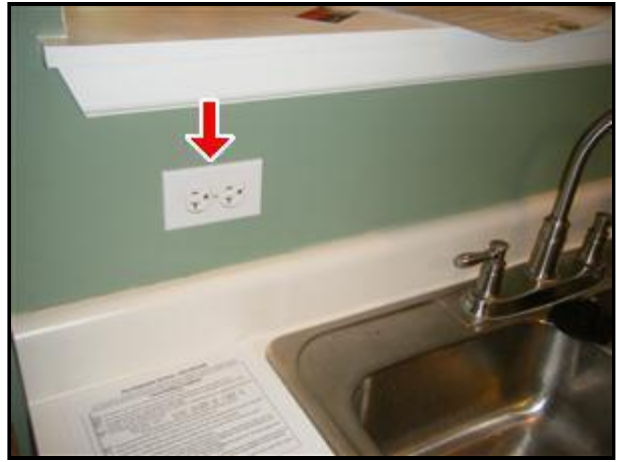
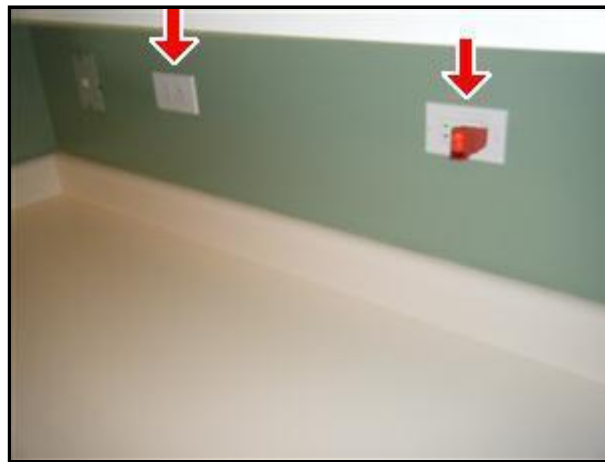
The exterior outlets are not functioning properly, the kitchen GFCI and outlets surrounding the sink are not GFCI protected, as well as the garage GFCI. Recommend a qualified individual repair or replace these devices as necessary to ensure all devices are properly protected.

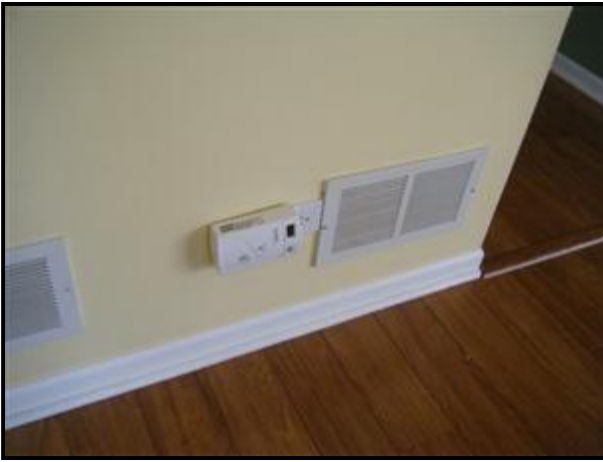
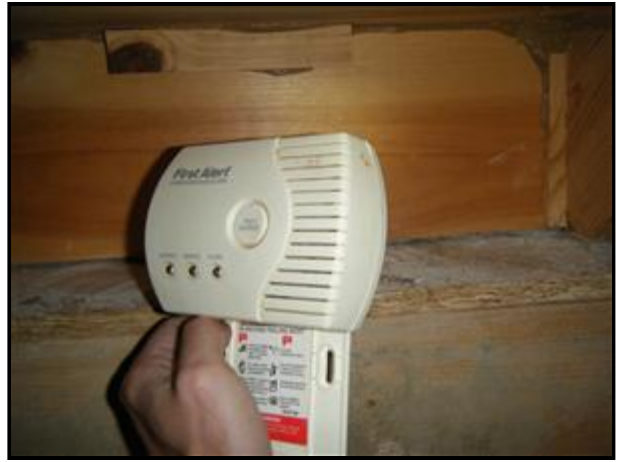
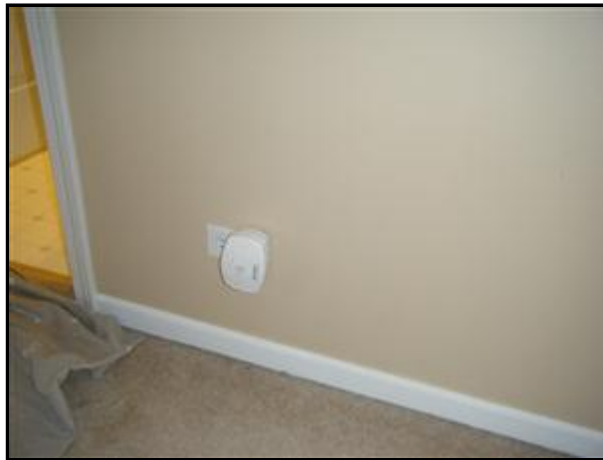
The average service life of a carbon monoxide detector is 2-3 yrs. Be sure to replace batteries yearly and replace the units entirely after 3 years. Recommend one CO detector near each CO source (water heater / furnace, kitchen, door to garage, etc) and one within 15 feet of the bedrooms.

7.8 Picture 1 Plug-in CO detector

7.8 Picture 2 Battery CO detector in basement - w/o battery

7.8 Picture 3 Plug in CO detector on 2nd floor

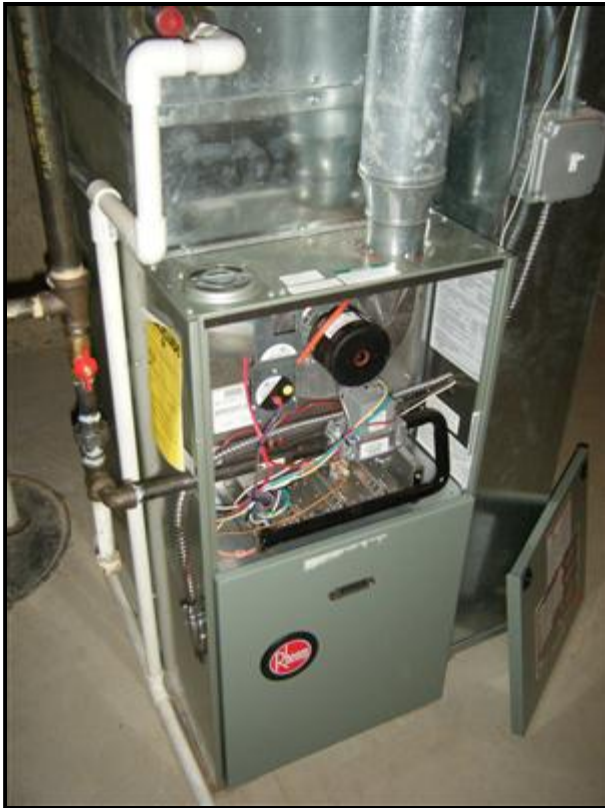
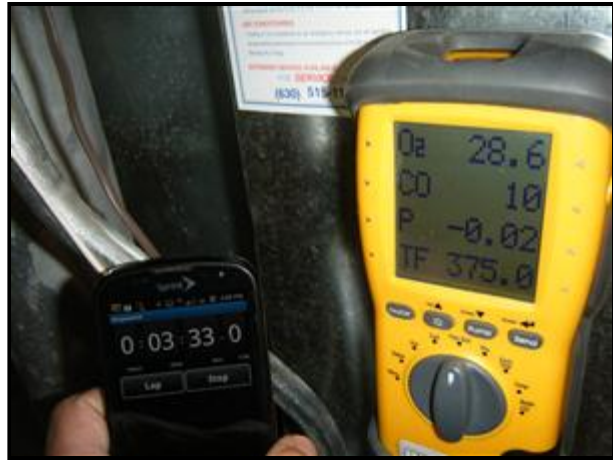
The furnace is about 15 years into an expected service life of 25 years and seems to be in fine condition. Recommend the unit be cleaned and/or serviced twice a year to prolong its service life. Filter should be changed monthly or as needed.

8.0 Picture 2 CO - 10 ppm @ 375 degrees

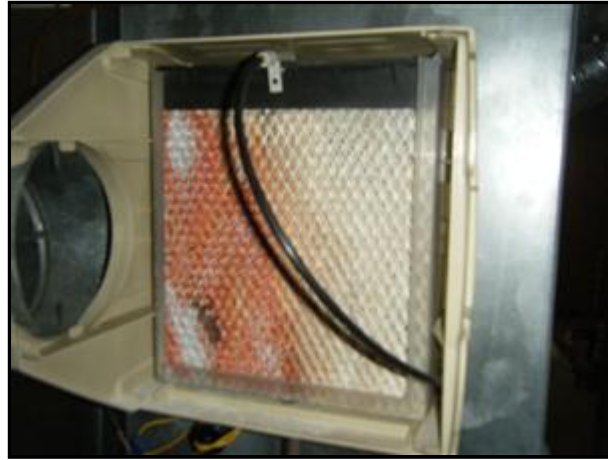
The humidifier panel is in fine condition but should be cleaned of mineral deposits periodically (soaked in CLR or Lime-away solution).

8.3 Picture 1 Humidifier inner pad

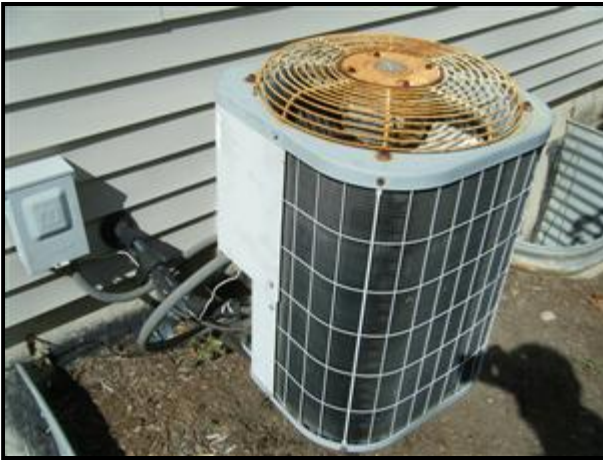
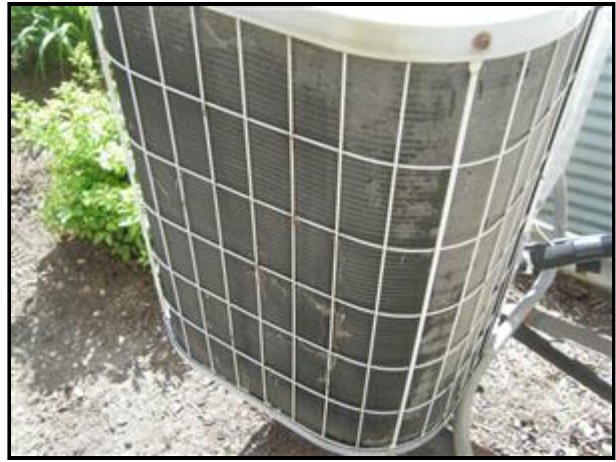
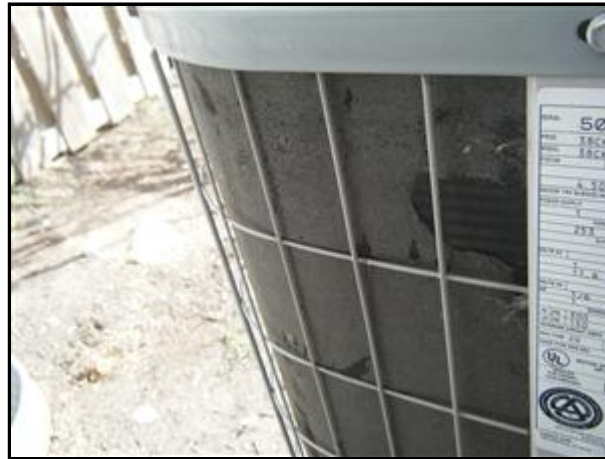
While the air handler was turned on and seemed to function well, the AC could **not** be turned on because the outside temperature was below 65 degrees. Recommend a qualified HVAC technician clean and assess the unit before regular summer function is needed.

8.6 Picture 2 Lint and pollen

8.6 Picture 3 Lint and pollen

(1) The AC is about 15 years into an expected service life of 20 years and seems to be in fine condition. Recommend the unit be cleaned and/or serviced once a year to prolong its service life. Lint, debris and vegetation should be kept clear of the sides of the unit to ensure proper air flow and efficient function. The unit should also be covered in the fall and winter to keep out debris and snow.

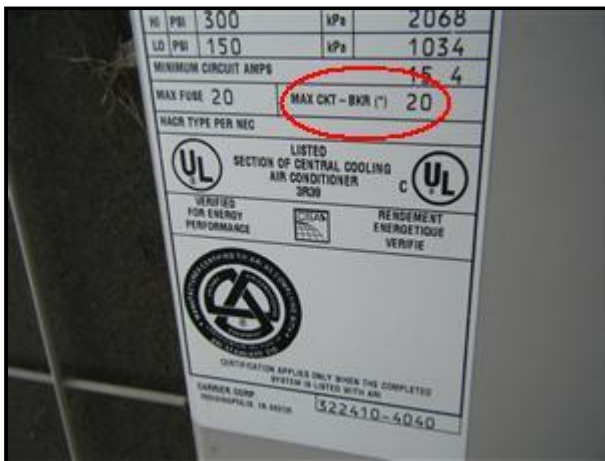
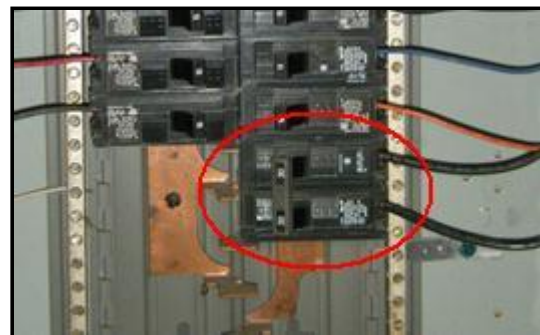
(2) While the maximum rated fuse to be used is listed as 20Amps, the unit is connected to a 30 Amp breaker at the panel. This means the unit can receive a higher current than it can handle - potentially damaging the unit - before the breaker shuts down power. A qualified HVAC technician should investigate this issue further and replace the breaker as needed.

8.6 Picture 4 Max Breaker 20 Amp

8.6 Picture 5 30 Amp breaker

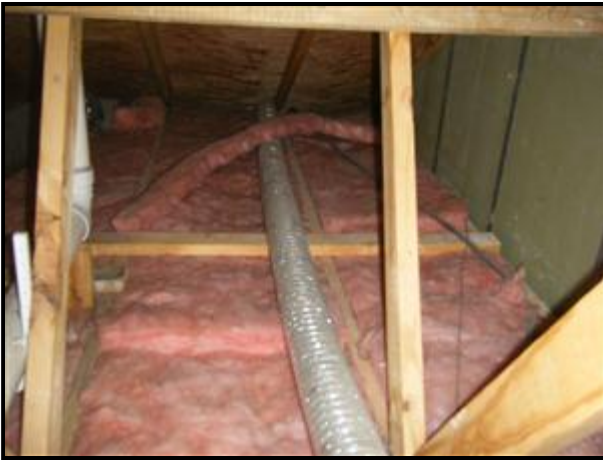
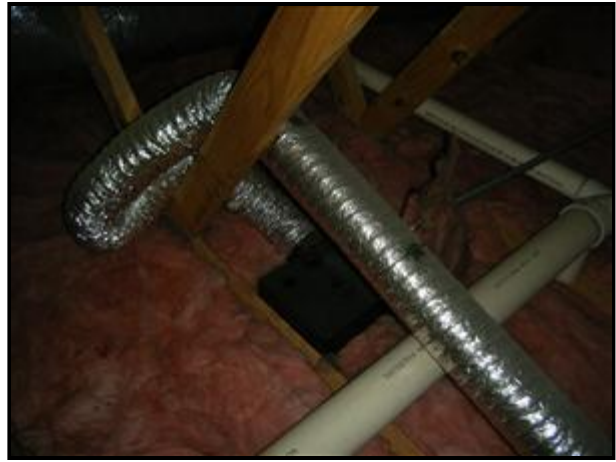
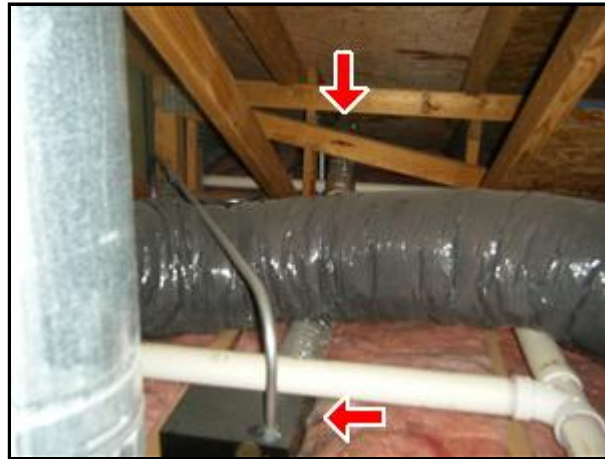
The bath fan exhaust lines are too long, with too many bends for optimum air flow. They also exhaust into the soffits where the air flow carries the moisture back into the attic.

9.5 Picture 3 Master bath fan &amp; exhaust

Recommend new 80+cfm, quiet (<1.5 sones) be installed in the hall bath and master bath and vented through the roof by way of flexible, insulated duct and proper, dampered vents. This should be completed before any additional attic insulation is installed. The ducts should be as short as possible and sized one step larger than the outlet on the fan to avoid air friction which reduces the air flow.

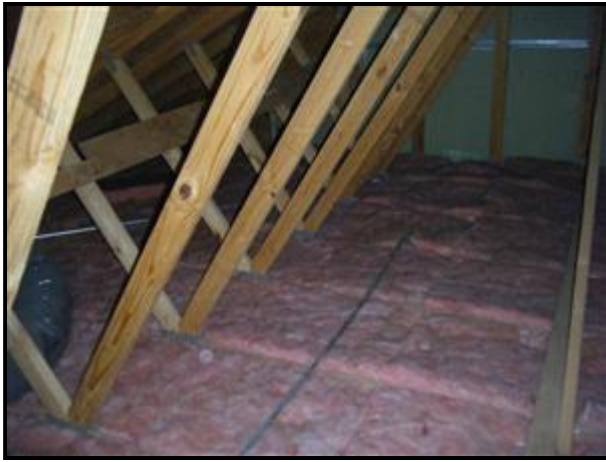
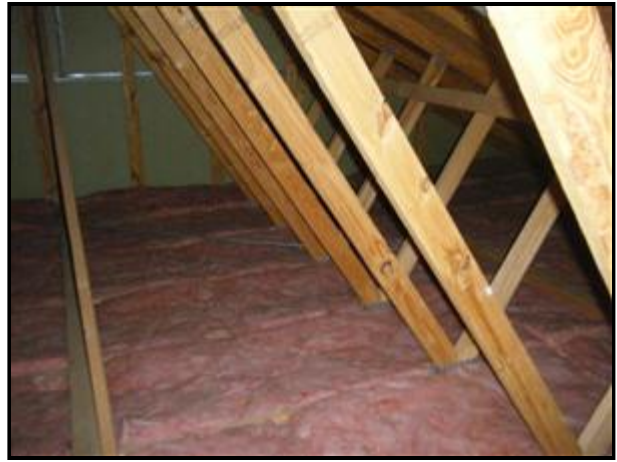
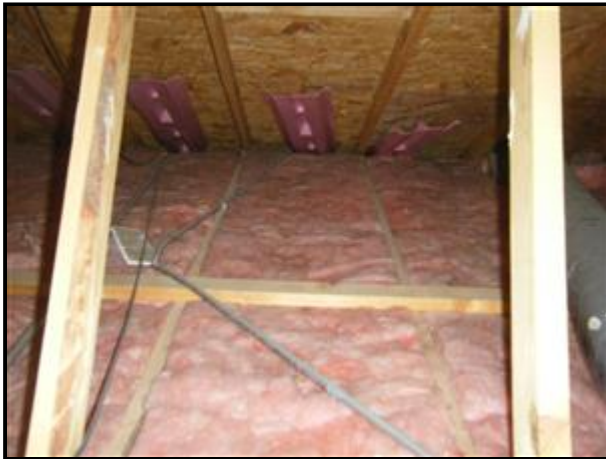
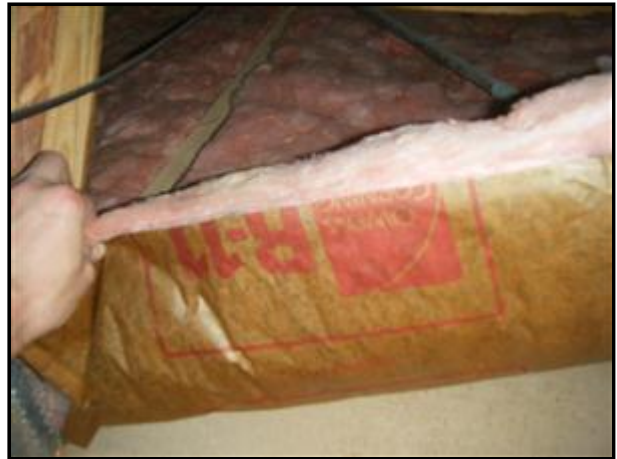
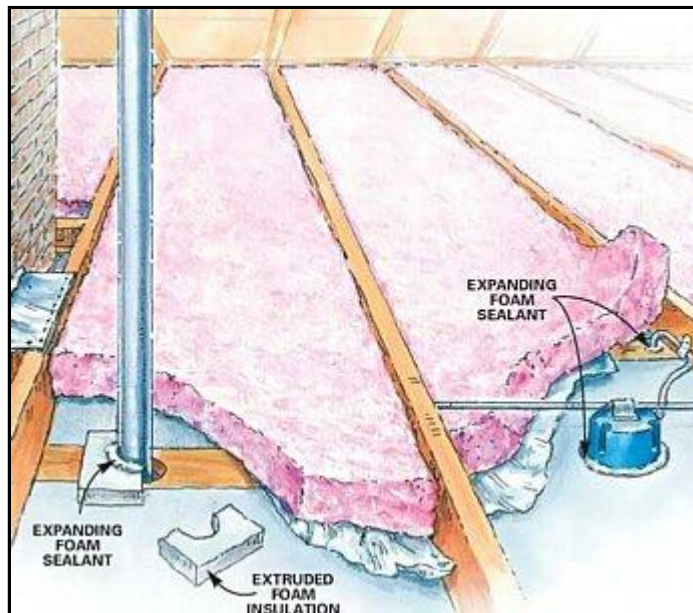
(1) The attic currently has R-11 fiberglass batt insulation, below the current code minimum of R-38. Likely the original design intended additional insulation be blown over the batt insulation. Recommend the attic be insulated to a more cost effective R-50/60 with blown cellulose (settles to an air-impermeable mass-unlike fiber glass), only **after air sealing and attic ventilation** issues have been completed.

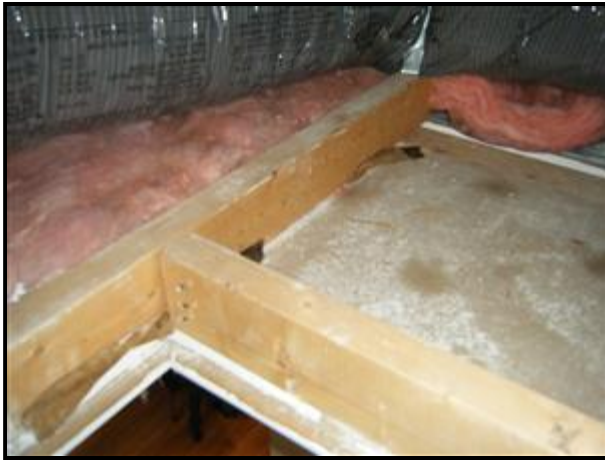
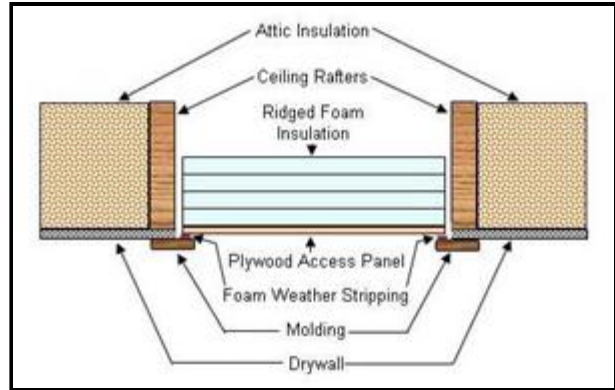
(2) The attic hatch should be air sealed and insulated. The casing should be fastened securely to the ceiling, caulked at all corners & seams and weather strip installed where the cover sits on the casing. The cover should have 8" of foam board fastened to the top, resulting in an R-40 assembly.

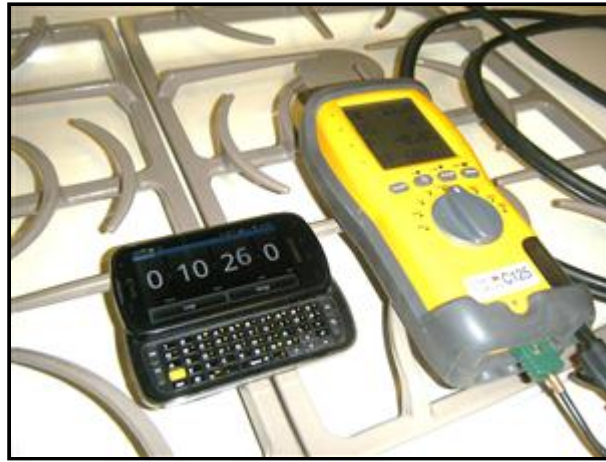
A carbon monoxide (CO) output test was done on the oven. The CO measured at Steady State operation (normal operating level) of the gas oven is **47 ppm at 606 degrees**. CO less than 25 ppm is ideal. 26-100 ppm recommends a cleaning and adjustment. 100+ ppm requires the unit be thoroughly serviced, cleaned and adjusted by a qualified service technician.

10.1 Picture 1 CO - 47ppm @ 606 degrees

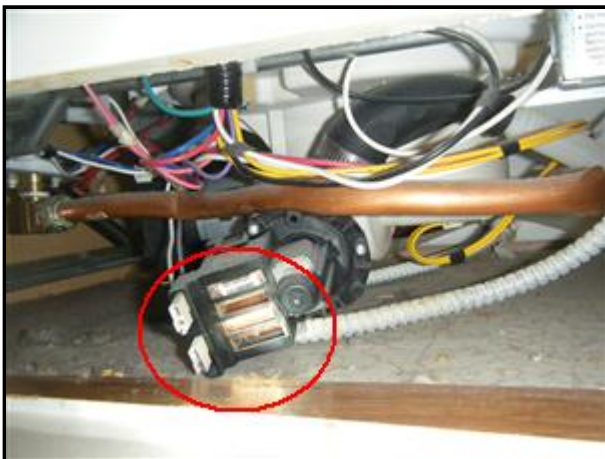
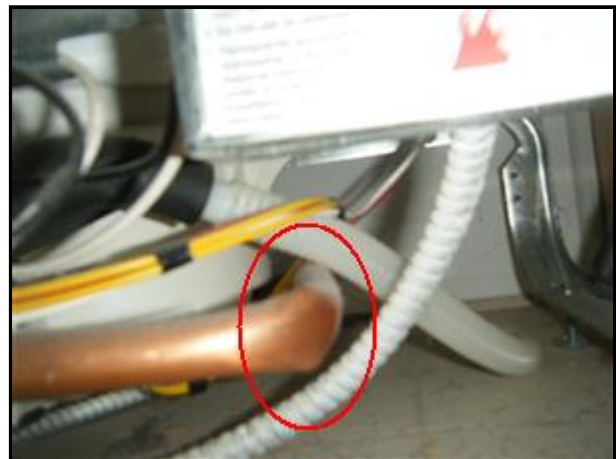
The copper supply to the dishwasher is kinked at the bends and seems to have put the drain valve electrical relay in contact with the floor. If a leak occurs, an electrical shock hazard is present. Recommend a qualified individual replace the copper supply with a flexible, stainless steel braided supply and adjust the drain relay up off the floor.

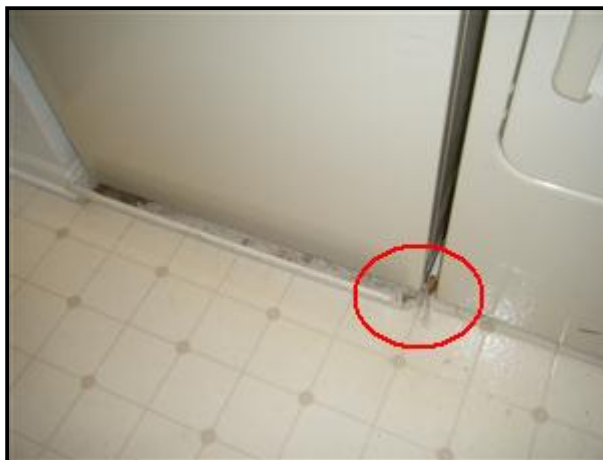
10.5 Picture 1

The washer pan is cracked at the corner. Consider replacing the pan to effectively manage leaks that may occur.

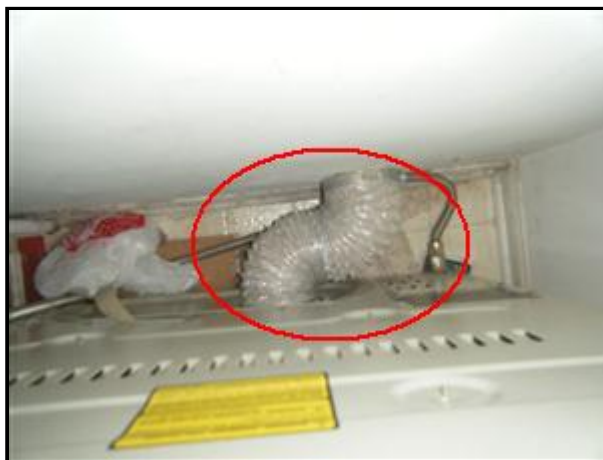
10.6 Picture 1

The dryer vent pipe should be a metal duct, solid or flexible. Vinyl material or metalized mylar are a fire hazard with gas dryers
