Home Performance Report

115 E. Ogden
Naperville IL

Insight Property Services, Inc

Date: 1/1/2013	Time: 09:20 AM	Report ID: HP - 11-010
Property: 115 E. Ogden Naperville IL	Customer: T. Smith	Real Estate Professional:

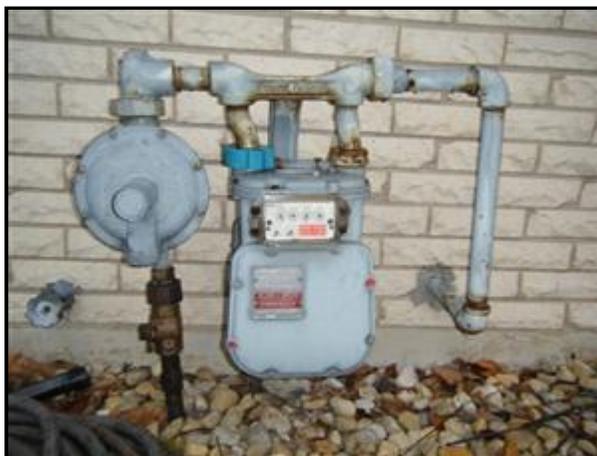
2.16 Picture 1 Gas Meter

There were no gas leaks detected outside the home.

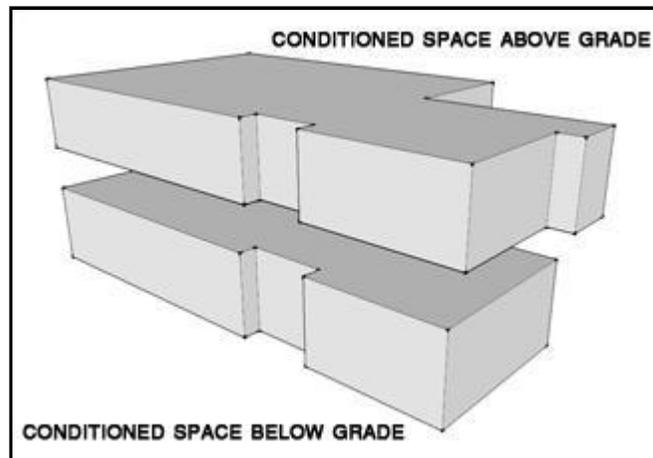
4.0 Picture 1 Thermal Boundary

The "Thermal Boundary" of your home is what separates the conditioned air inside from the outside air, attic or crawlspace. Typically the thermal boundary is made up of an air control layer (like gypsum board) and a thermal control layer (insulation). A thermal boundary has 6 sides (top, bottom, front, back and two sides). Anywhere along the thermal boundary that is not aligned properly (meaning air control layer or thermal control layer, missing or not in tact) energy loss can occur. Energy loss (money) can be heating or cooling and can be significant as breaks in the thermal boundary can allow air leaks through house pressures and heat flow through conduction. It is important to preserve the thermal boundary and air seal and insulate when remodeling.

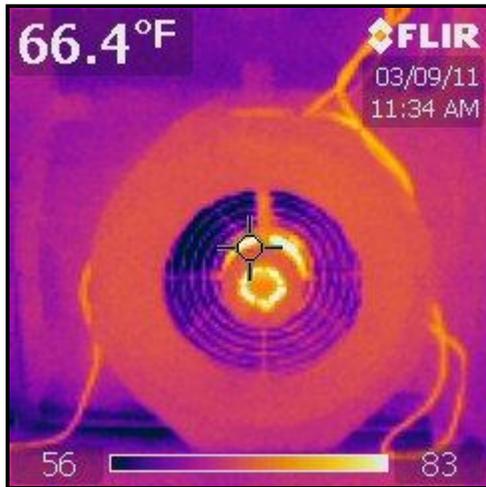
4.4 Picture 1 Blower Door Test

(1) With the home depressurized to -50 Pa, rooms were closed and the pressure difference measured tells how much pressure relief is resulting from leaks to the outside. 0 is no leaks. 50 is "open door" leaky.

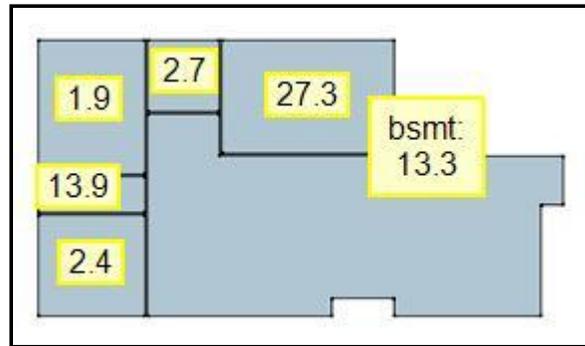
4.4 Picture 2 Blower Door Room Pressures

(2) While all rooms showed some evidence of air leakage during the blower door test, the kitchen and basement showed the greatest air leakage. The basement has the most surface area exposed to the outside and the kitchen has multiple penetrations due to the soffits and connections to both the basement and garage. Comprehensive air sealing efforts will result in a significant increase in comfort.

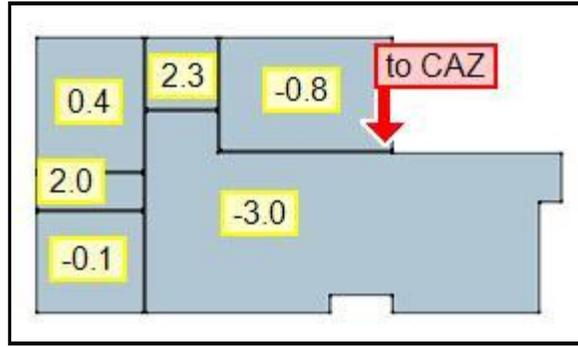
4.5 Picture 1 Air Handler Pressure Test

Using the air handler fan each room was tested by placing a manometer tube in the room with reference to the hall or main part of home and closing the door. Positive pressure readings of more than 3 pascals in a room indicates the need for more return air or a more balanced system between return and supply. There were no signs of duct imbalance during the room pressure test.

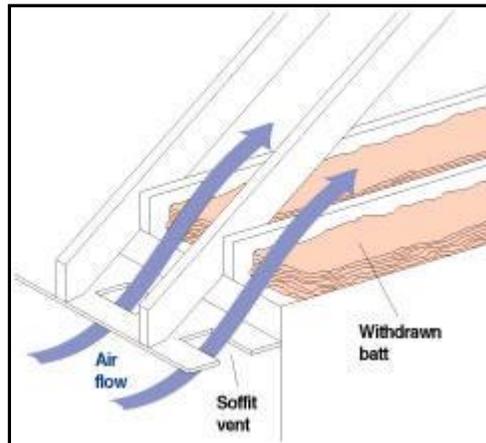
4.8 Picture 2 Attic Soffit Ventilation

(2) Ventilation of the home attic is important for two reasons. During the summer, excess heat that builds up in the attic during the day results in high energy costs for cooling. Also, moisture produced within the home may move into the attic if ceiling vapor barriers are not used. If this moisture is not exhausted from the attic, it can condense and cause insulation and construction materials to deteriorate. Thus, temperature and moisture control are the major reasons for providing attic ventilation.

(3) The attic could benefit from having additional soffit vents cut into the eave overhangs to allow additional ventilation capacity. This is especially true when increasing the tightness of the conditioned space of the home, when the attic no longer relies on ventilation from the rest of the house. Minimum required ventilation is to have 1 square foot of ventilation for every 300 square feet of attic floor area. Minimum recommended ventilation is to have 1 square foot of ventilation for every 150 square feet of attic floor area is often recommended. For this attic, that means about 8 to 16 square feet of soffit ventilation.

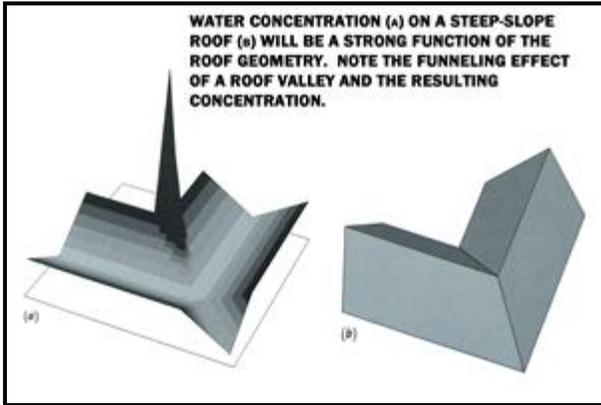
5.1 Picture 1 Valley Roof Water Concentration

(2) Valley roof sections not only carry a large amount of water, but that water is funneled down to a point. As shown in the diagram, the eave of the valley concentrates all the water from an entire corner of roof section to a single point. That point where roof sections are joined becomes a critically important area of water management. Having the chimney at the bottom of the roof valley makes the area even more critical as it must properly divert a large amount of water around it. This section of roof should be periodically monitored with regard to the integrity of the chimney flashing and also be kept clear of debris.

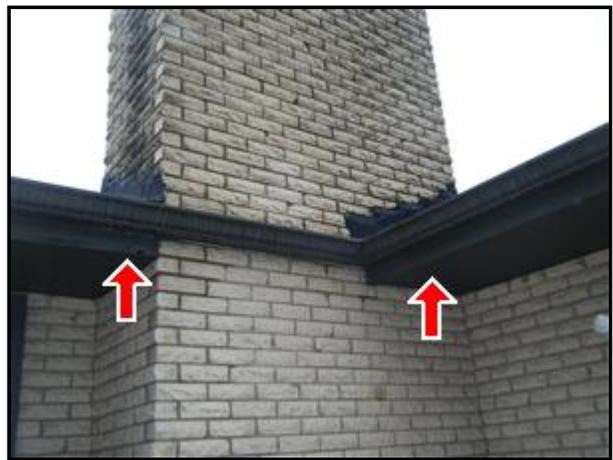
5.1 Picture 4 Possible Overspill

(1) The gutters are in fair condition and seem to be managing rain water effectively. Gutters should be periodically cleaned. There is no obvious evidence of water overtopping the gutters, but the north face of the building may already be near or at capacity. Recommend monitoring during rain events to determine whether additional downspouts are needed (wherever rain is spilling over gutters).

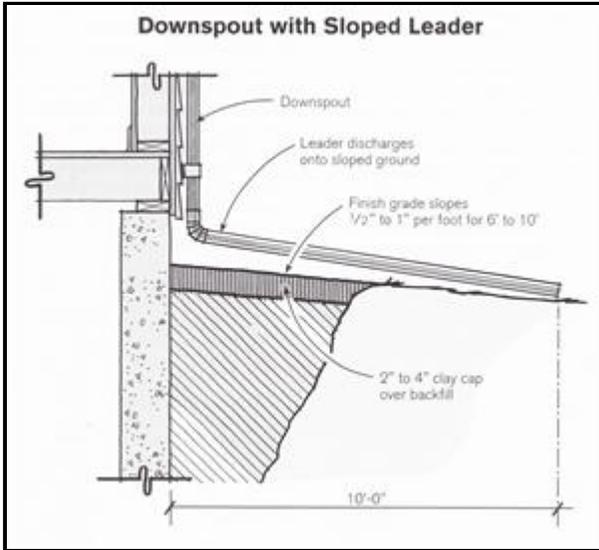
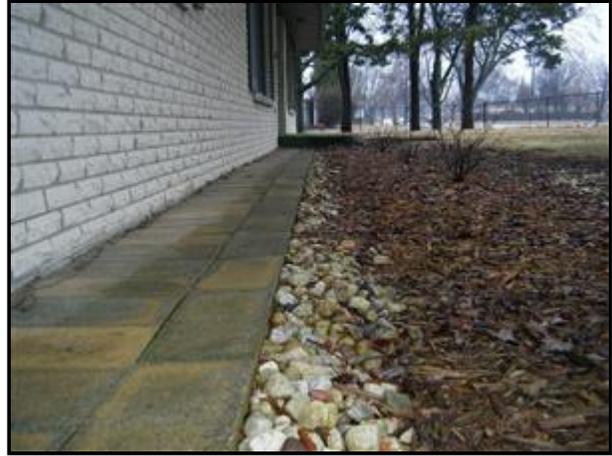
(2) There is a not a significant amount of slope in the front, rear or sides to drain water away from the home. The slope should allow water to flow away from the home's foundation to prevent any flooding, or damage to

the home. Because the existing grading is relatively flat, the ground around the foundation should be monitored for signs of drainage concerns, especially during heavy rain.

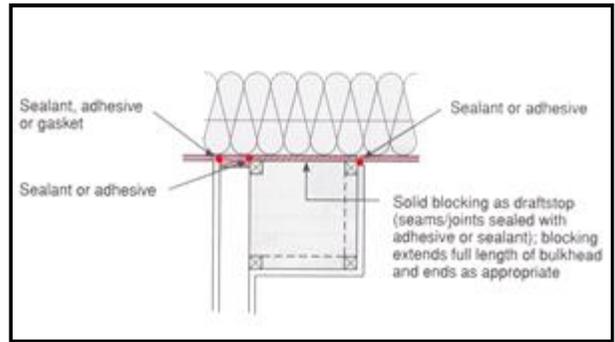
6.2 Picture 2 Soffit Sealed at Top

The top of the soffit should be covered with foam board and sealed to the framing and drywall to create a continuous air tight sealing, the air barrier between the conditioned second floor and the unconditioned attic.

Recommend having a qualified contractor insulate, and air seal the soffit.

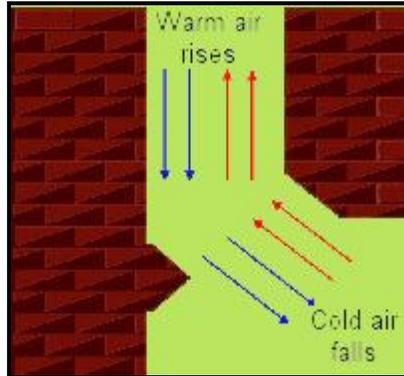
6.6 Picture 1 Before

If the chimney is not used very often it is recommended that a chimney balloon be installed. The damper flue, currently in your chimney, does not seal off the opening completely. By installing a chimney balloon you are creating a tighter seal in which less air flow will be lost.
